January 22, 2009

RE: Existing Conifer Trees along Willamette Street

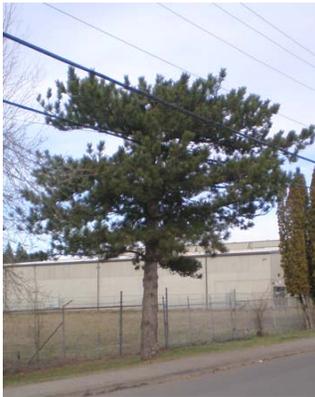
Tree 6

We believe that there are of problems with the health of the existing trees that warrant the removal and replacement with healthy tree specimens. Due to the existing overhead power lines, each of the trees appears to be topped. Topping a tree will make the tree more susceptible to storm damage and prone to insect and disease problems. Depending upon how the top of the tree was treated, it may also be more likely to develop root rot over time. In addition, it is our experience that street trees are limbed up 6-8 feet for visibility, safety and security. As you can imagine, a tree that has been topped and pruned up will not be truly expressive of the tree's natural form and character.

As part of the proposed development, this portion of Willamette Street will be widened. The construction of the road and new sidewalk would cause additional stress to the trees. Tree no. 6 is located 6-feet from the new curb. Even with a small, curb-tight sidewalk, construction would be well under the tree's canopy and require cutting the roots. The result would be weak, unhealthy specimens.

After our on-site inspection, we feel that removing the existing trees and replanting with approved street trees is the best option because it will limit extra maintenance, offer healthier specimens and provide a better buffer to the adjacent neighborhood.

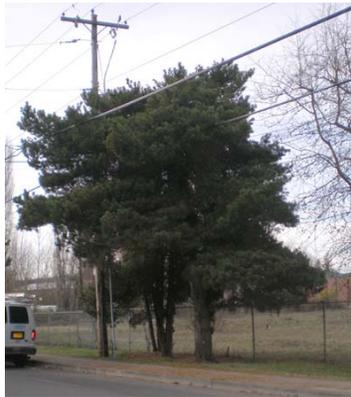
Tree 7

Also, we noticed that the trunks of trees no. 7 and 8 show signs of stress and illness. Excessive sapping is visible on no. 7 (photo 1, attached) and boring indicative of beetle infestation is visible on no. 8 (photo 2, attached.)

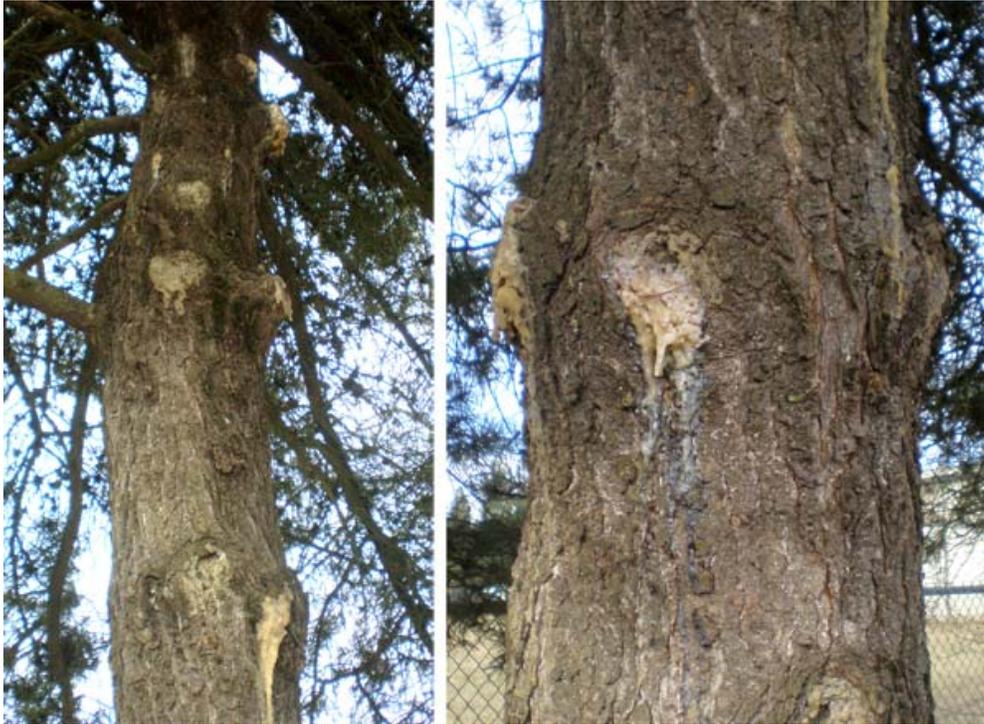
Photo 1 – Excessive sapping on Tree no. 7

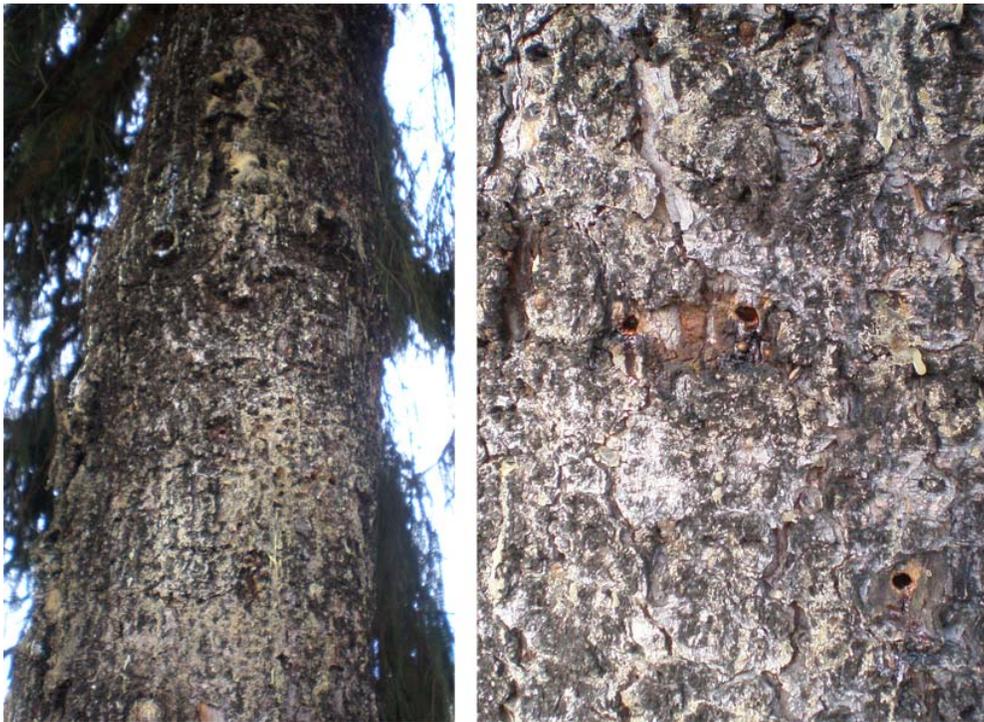
Photo 2 – Boring evidence on Tree no. 8
