# Tree Removal December 2022 Open Spaces (Dewberry and Fitch)

December 5th, 2022

# Open Space- 23833 SW Dewberry Pl.

Reference: Tree Assessment  
Location: Green Space Behind 23833 Dewberry Place, Sherwood, OR.  
Subject: Cherry Tree  
Inspection Date: 11.7.22

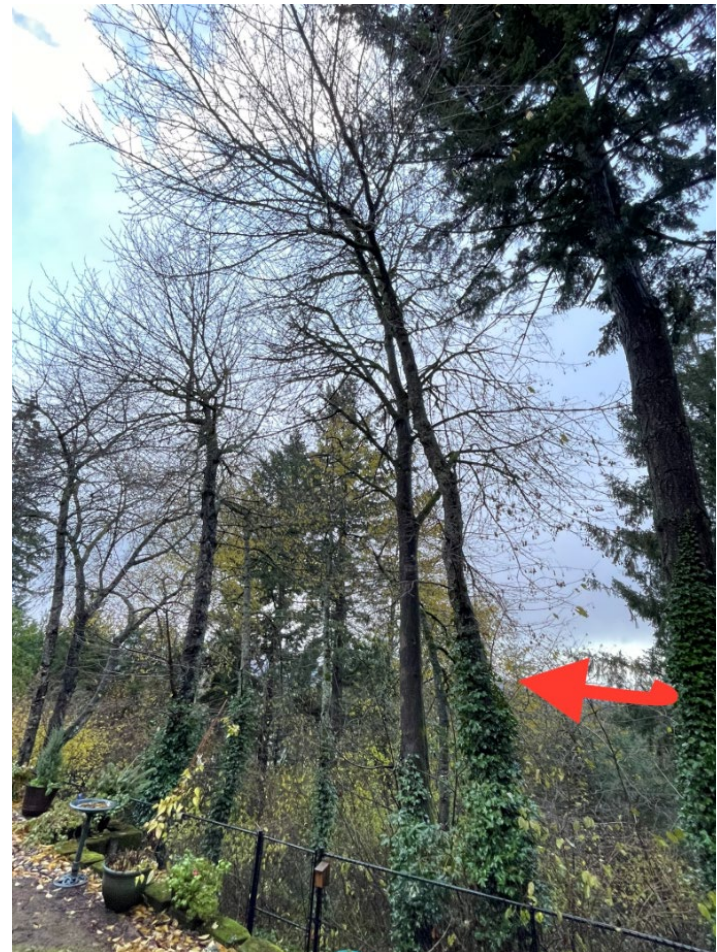
**Evaluation:** The tree is in fair health. The structure of the tree is very poor due to poor symmetry and a heavy lean toward the nearby residence due to overcrowding. There is a history of limb breakage throughout the canopy.

- Remove one Cherry Tree, due to poor condition, overcrowding and safety of surroundings

**Results:** Due to the trees poor structural condition, I recommend the trees removal for safety to surrounding persons and property.
