Here is the Tree Identification and Report for Project 17687 SW Brookman Road Sherwood, OR 97140. This document is for use the meeting City of Sherwood Urban Forestry Plan Standards / codes (16.142.070). The site map shows the location of the trees.

Project Name: 17687 SW Brookman Road Sherwood, OR 97140

Application#: Brookman's Place

I inspected the site on January 5, 2022. Observations and conclusions are as of that date.

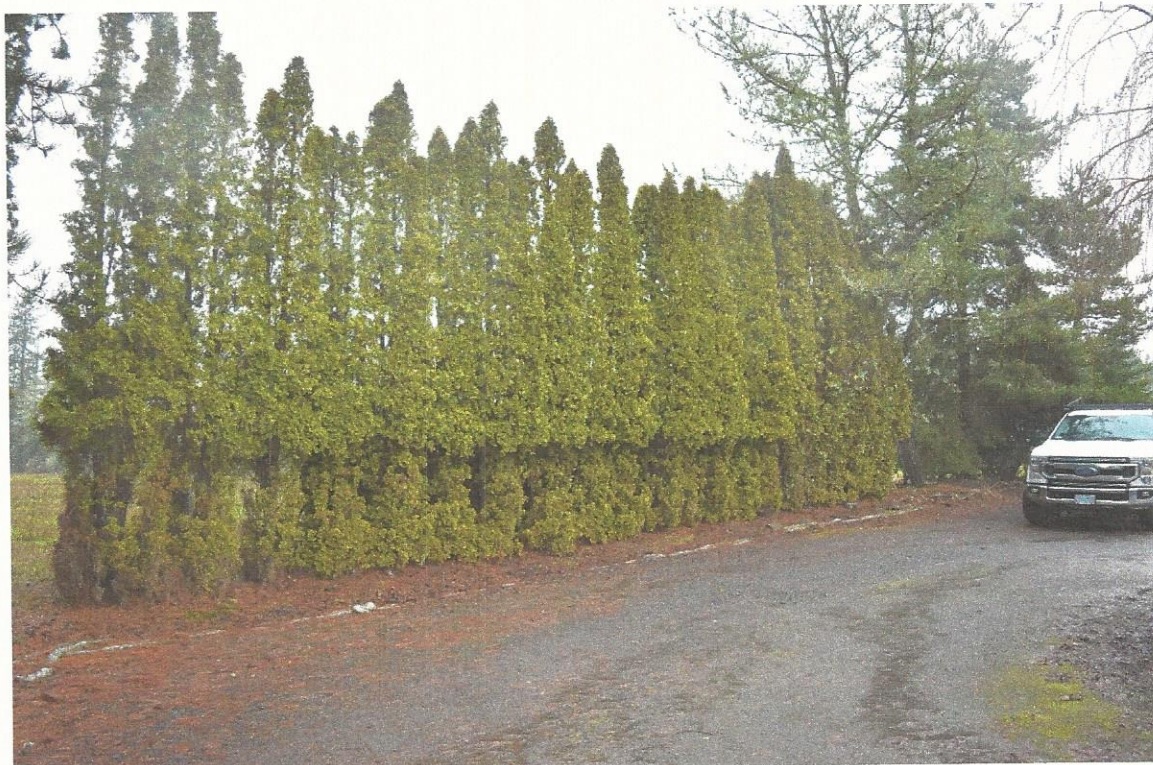
The arborvitaes are in fair condition and mature. They do provide canopy cover and privacy for the existing buildings.

Arborvitae along existing driveway.

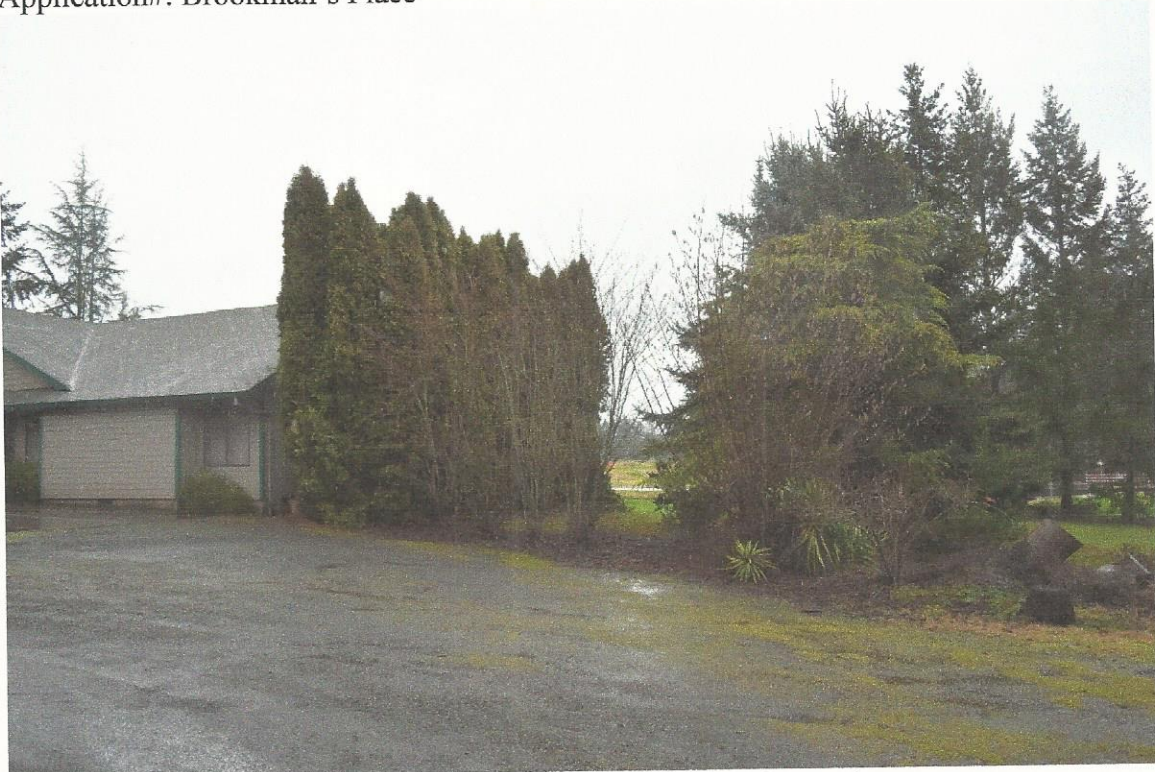
Arborvitae by existing house, view of spruces and firs to the south.

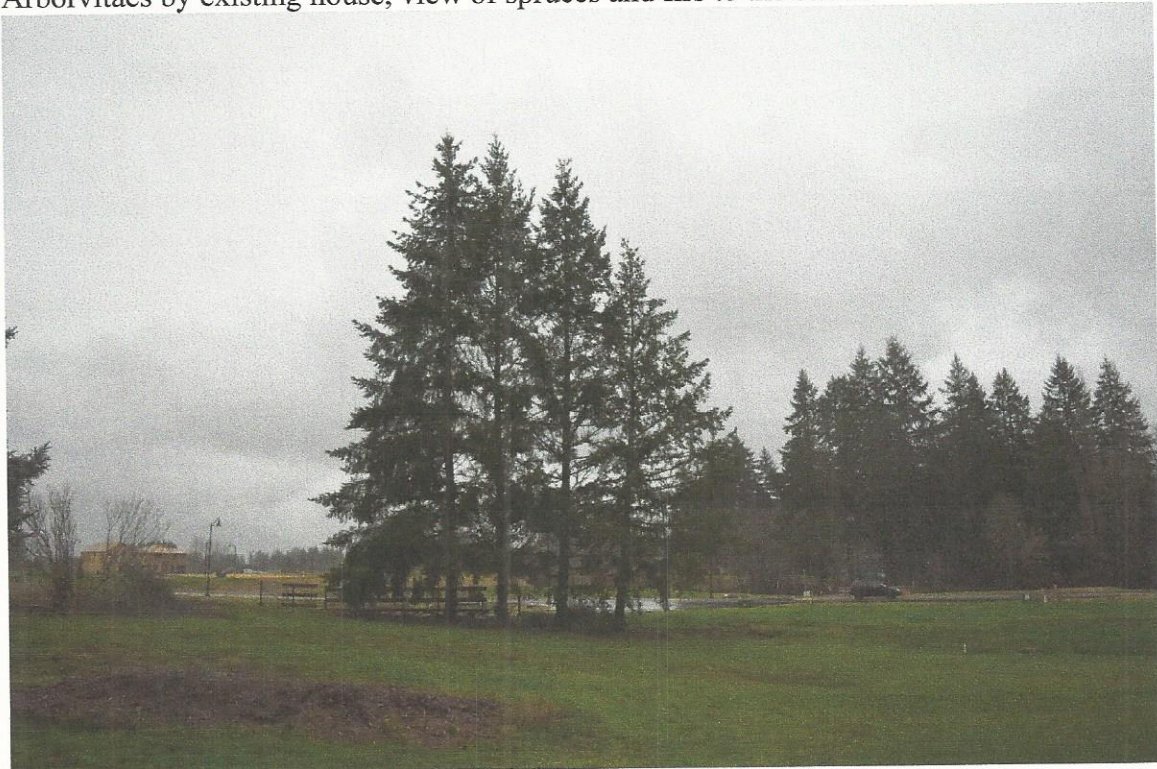
Many of the site trees, especially the Douglas firs have root disease as seen by tip dieback and poor growth seen in the trees.

Douglas firs on the southern edge, the trees on the right show tip dieback and lack of growth.

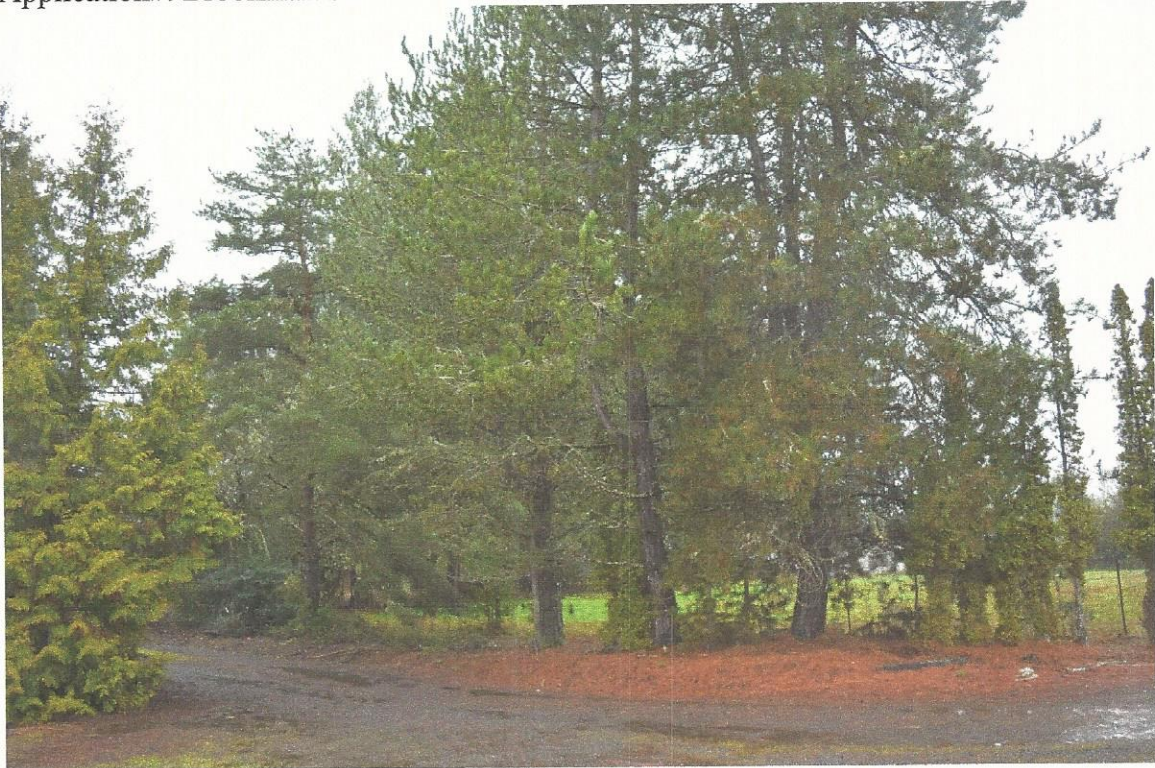
The pine trees have pine beetles, but could fight off the insects till they turn brown and die.

Pine trees across from existing house.

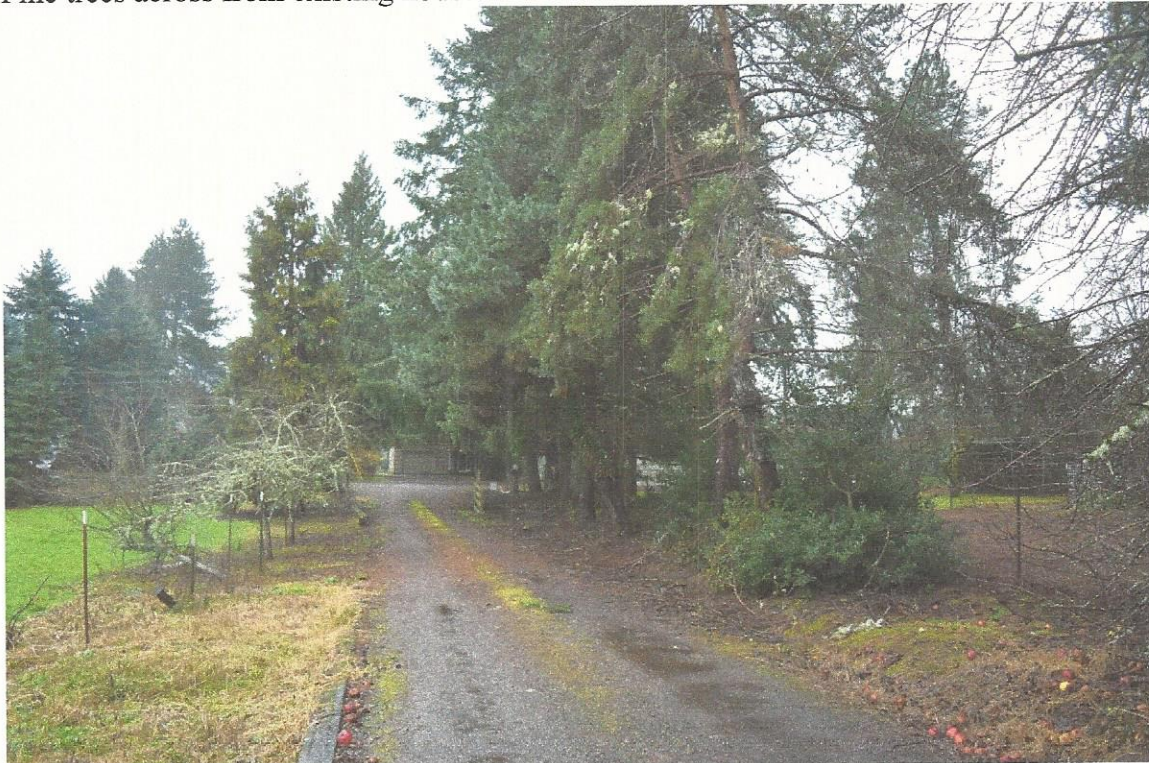
Pines along existing driveway and apple trees toward Brookman.

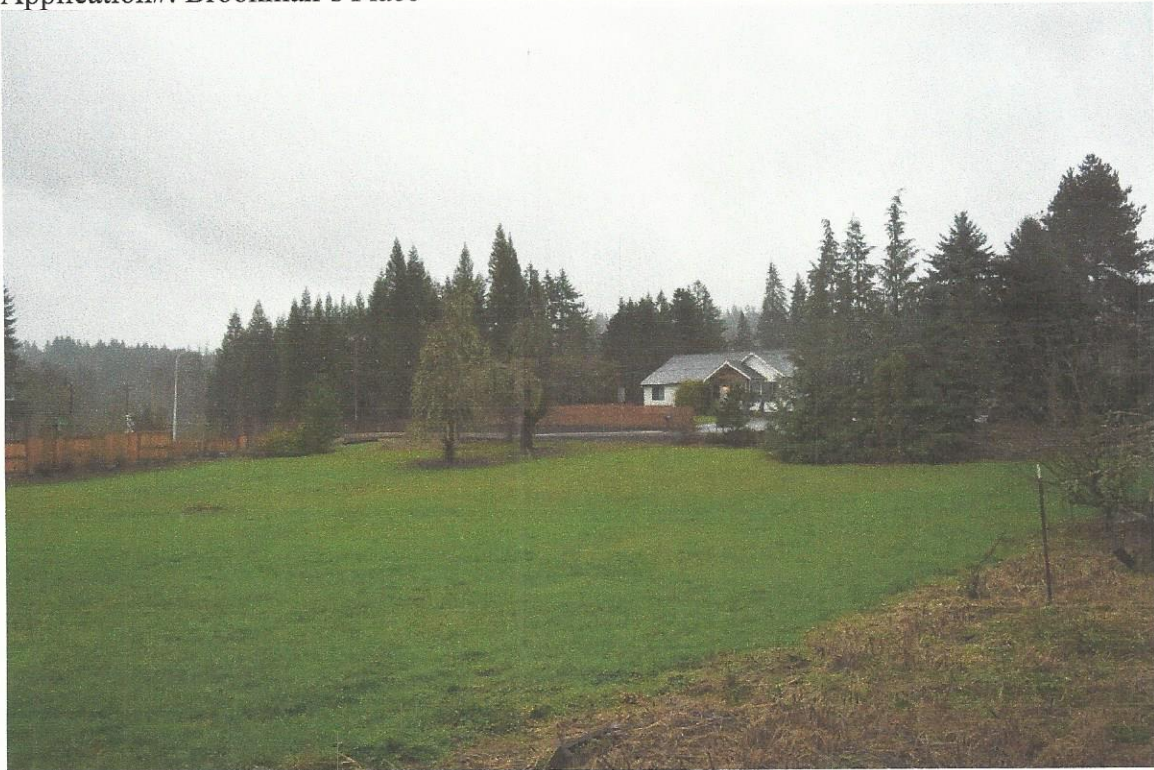
The cottonwoods/ poplars were cut when the property to the south was developed. The poplars send root suckers out and can damage future properties or infrastructures placed on site. I have seen poplars cause great degree of property damages. The issues are they were not poisoned after cutting. The options are to dig the stumps and roots out prior to development or cutting and poisoning. Either way, the poplar area will need to be monitored to make sure the poplars don't regrow and spread more roots and shoots.

View of the west side with apple trees and clump of cedar and spruce trees. Cottonwood stumps are on the left side of photos.

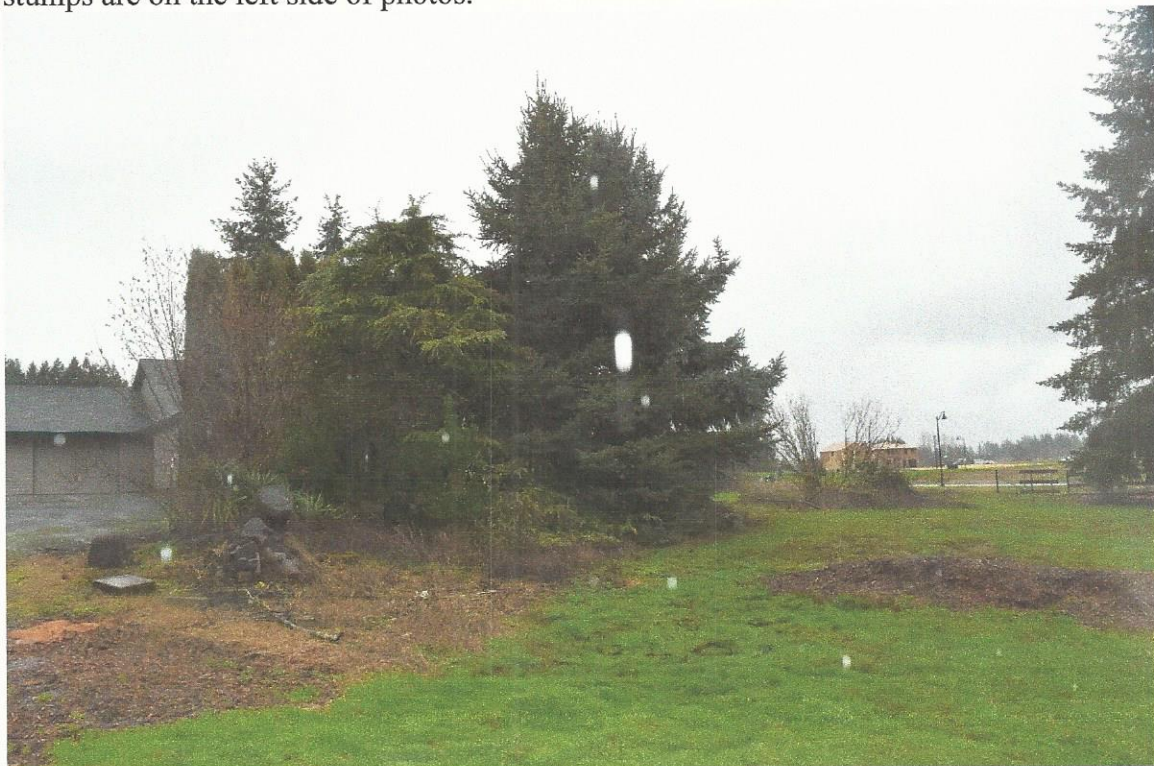
Spruce trees and regrowth of trees that were cut down.

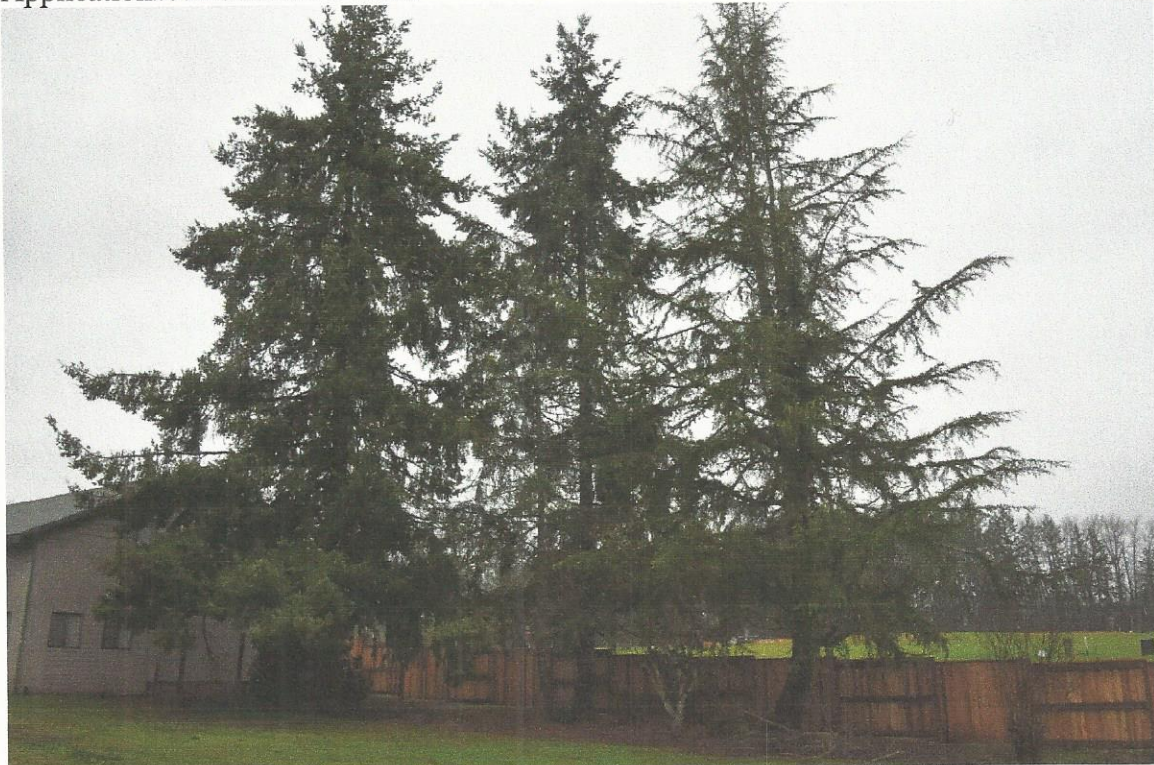
Trees on the east side. Tip dieback can be seen in the trees.

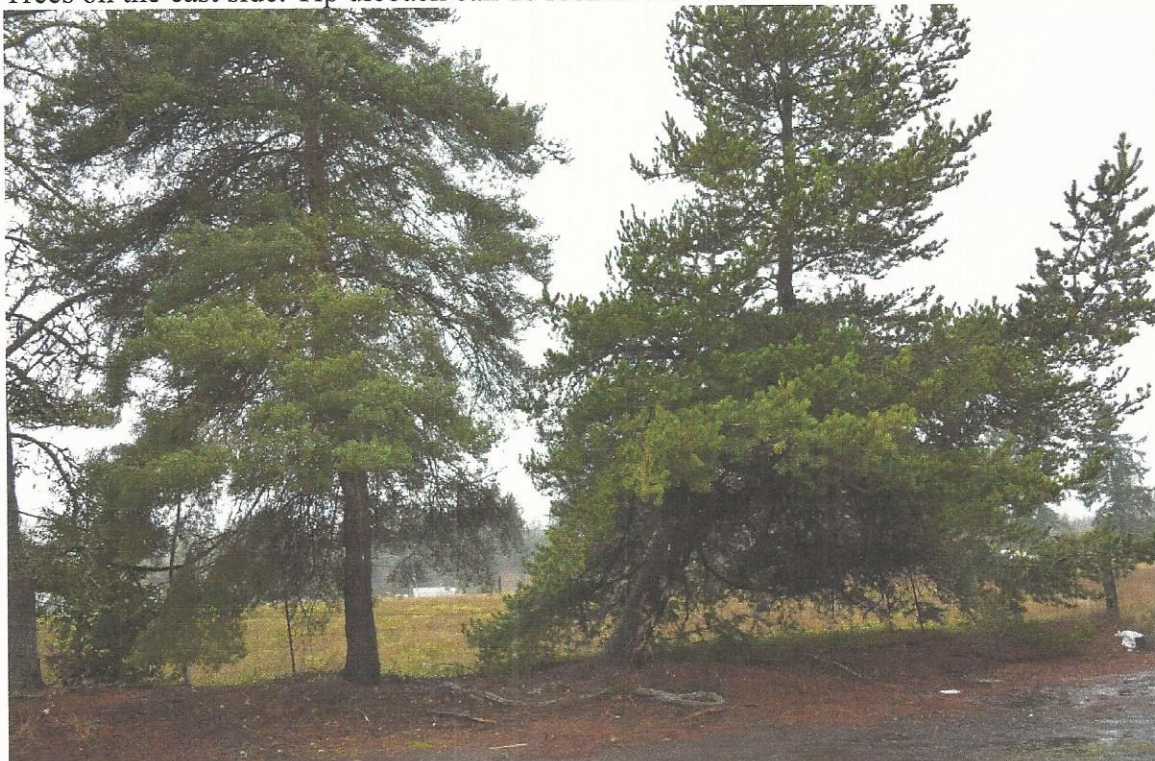
Pine trees to north of property, existing house.
