**Re: The Springs Living; Proposed facilities expansion
Clean Water Services File Number 13-002937
PHS Project # 5359**

Pacific Habitat Services, Inc. (PHS) completed a Simplified Site Assessment for a proposed residential development in Sherwood, Oregon (Township 2S, Range 1W, Section 32BA tax lots 400, 401, 402, 600, 4300 & 4400). The site within the limits of the tax lots as shown on Figure 2 is proposed for development entailing expansion of the existing assisted living facility. According to CWS protocol, an on-site assessment was completed by PHS on December 4, 2013. The following documentation has been submitted on behalf of the owner and applicant of the above referenced CWS file.

Photodocumentation of conditions at The Springs Living in Sherwood, Oregon. Both photos taken December 4, 2013.

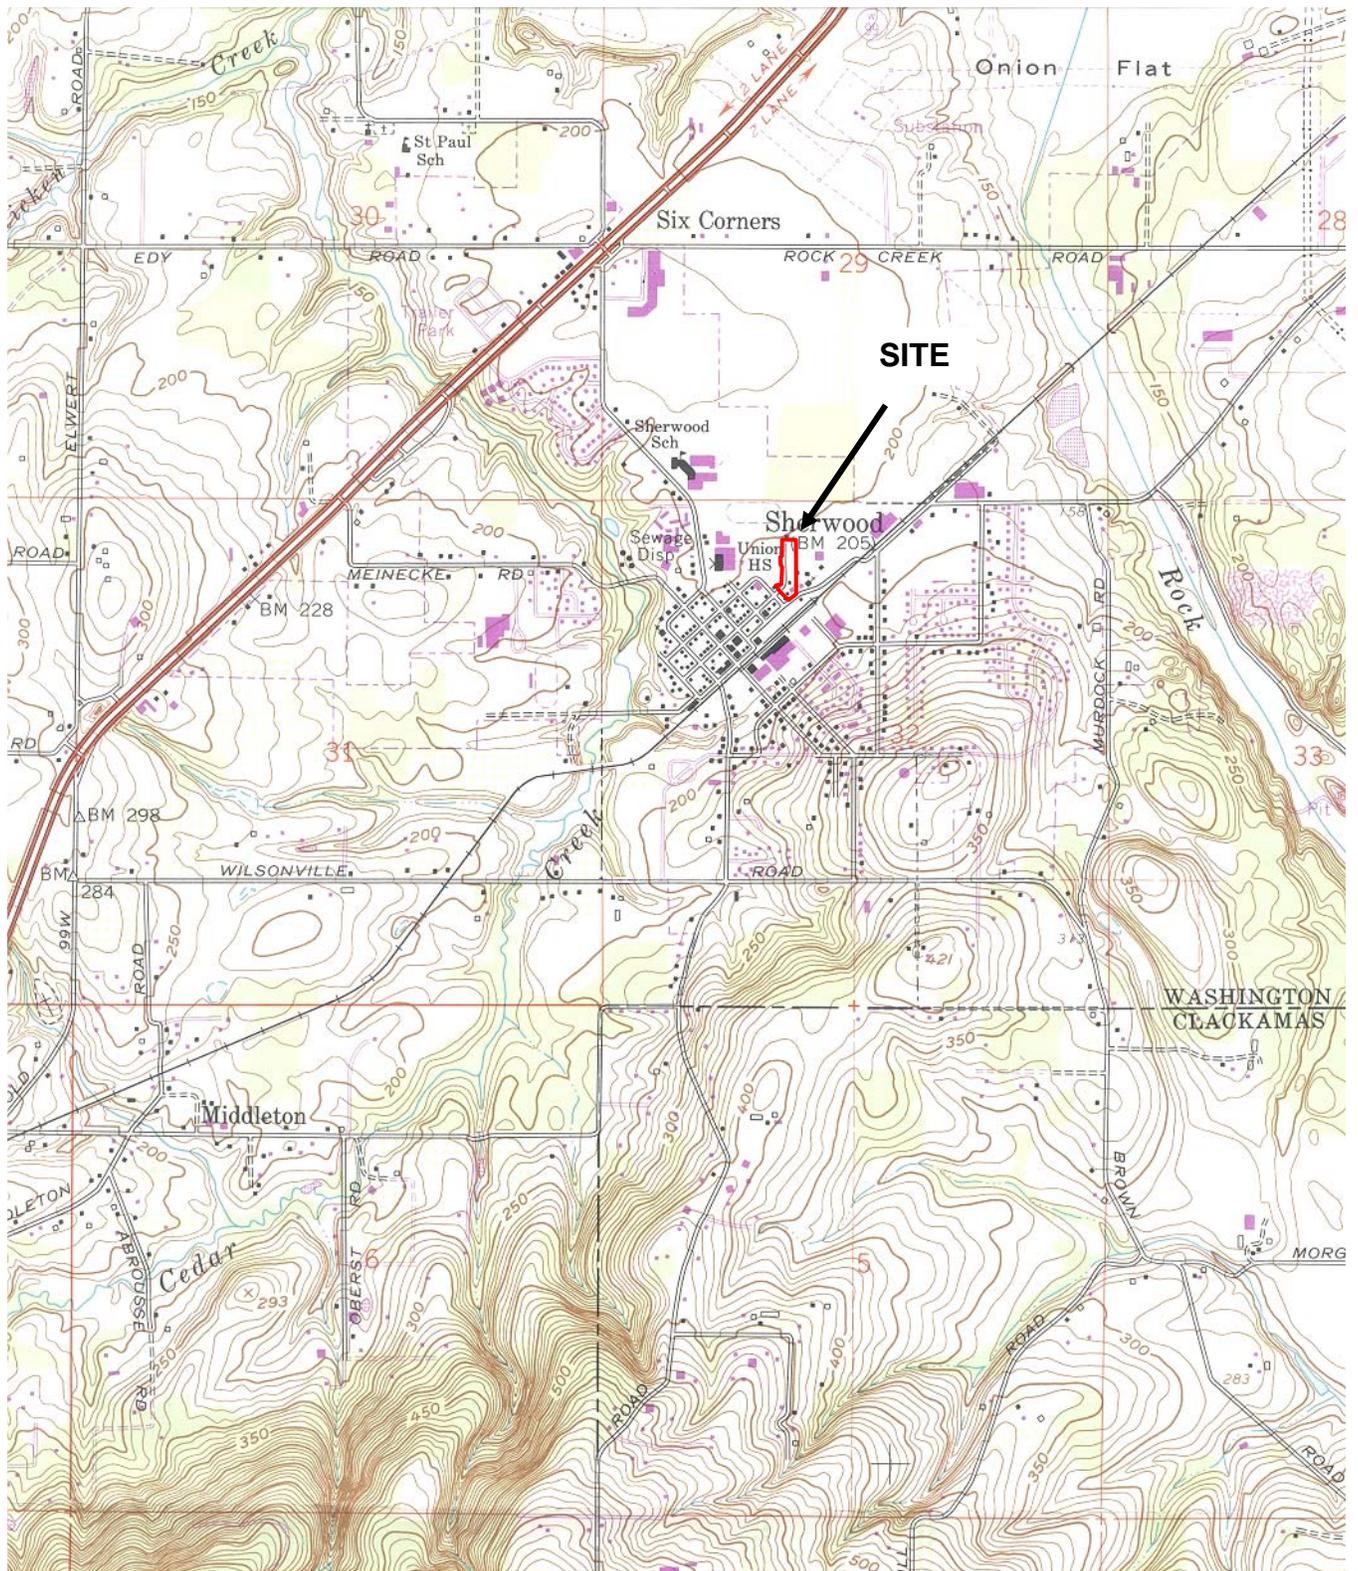
FIGURE
1

Location and general topography for the vicinity of The Springs Living in Sherwood, Oregon (USGS, Sherwood, Oregon quadrangle, 1961, photorevised 1985).

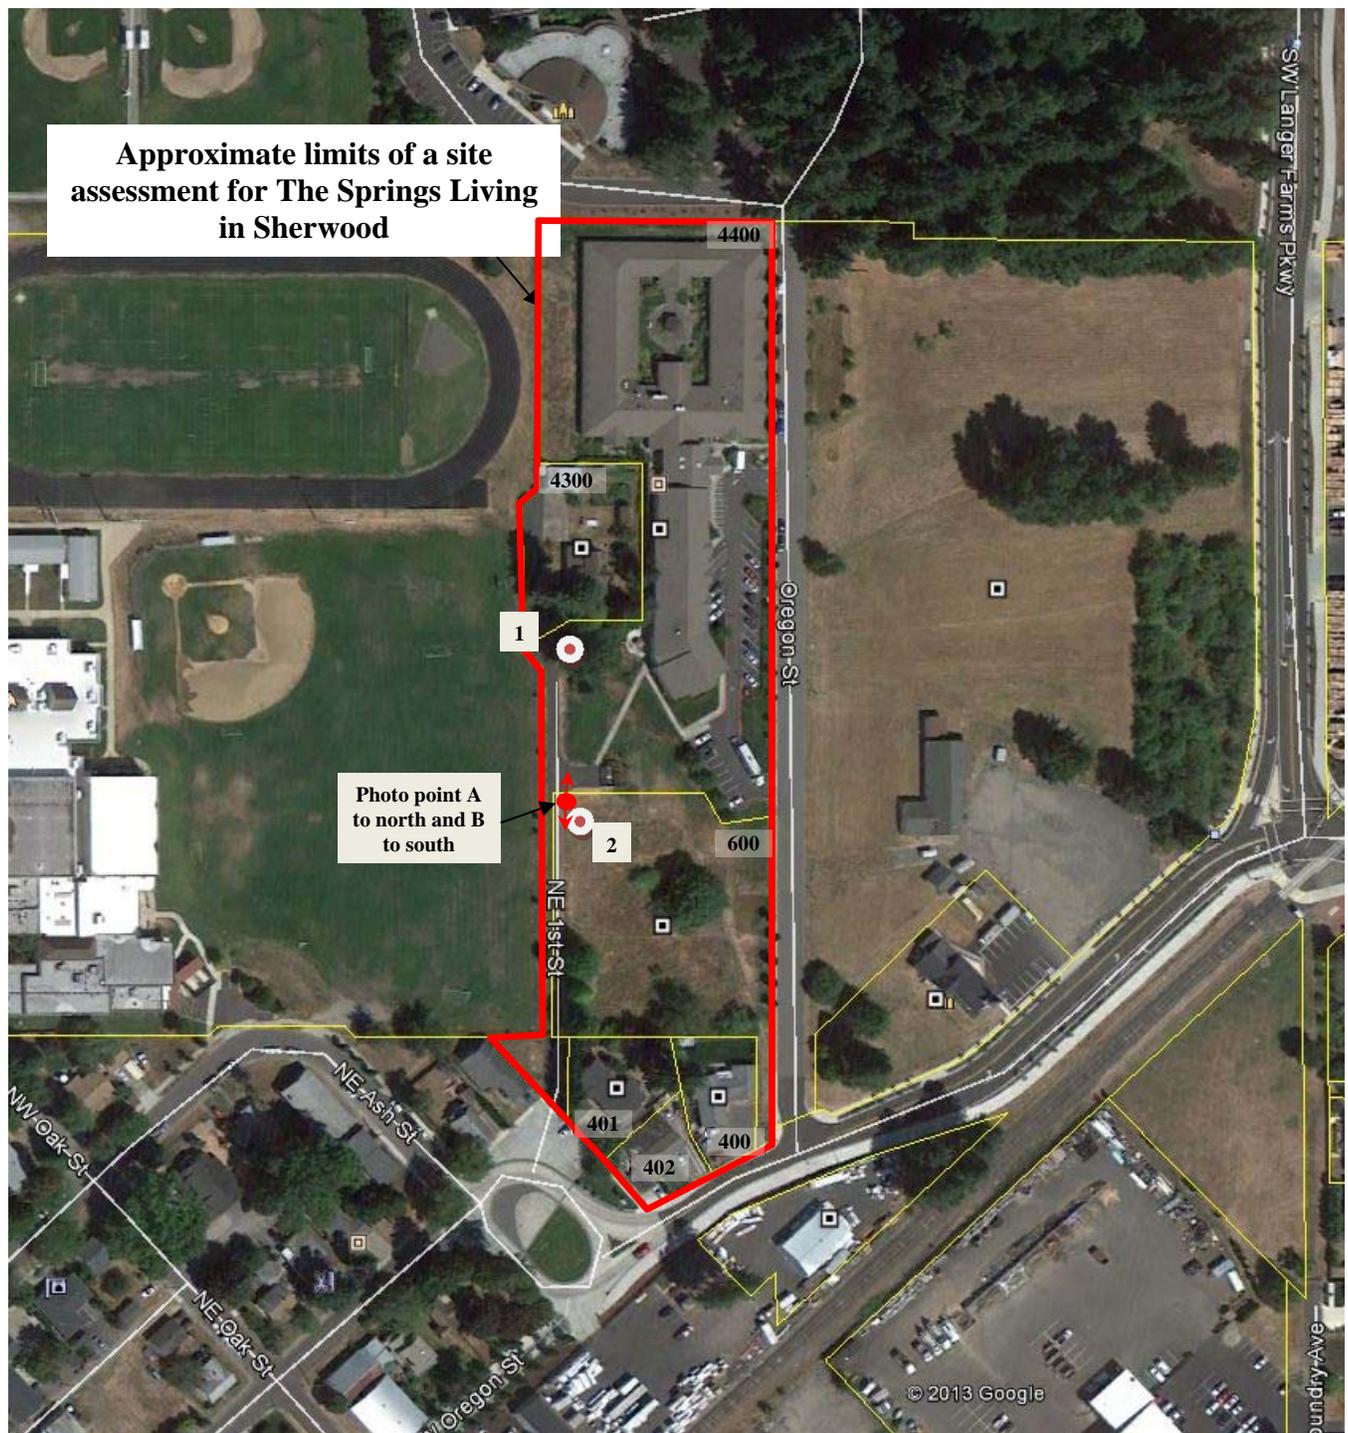
FIGURE
2

Photo point A to north and B to south

Existing conditions at The Springs Living in Sherwood (Google Earth, 2013). The approximate location of Sample Points 1 and 2 and Photo Points A and B are identified. Lot numbers are identified for each lot.

In order to document the wetland determination, two sample points were recorded. The first is located in the shrub area north of the lawn on lot 4400, and the second in a local low point in the northwest portion of lot 600. The northern and eastern portions of lot 600 include manicured lawns. Beyond the limits of lawn care on lot 600, vegetation is a mix of non-native grasses and common herbaceous weeds. The most common species on lot 600 include Colonial bentgrass, English plantain, Queen Anne's lace, sweet vernal grass, orchardgrass, tall fescue, and common velvetgrass. Trees on lot 600 include big leaf maple, California black oak, sweet cherry, and apple; shrubs include rose, English hawthorn, cherry or plum, and Himalayan blackberry. Mature trees on lot 4400 include two Douglas fir and one each of elm, redwood, and an unidentified willow. The residential parcels in the south include a large Douglas fir tree as well as several hedge rows (*Arborvitae*) and ornamental deciduous trees.

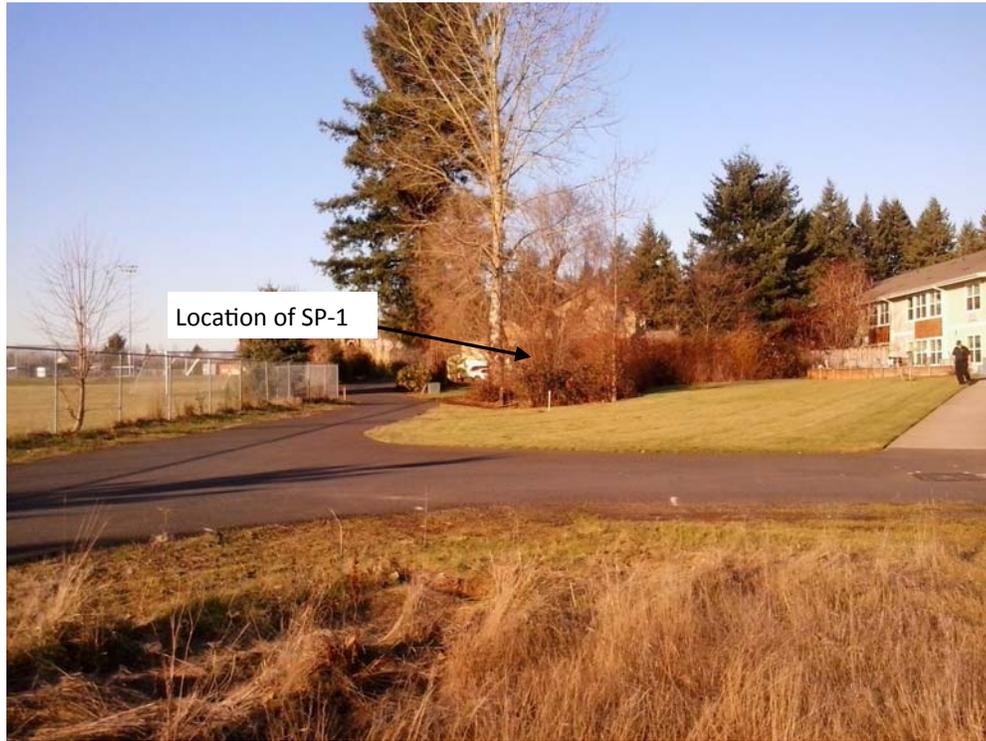
Photo A

View to the north across the southwest portion of lot 4400.

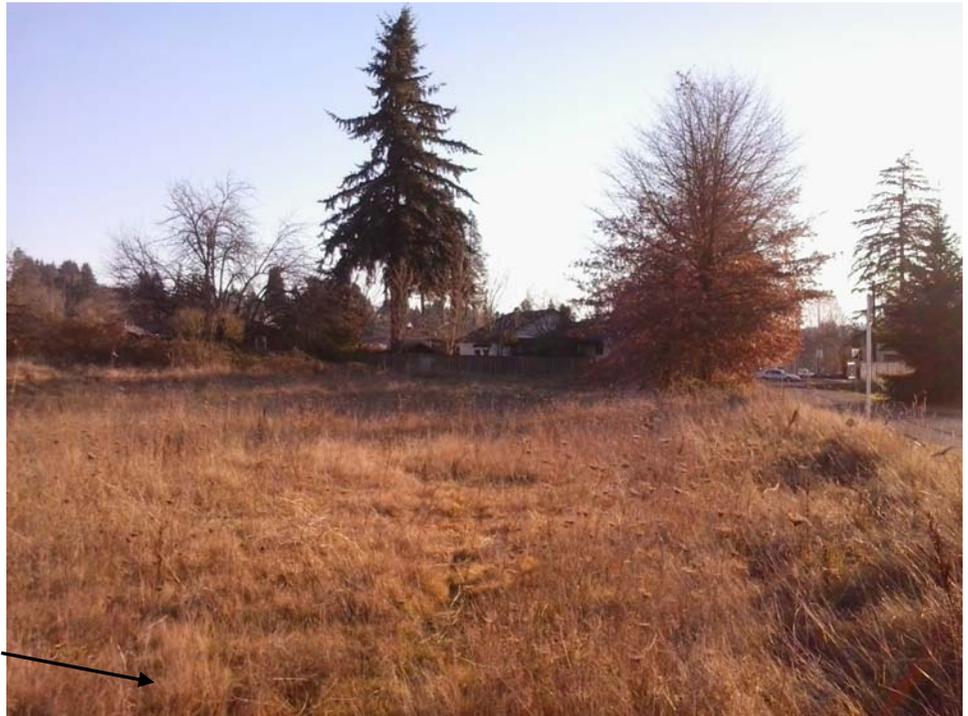
Photo B

View to the south across the west portion of lot 600. The large Douglas fir is located among the residential parcels at the southern limits of the site.

Location of SP-2
