## Natural Resource Assessment

**To:** Amber Wierck, Clean Water Services  
**Cc:** Nathan Doyel, Applicant  
Chris Goodell, AKS Engineering and Forestry  
**From:** Stacey Reed, Wetland Scientist  
**Date:** May 13, 2013  
**Subject:** Request for Service Provider Letter  
17680 SW Handley Street and 22065 SW Pacific Highway  
Sherwood, Washington County, Oregon  
Tax lot 1600 of tax map 2S 1 30CD and tax lot 2100 of tax map 2S 1 31BA

SW Handley Street and SW Pacific Highway  
 Natural Resource Assessment  
 Sherwood, Washington County, Oregon

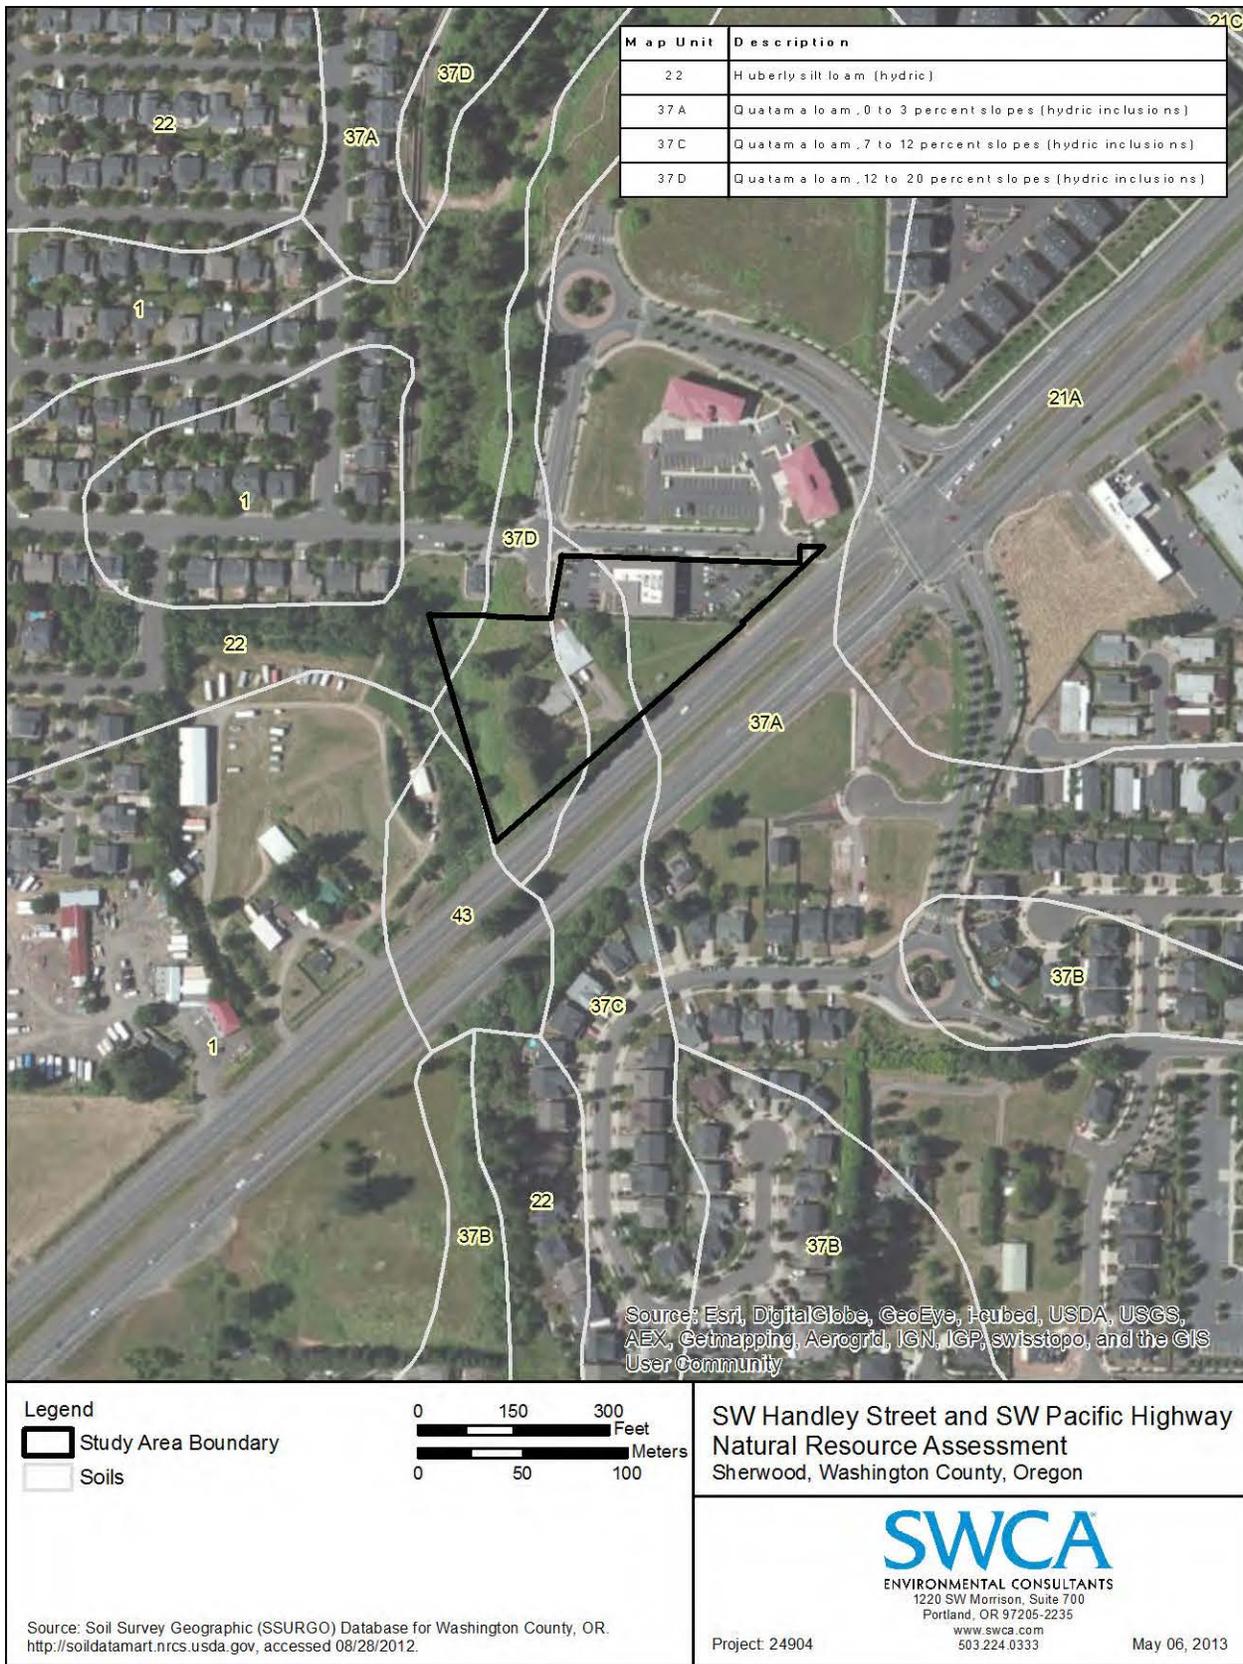
**Figure 3.** Soil survey map.

According to the Natural Resources Conservation Service (NRCS) Washington County, Oregon area soil survey, hydric Wapato silty clay loam (Unit 43) and Huberly silt loam (Unit 22) are mapped in the western portion of the site along the tributary and adjacent wetlands. Non-hydric Quatama loam with 0 to 3% slopes (Unit 37A), 7 to 12% slopes (Unit 37C), and 12 to 20% slopes (Unit 37D) are mapped throughout the remainder of the study area (Figure 3). Quatama loam soils may have hydric Huberly inclusions. According to the City of Sherwood Local Wetland Inventory (LWI) map, wetlands are mapped in the western portion of the study area (Figure 4). Our site investigation generally agrees with the LWI mapping.

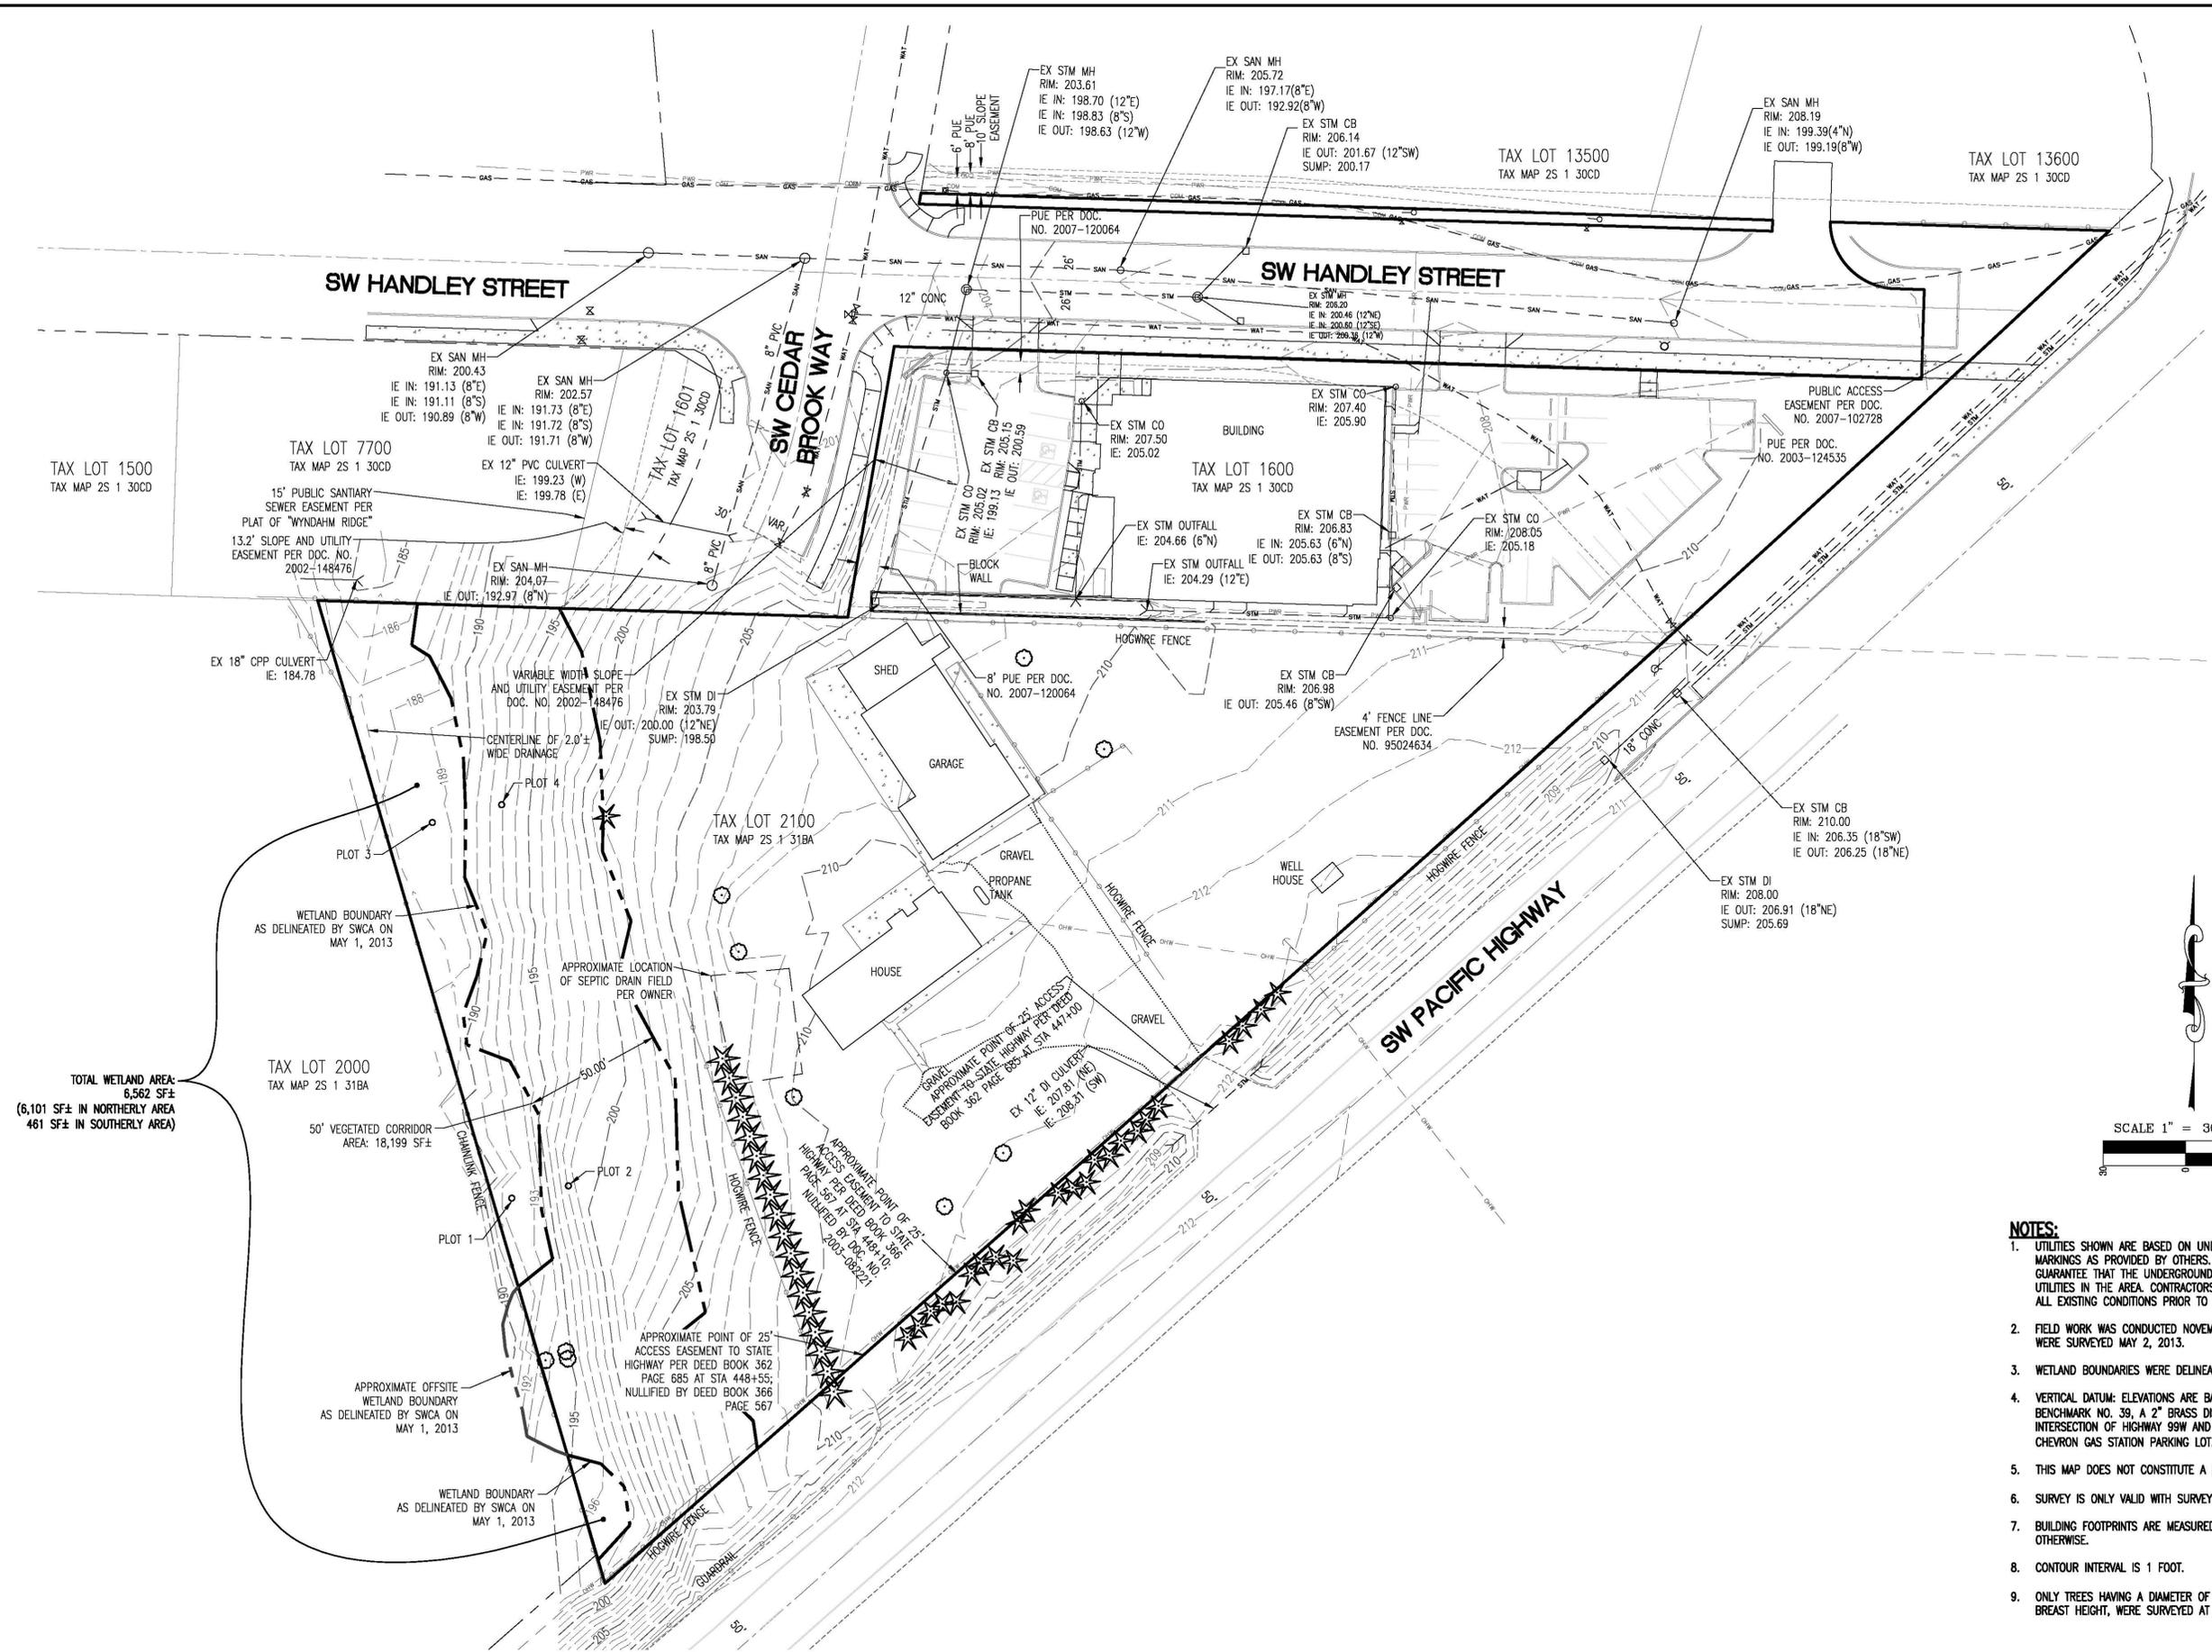
Figure 5  
SW Handley Street and SW Pacific Highway  
Natural Resource Assessment  
Wetland Delineation Map

The on-site wetland boundaries and Plots 1 through 4 were flagged in the field by SWCA on May 1, 2013, and their locations were professionally land surveyed by AKS Engineering and Forestry (Figure 5, Existing Condition).

The slope adjacent to the floodplain wetland is less than 25 percent, which requires a 50-foot-wide vegetated corridor. The total on-site vegetated corridor is 18,199 square feet. The extent of on-site corridor is shown in Figure 5.

TOTAL WETLAND AREA:  
6,562 SF±  
(6,101 SF± IN NORTHERLY AREA  
461 SF± IN SOUTHERLY AREA)

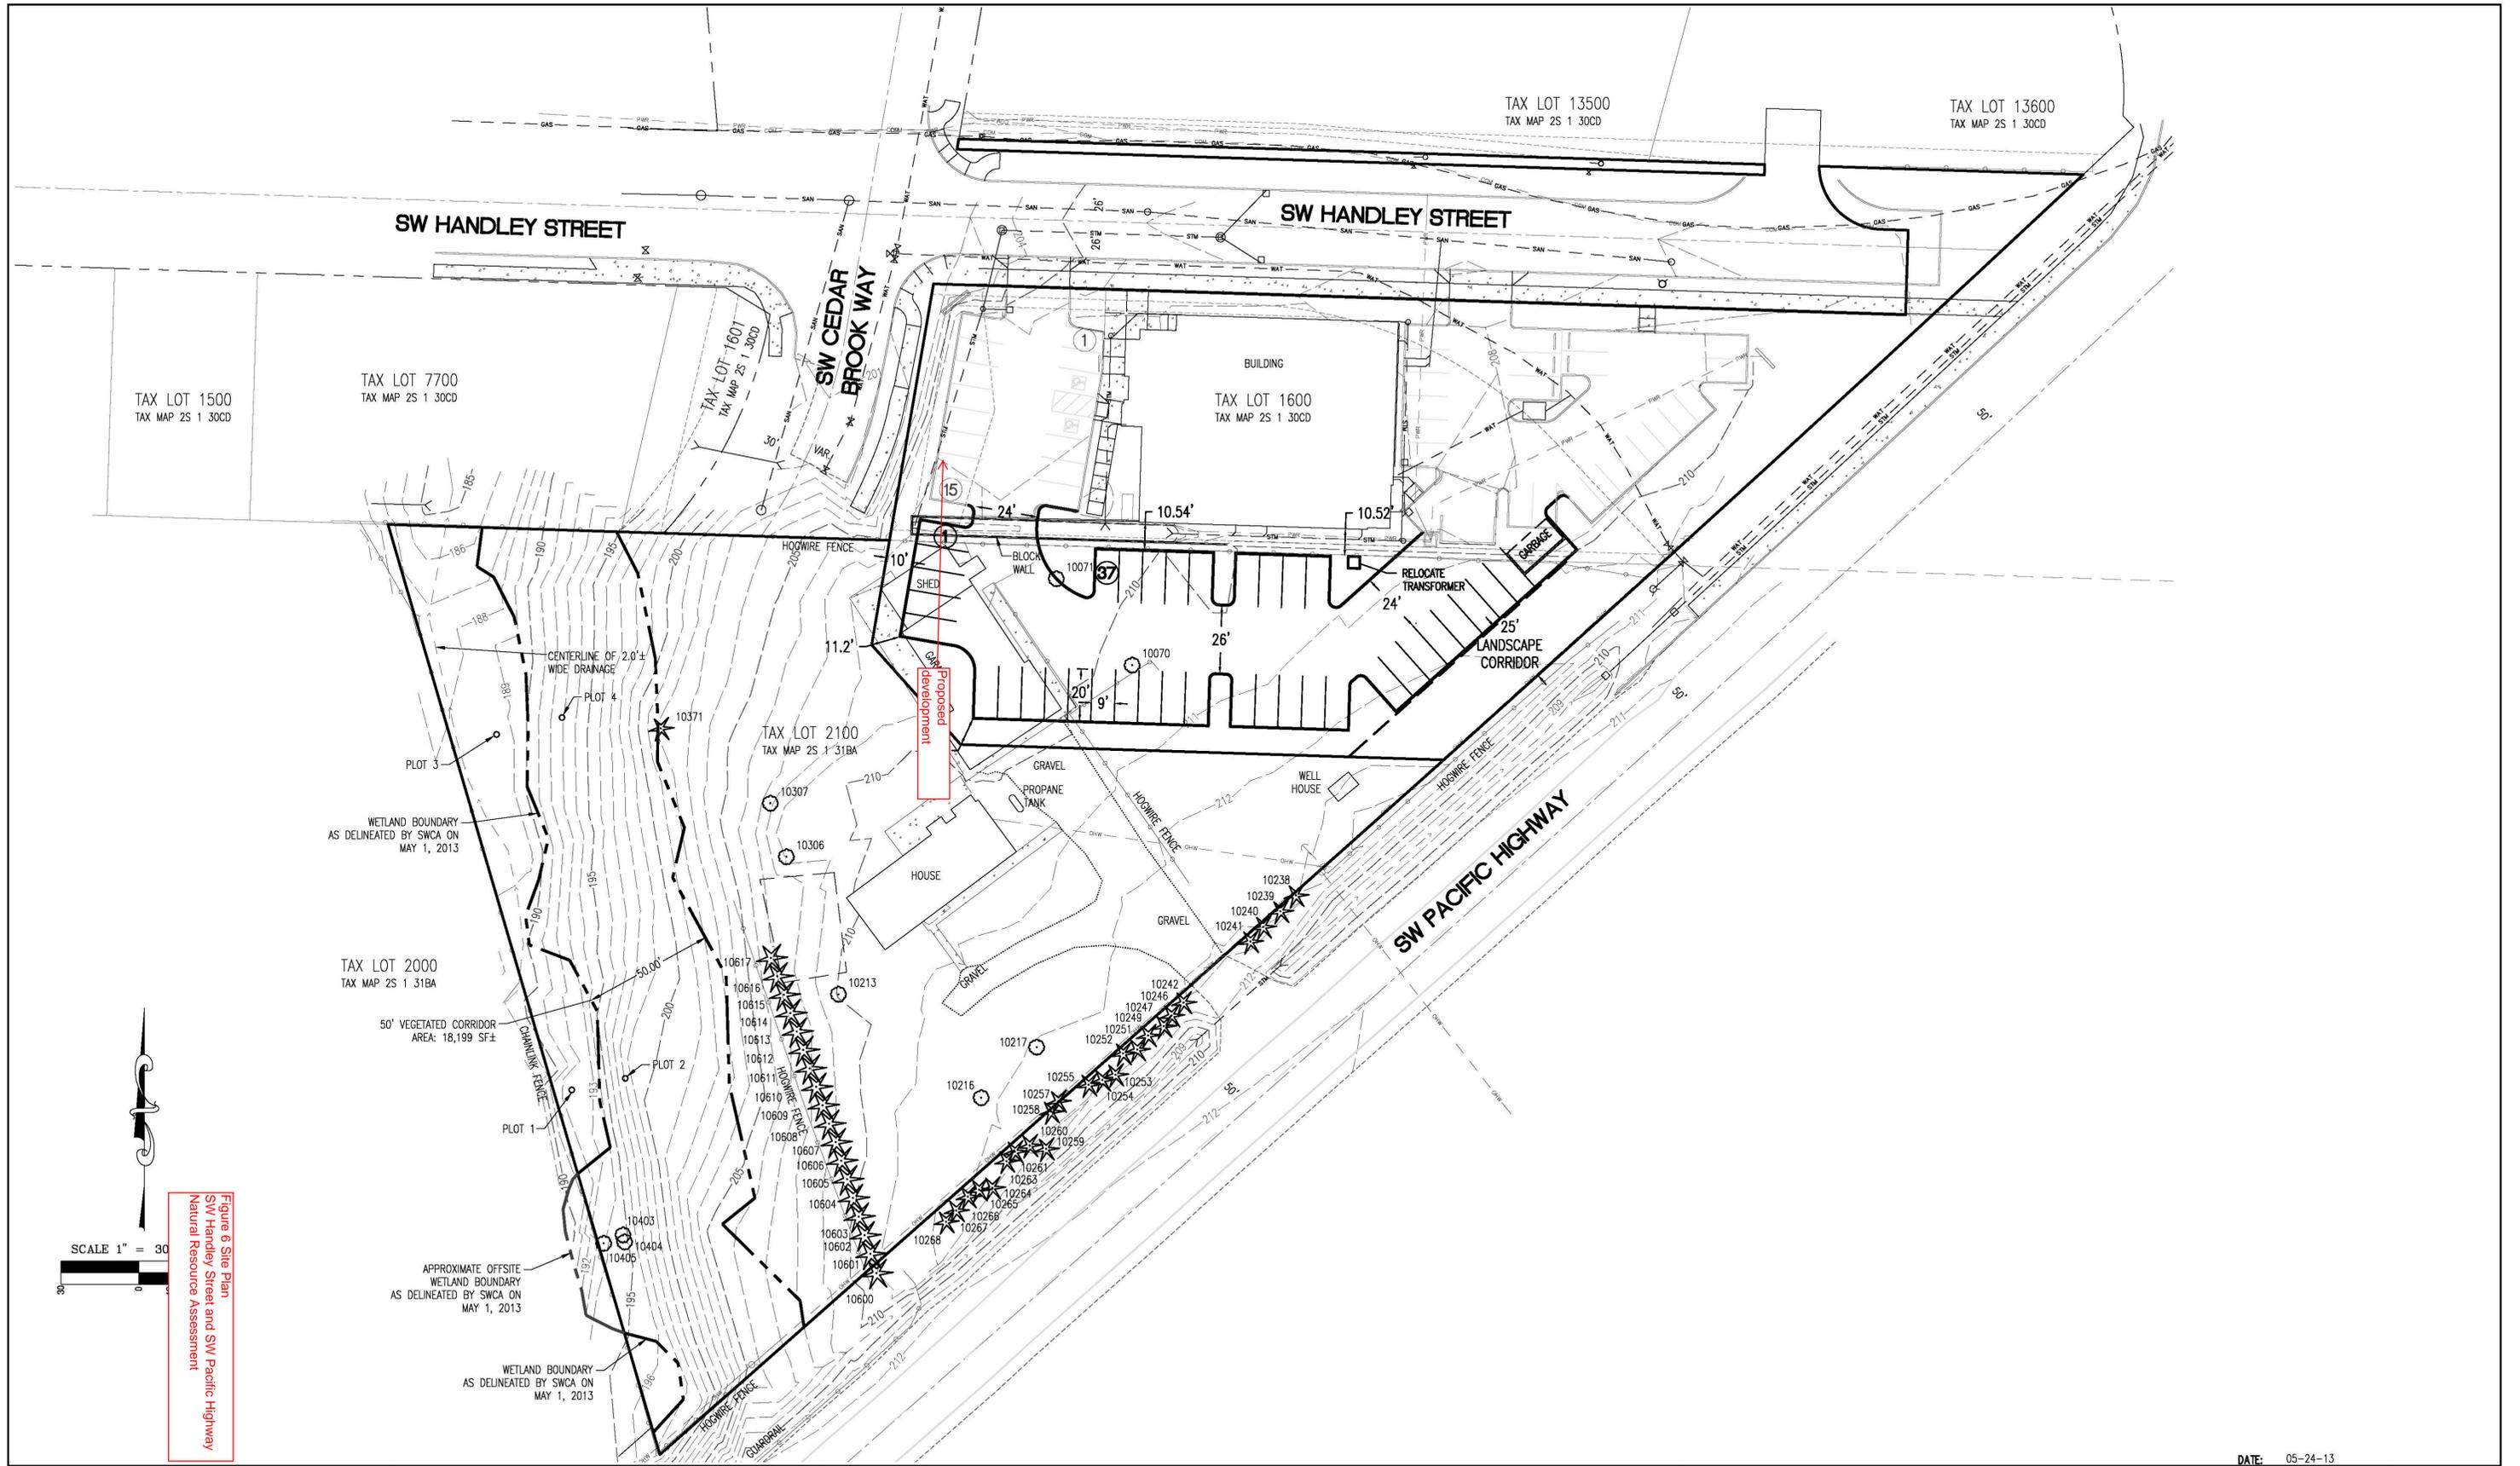
Figure 6 Site Plan  
SW Handley Street and SW Pacific Highway  
Natural Resource Assessment

The project will not result in any permanent or temporary vegetated corridor impacts. The proposed site plan is included as Figure 6 and involves constructing approximately 12,700 square feet of paved parking and curb area in the northern portion of tax lot 2100.

All of the 18,199 square feet of on-site *degraded* condition vegetated corridor on tax lot 2100 will be enhanced to *good* condition. The attached vegetated corridor planting specification table lists the species, size, spacing, and quantities recommended for the vegetated corridor enhancement areas. The proposed planting specifications are in accordance with Appendix A, Planting Requirements, of CWS' updated Design and Construction Standards (R&O 07-20). This is only a recommended list of native plant species that can be used in the vegetated corridor. Final selection of plants may be revised, but plants must be native and planted at densities consistent with CWS planting requirements.

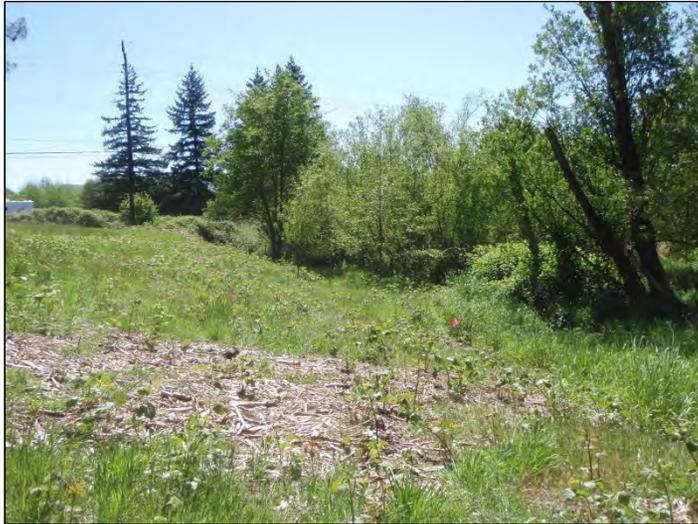
* Dominant			
		Total Cover	50%
	Absolute areal cover		
<b>% Tree canopy:</b>	<b>0%</b>		
% Cover by natives:	10%		
% Invasive:	20%		
% Noxious:	2%		
% Non-native:	18%		
	<hr/>		
	50%		
<b>Corridor Condition:</b>	Degraded

**Photo A.** View south of degraded condition vegetated corridor.

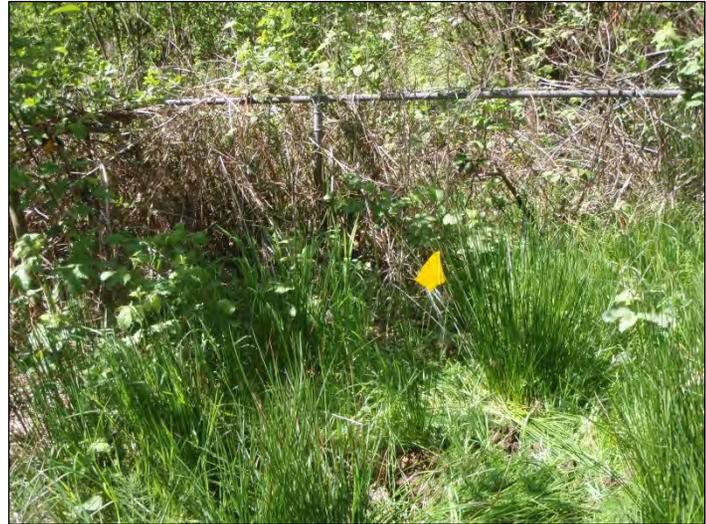
**Photo C.** View west of Plot 1.

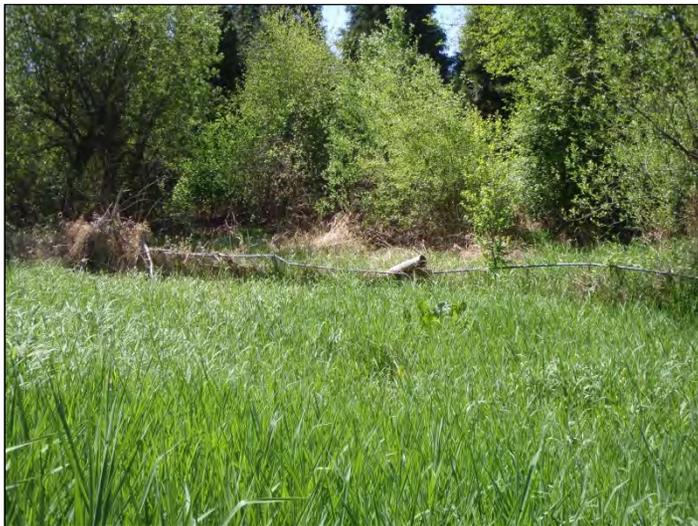
**Photo B.** View west of Plot 2.

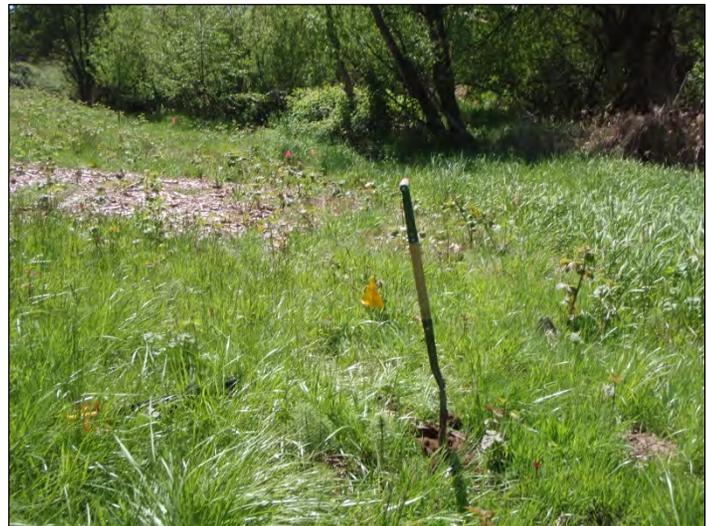
**Photo D.** View west of Plot 4.
