WOODHAVEN PARK, PHASE 2 Natural Resource Assessment Report

Preliminary Jurisdictional Determination Report

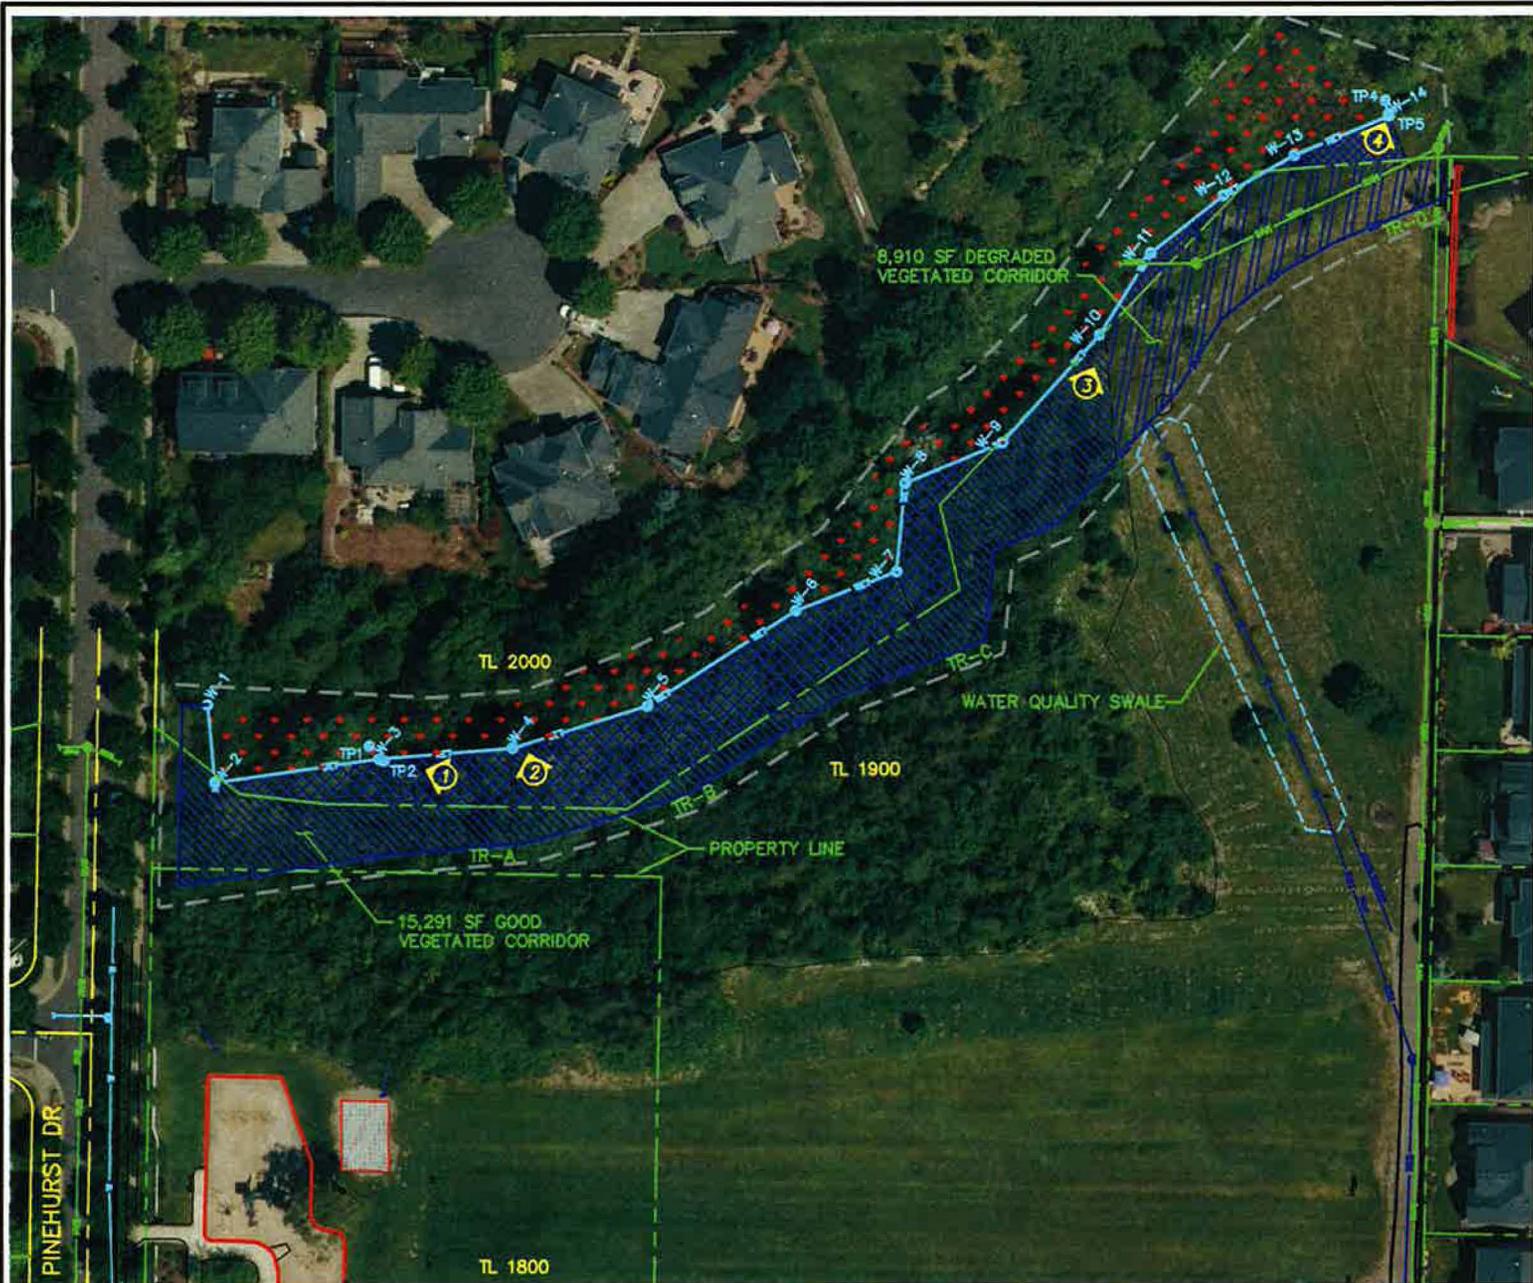
GOOD CONDITION - VEGETATED CORRIDOR
 -

DEGRADED CONDITION - VEGETATED CORRIDOR
 -

Refer to Appendix A – Figure 7 –Natural Resource Assessment and Jurisdictional Determination Map, Appendix B – Vegetated Corridor Condition Assessment Forms, Appendix C – Site Photographs and Table 3 above.

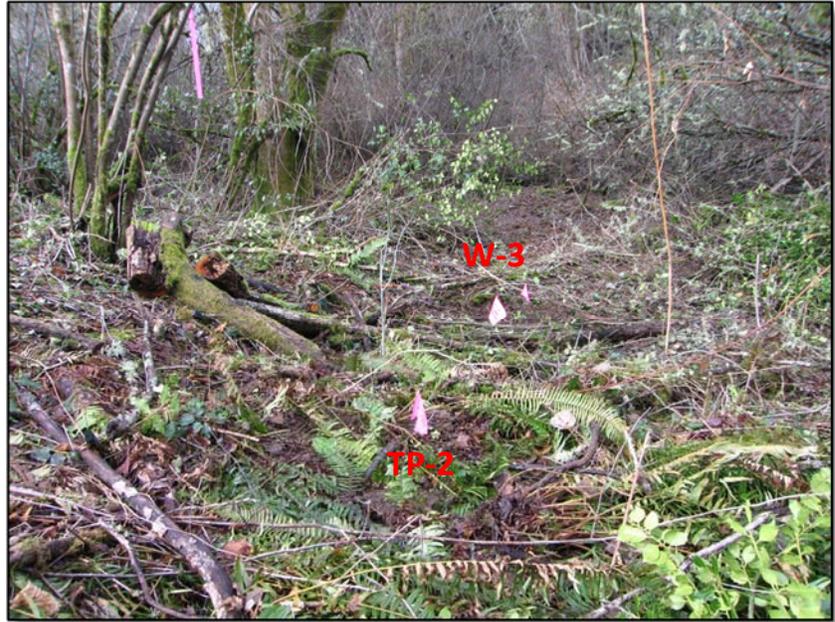
Photograph 1 – View of W-3 and TP-2 Flags in the western edge of the SA. Note the cleared understory and ground plane from invasive species removal efforts.

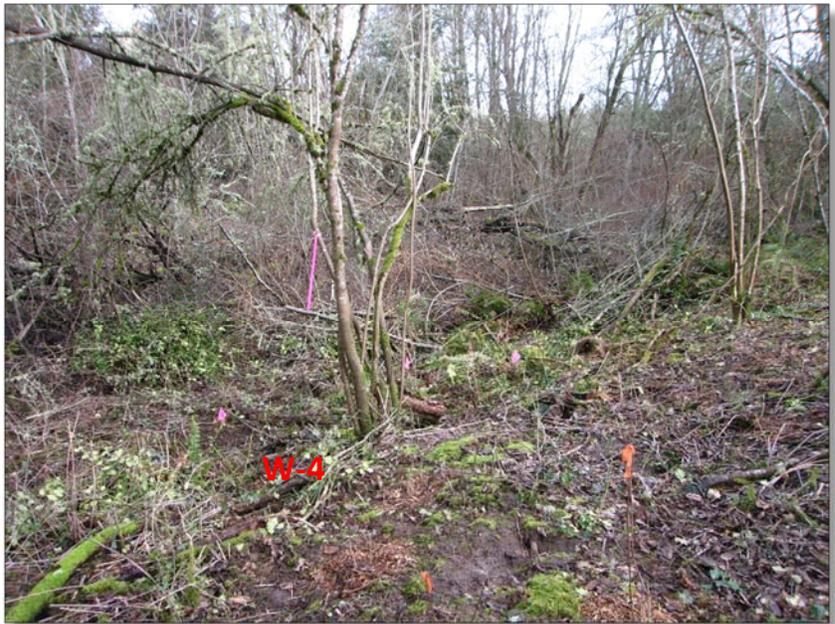
Photograph 2 - View of Wetland A flag W-4 Near TR-A. Note the cleared understory and ground plane from invasive species removal efforts.

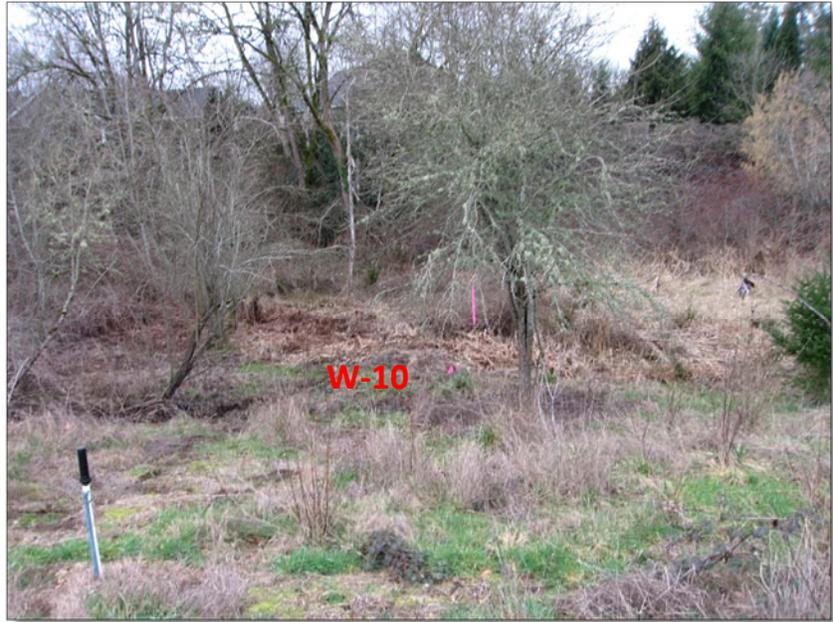
Photograph 3 – View
of Wetland A
upslope from W-10
in the vegetated
corridor.

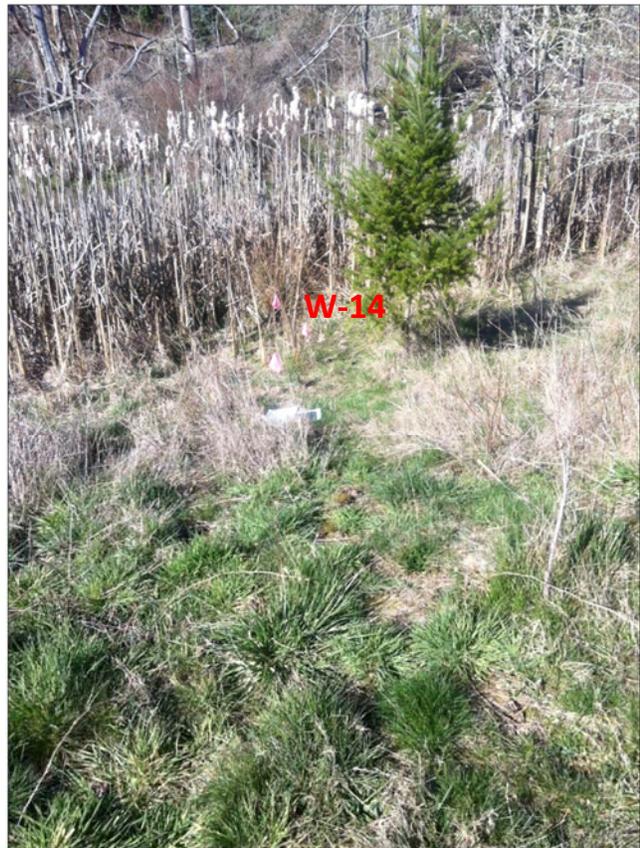
Photograph 4 - View of flag W-14 in Wetland A near TR-D.
Typha marsh a result of beaver activity slightly downstream in
the creek.

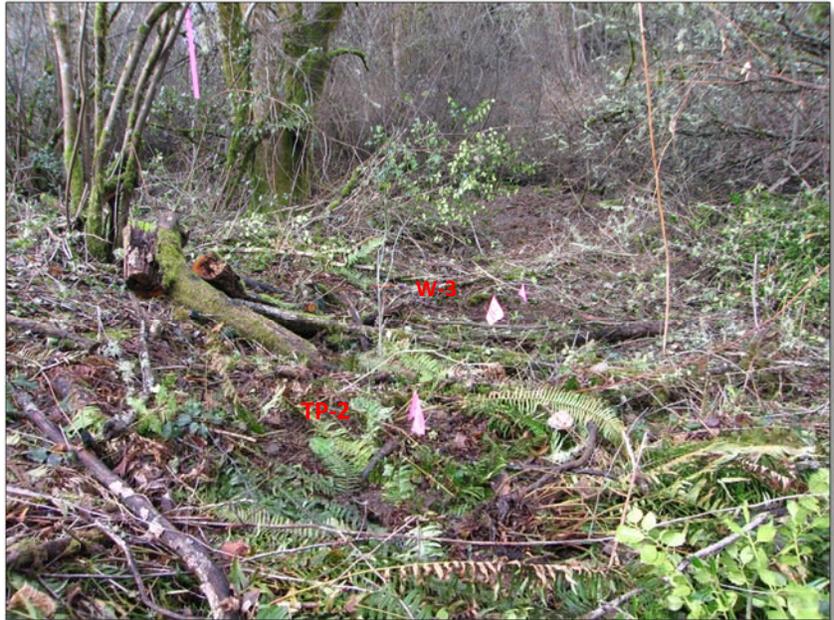
Photograph 1 – View of W-3 and TP-2 flags in western portion of Wetland A. Note the cleared understory and ground plan from invasive species removal efforts

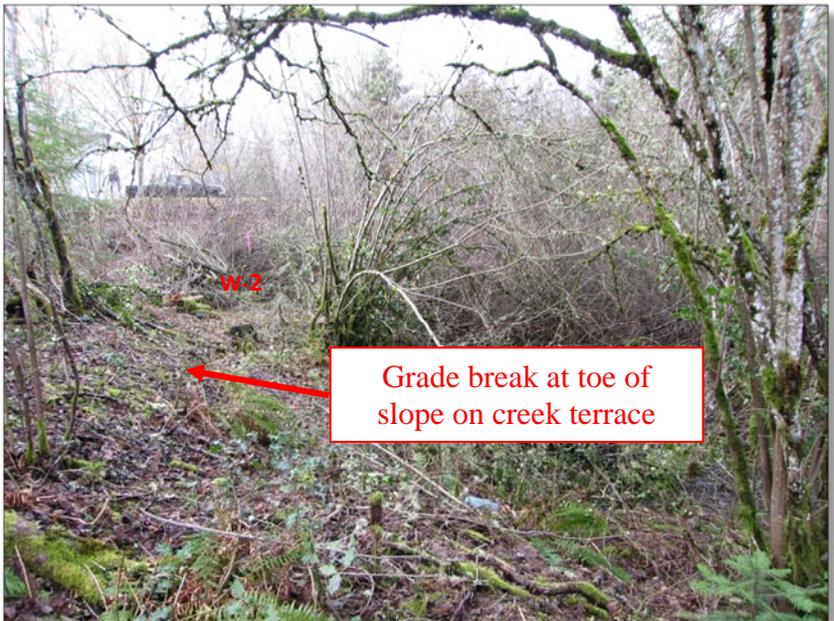
Photograph 2 - View of Wetland A flag W-2 looking toward the west from near W-3. SW Pinehurst Drive road prism is behind W-2.

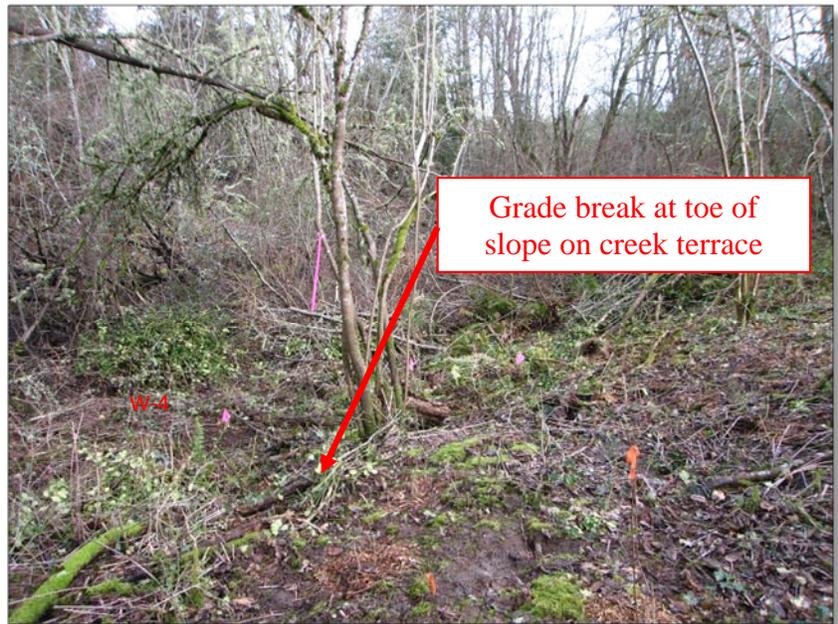
Photograph 3 – View of Wetland A flag W-4.

Note the cleared understory and ground plane from invasive species removal and slope grade break.

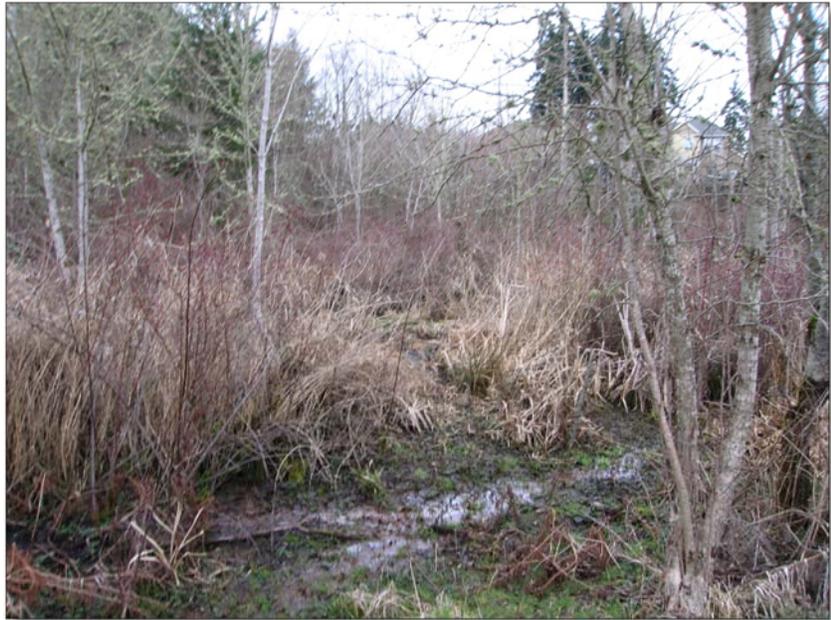
Photograph 4 - View of Wetland A between W-10 and W-11.

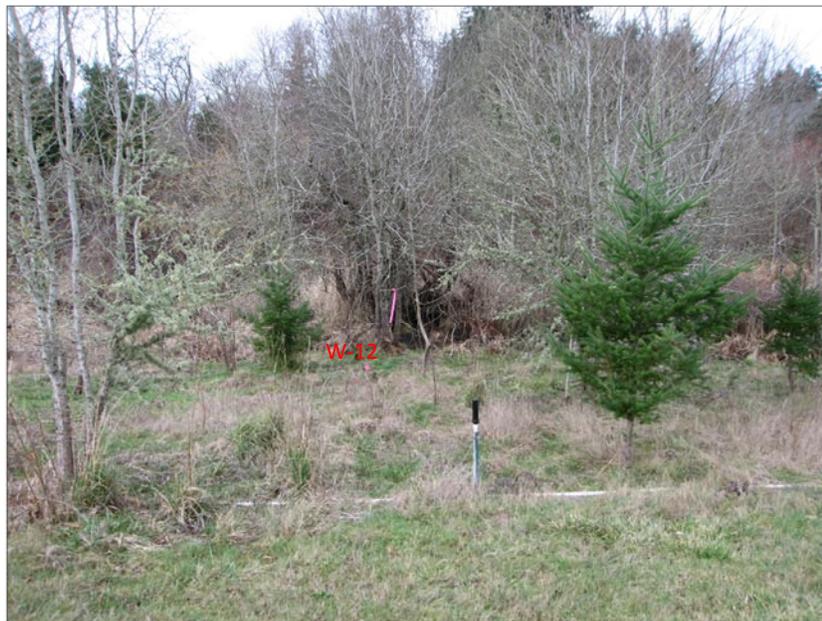
Photograph 5 - View of
Wetland A and W-12
from water quality
swale.

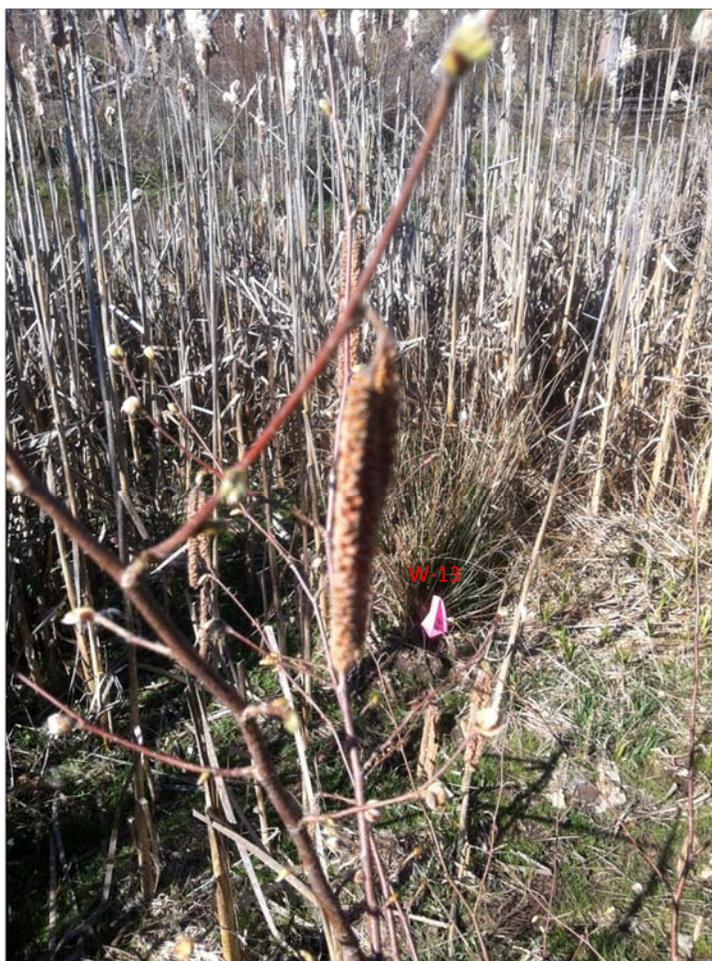
Photograph 6 - View of
Wetland A and W-13
from water quality
swale.

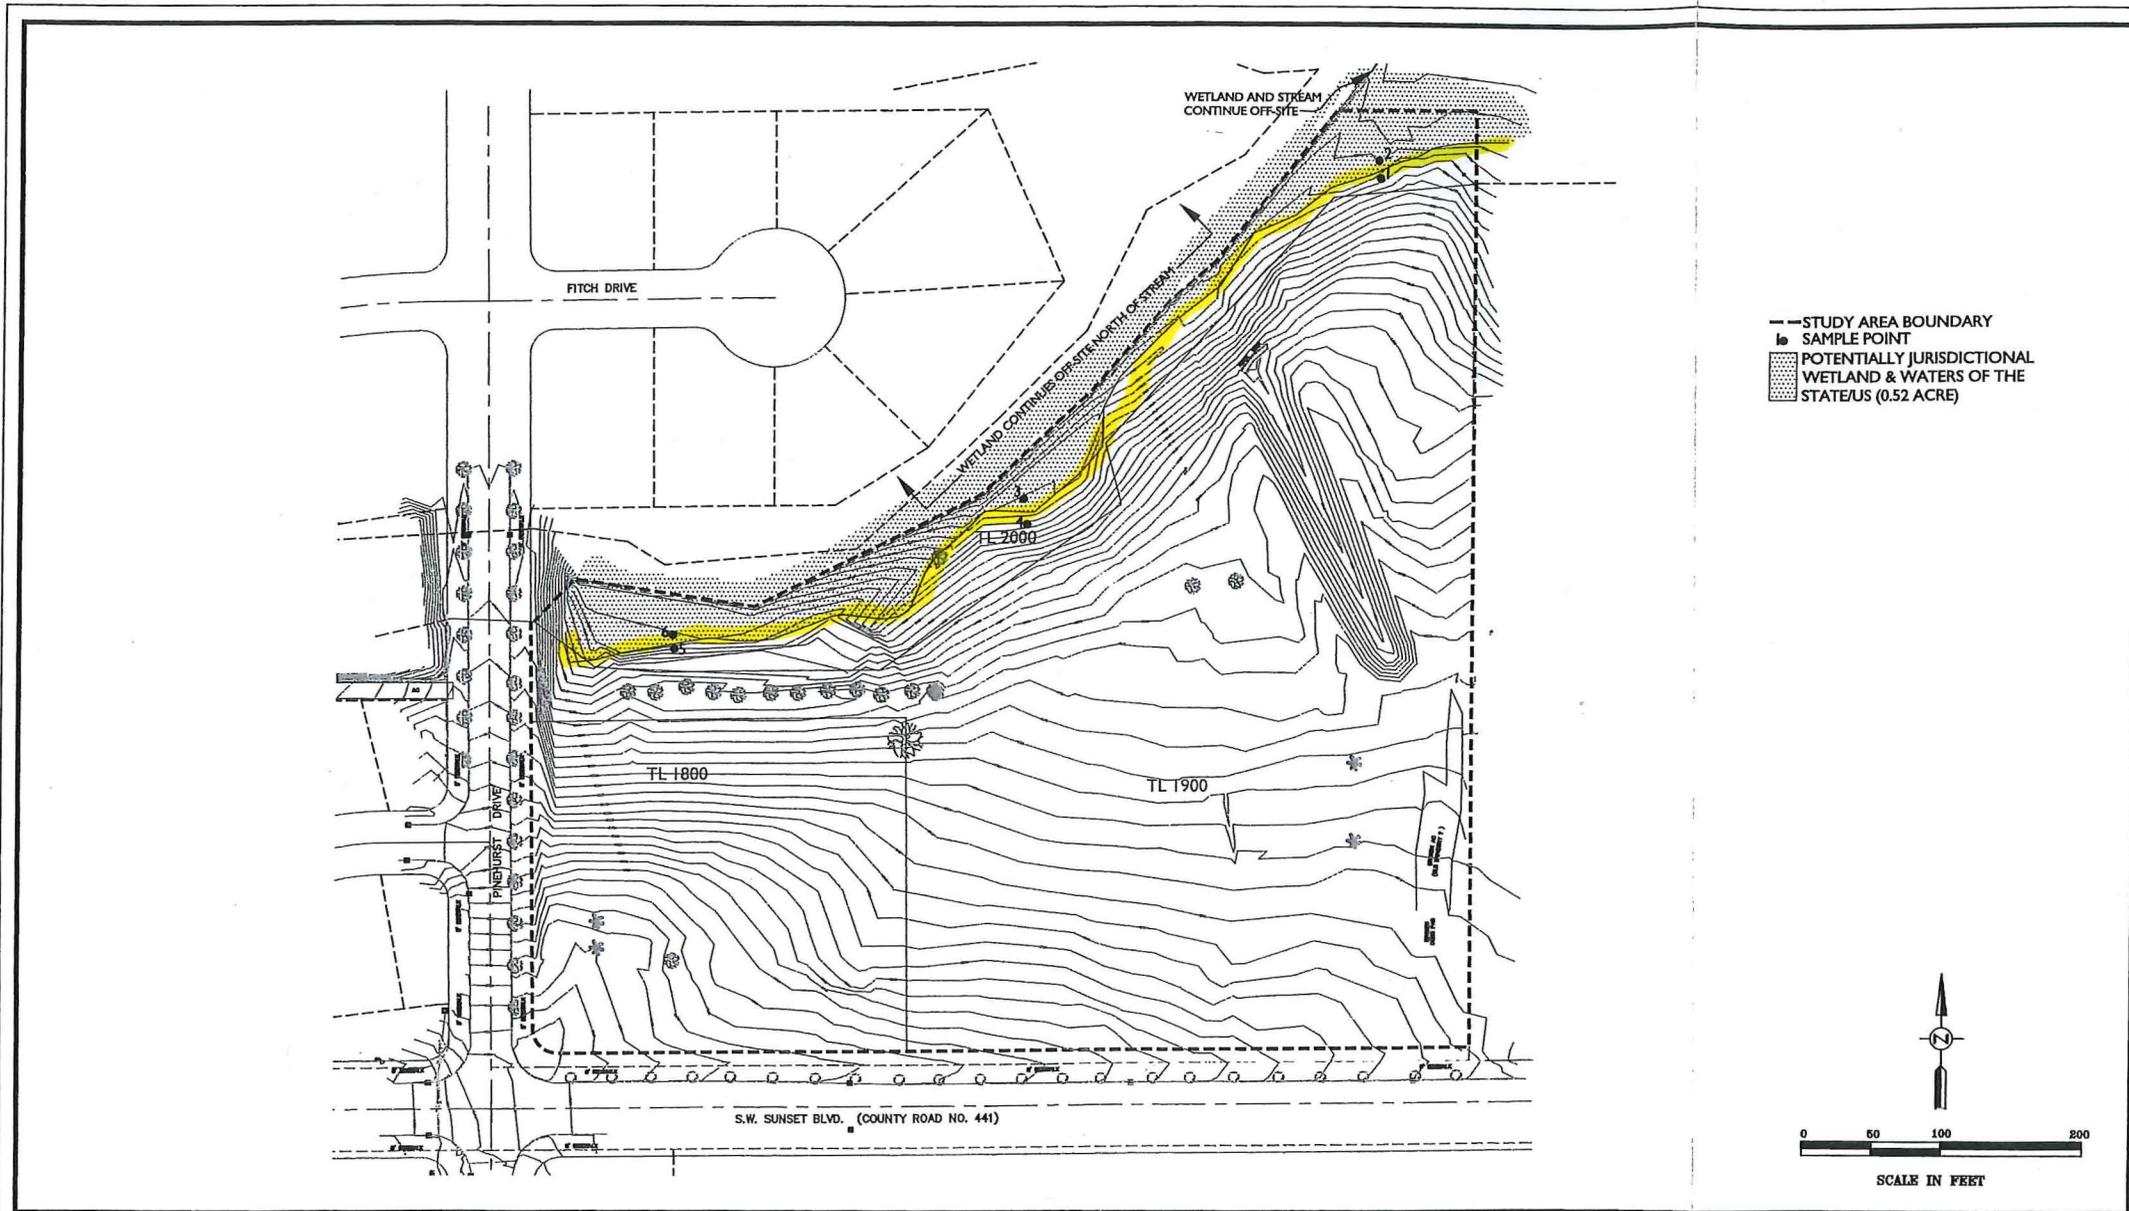
Approximate location of potentially jurisdictional wetland and waters of the state/US for Woodhaven Park in Sherwood, Oregon. Location of flagged wetland boundary and sample sites are approximated from known points. The accuracy of the wetland boundary is +/- 5 feet. Base map provided by Westlake Consultants, 2001.

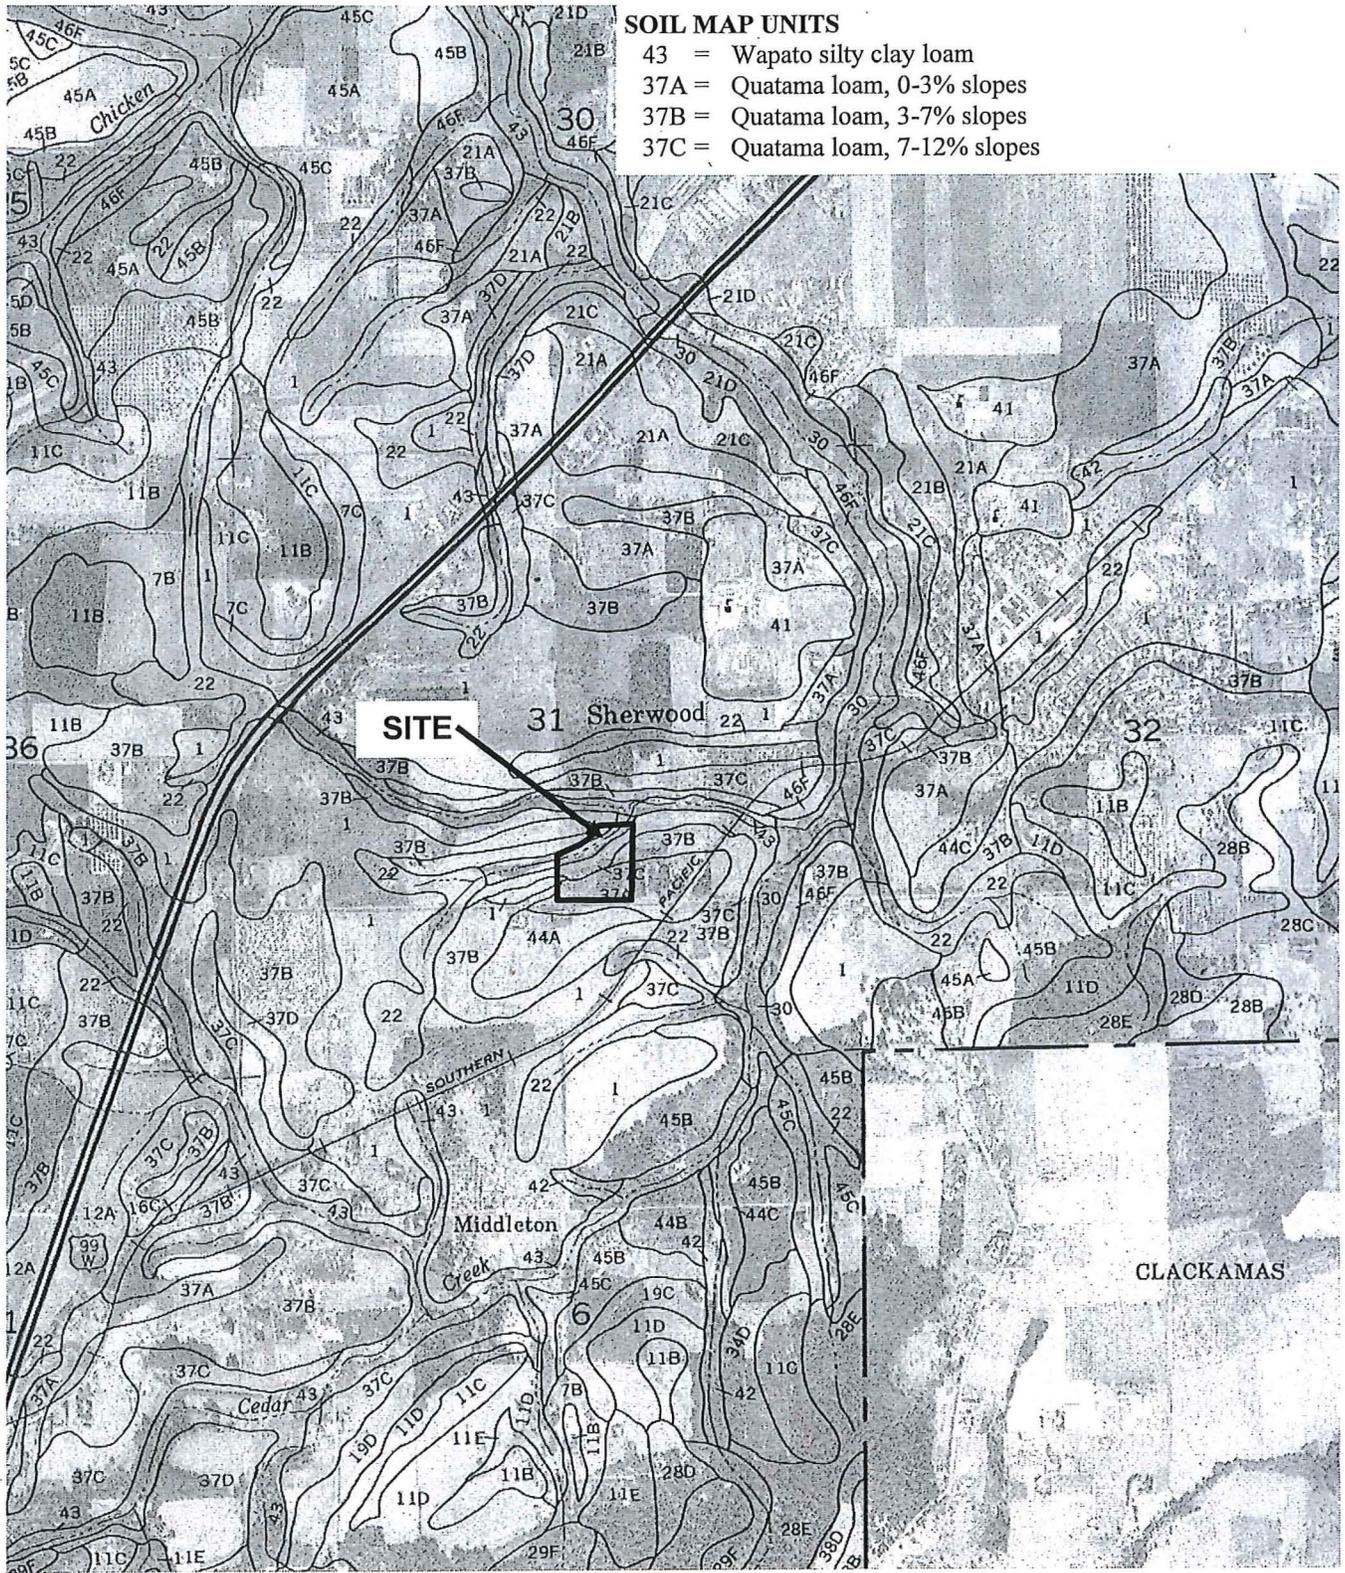
SOIL MAP UNITS
 43 = Wapato silty clay loam
 37A = Quatama loam, 0-3% slopes
 37B = Quatama loam, 3-7% slopes
 37C = Quatama loam, 7-12% slopes

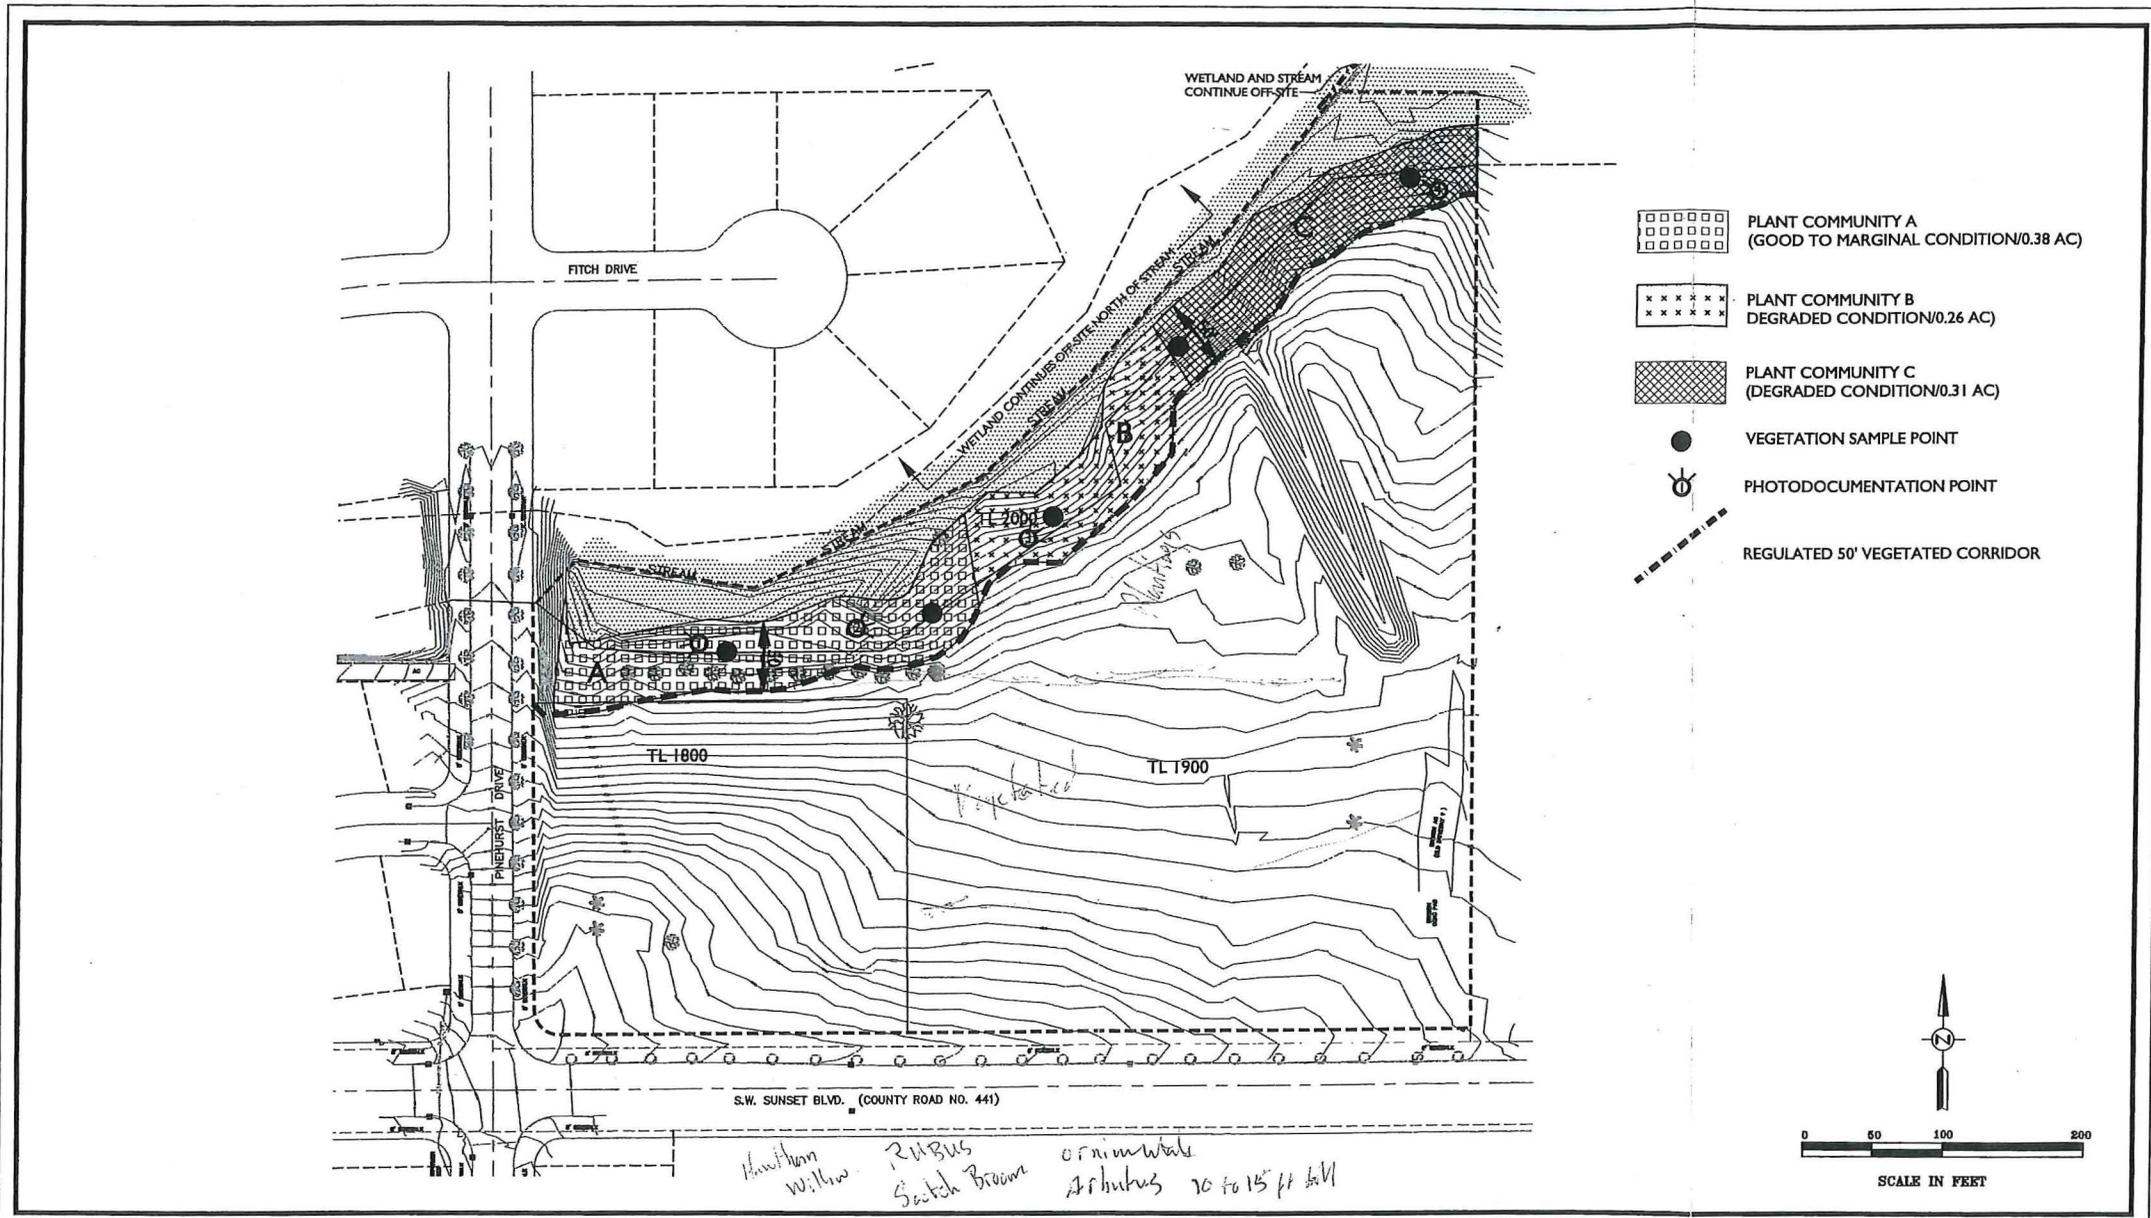
Location of the wetlands, regulated 50' vegetated corridor, plant communities, sample points, and photodocumentation points for Woodhaven Park in Sherwood, Oregon. Base map provided by Westlake Consultants, 2001.

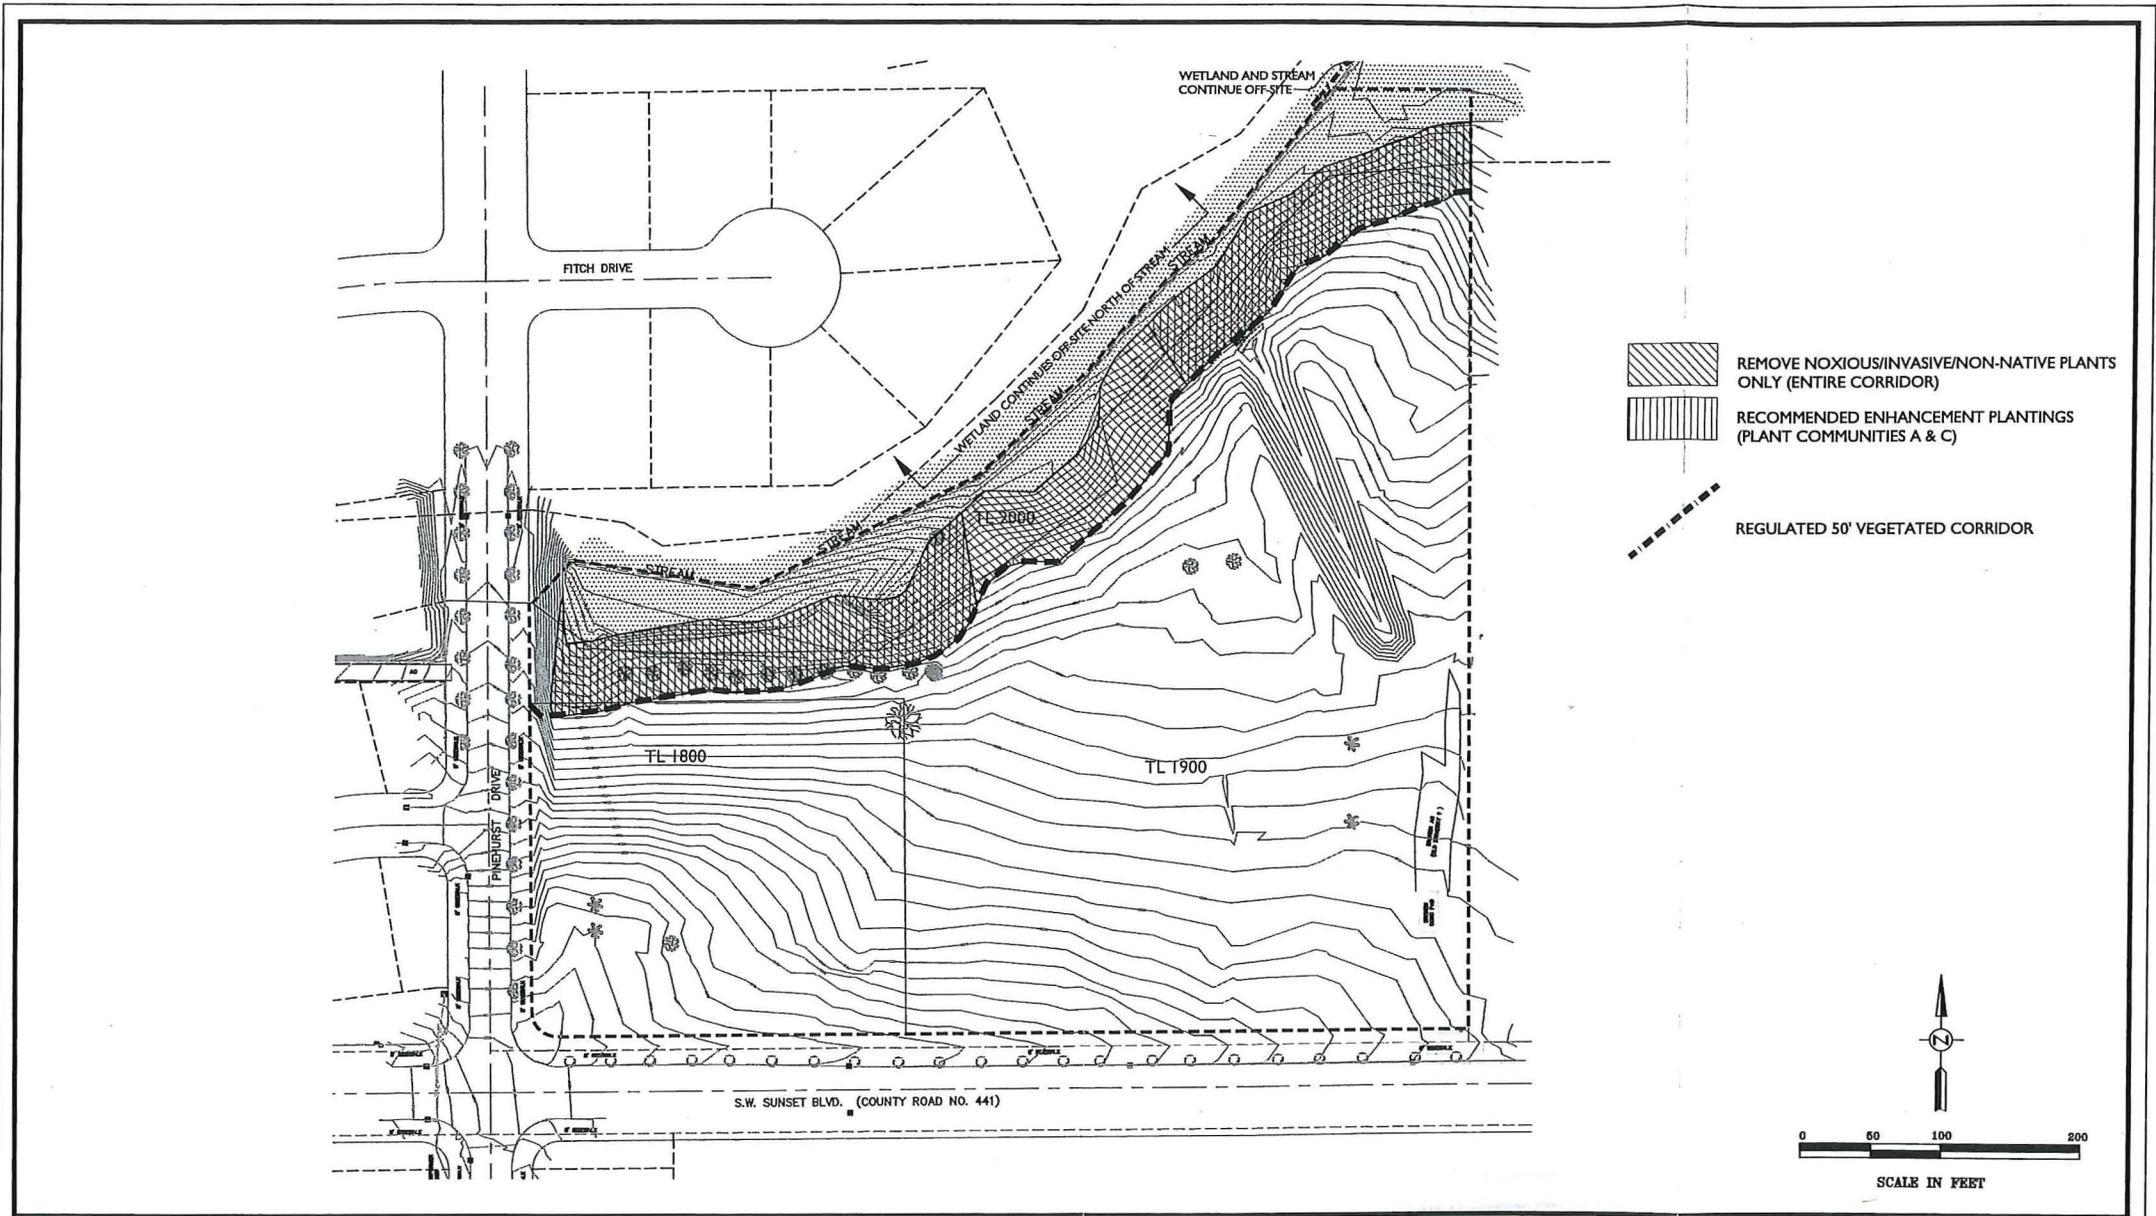
Vegetated corridor enhancement and proposed planting areas for Woodhaven Park in Sherwood, Oregon. Base map provided by Westlake Consultants, 2001.

The planting of trees, shrubs, and seed mix should be consistent with Clean Water Services' standards. Species should be grouped with a minimum of 2 tree species, 4 shrub species, and 3 herbaceous species used. The overall goal of the enhancement is to restore the degraded portion of the vegetated corridor as required by Clean Water Services.
