**Exhibit H: Response to Clean Water Services Comments and Clean Water Services Site Assessment, including Oregon Department of State Lands Concurrence Reports (WD # 2017-0008 and WD #2018-0040)**

# Willamette Water Supply

**SUBJECT:** Response to CWS comments regarding Water Treatment Plant Service Provider Application (CWS File #20-0001896)

**Willamette Water Supply Program  
Water Treatment Plant (WWSP WTP)  
CWS Site Assessment**

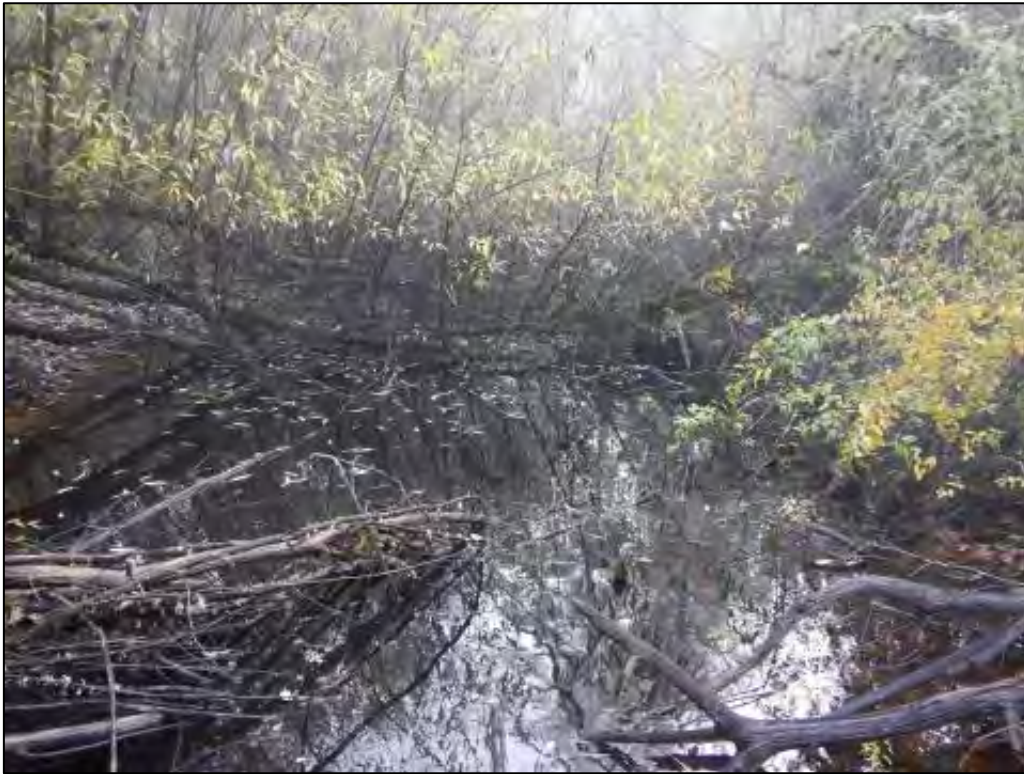
**Photo 1: Facing east at the inundated portion of Wetland A (November 3, 2016).**

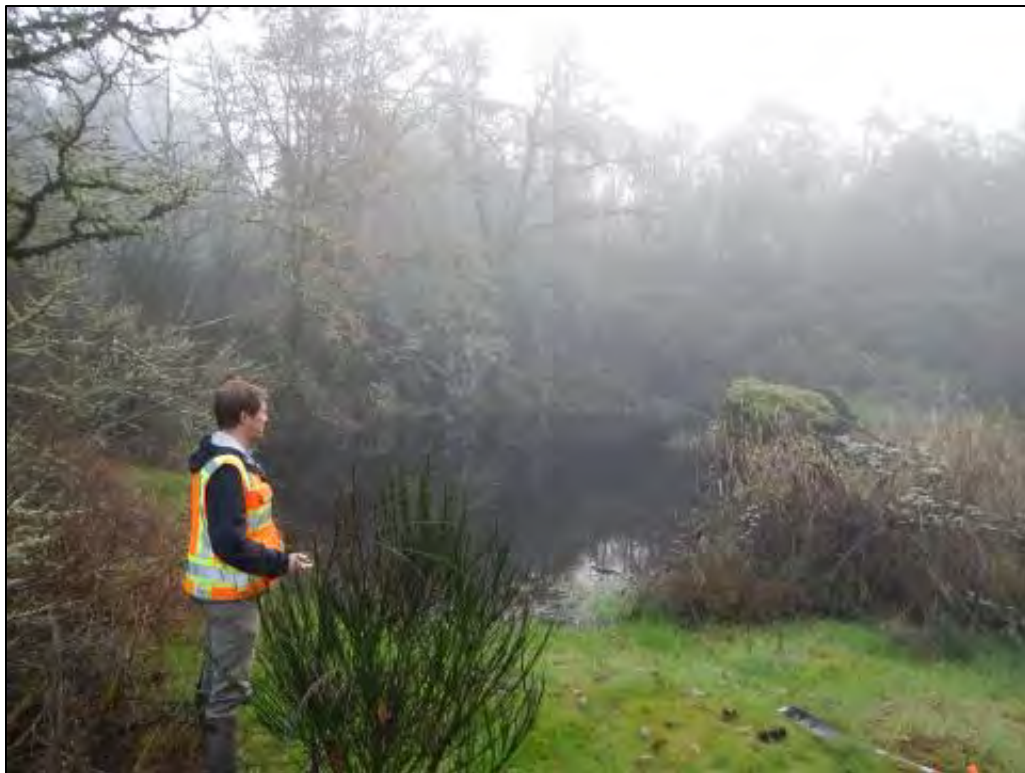
**Photo 2: Facing north at Wetland B (November 3, 2016).**

Wetland B (0.1 acre) was delineated northwest of Wetland A in the northwest portion of the study area. The wetland is isolated in a depression, consists largely of unvegetated ponded water over 2 feet deep, and is surrounded by rocky outcroppings, steep rock faces, and boulders. Wetland B would be classified as a palustrine unconsolidated bottom wetland (Cowardin et al 1979). The vegetated portion of Wetland B was dominated by reed canarygrass (*Phalaris arundinacea*), colonial bentgrass (*Agrostis capillaris*), and swamp rose. Wetland vegetation generally occurred in patches of soil within the inundated perimeter.

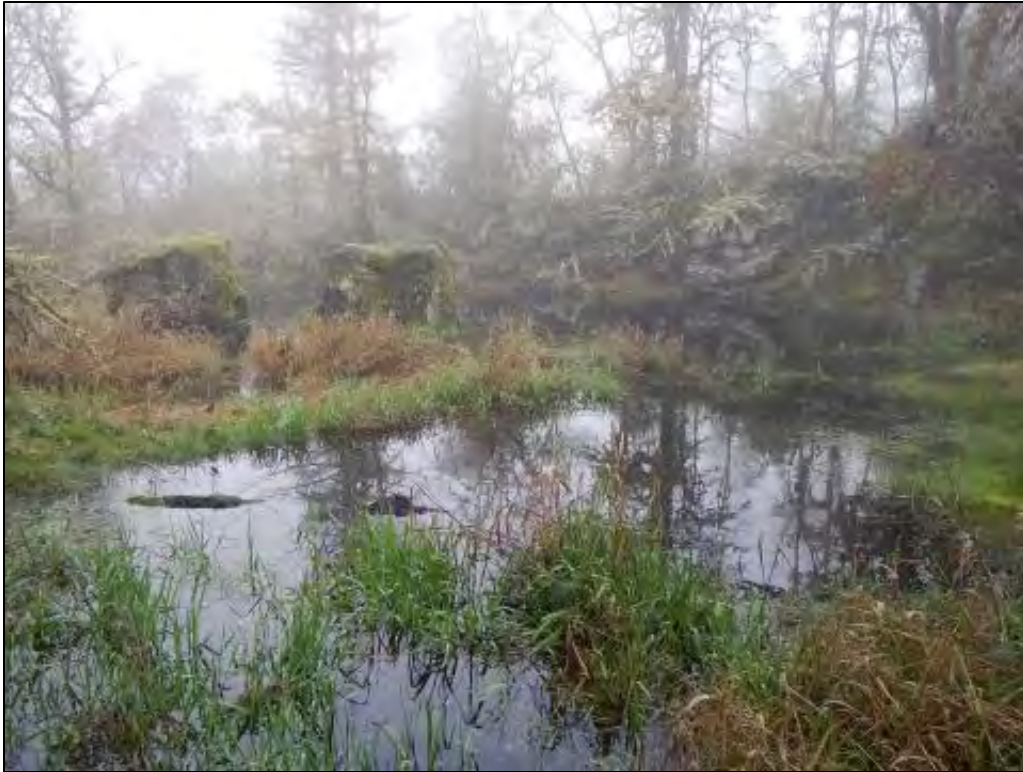
**Photo 3: Facing west at Wetland B (November 3, 2016).**

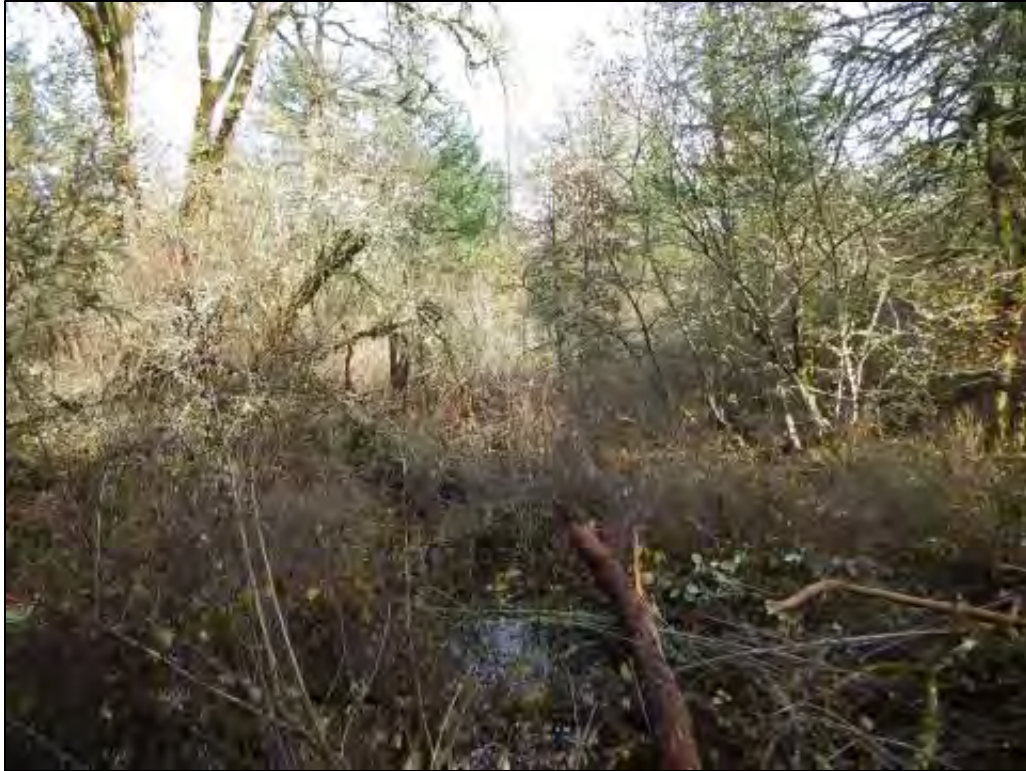
**Photo 9: Facing east at the western end of Wetland E (November 3, 2016).**

Wetland E (0.1 acre) is located near the center of the study area and is an inundated closed depression. Wetland E would be classified as a palustrine scrub-shrub wetland (Cowardin et al. 1979). The wetland is dominated by hardhack with smaller amounts of Nootka rose (*Rosa nutkana*), Pacific crabapple, and Oregon white oak. Roughly 6 inches of ponded water was observed throughout much of the wetland during the site visit.

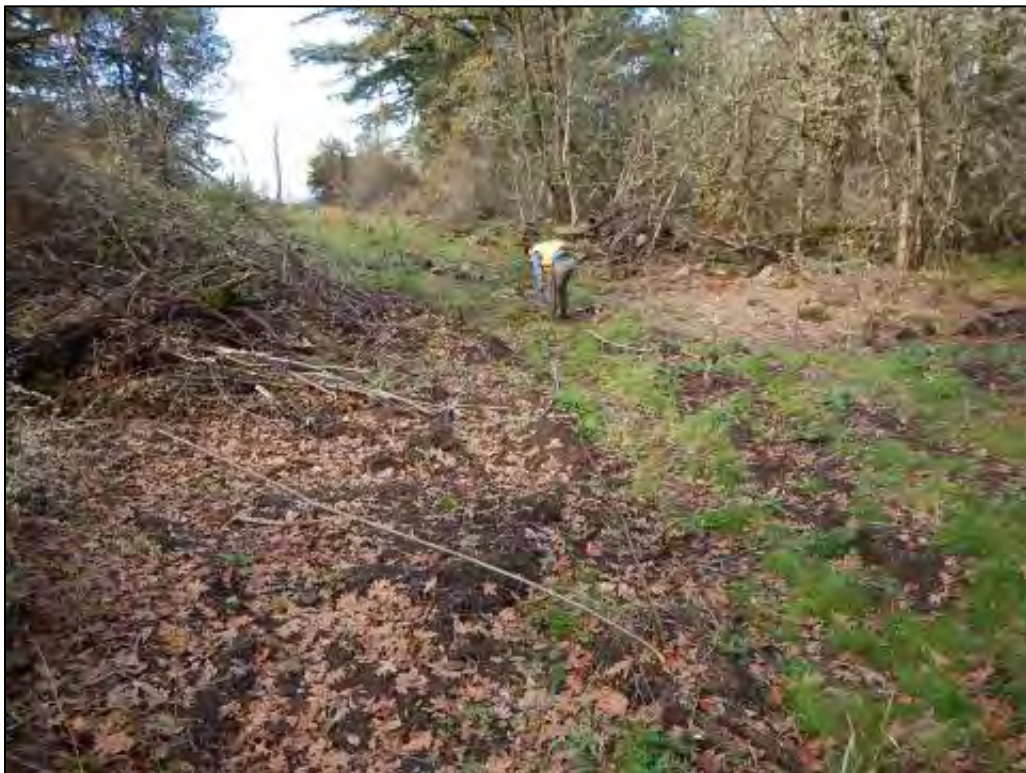
**Photo 10: Facing northwest toward the northern boundary of Wetland F (November 3, 2016).**

Wetland F (0.2 acre) occupies a closed depression in the northeast portion of the study area. It would be classified primarily as palustrine forested wetland, with some areas of palustrine scrub-shrub and emergent (Cowardin et al. 1979). Dominant plant species include Oregon ash, cluster rose (*Rosa pisocarpa*), Douglas spirea (*Spiraea douglasii*), snowberry (*Symphoricarpos albus*), colonial bentgrass (*Agrostis capillaris*), and toad rush (*Juncus bufonius*).

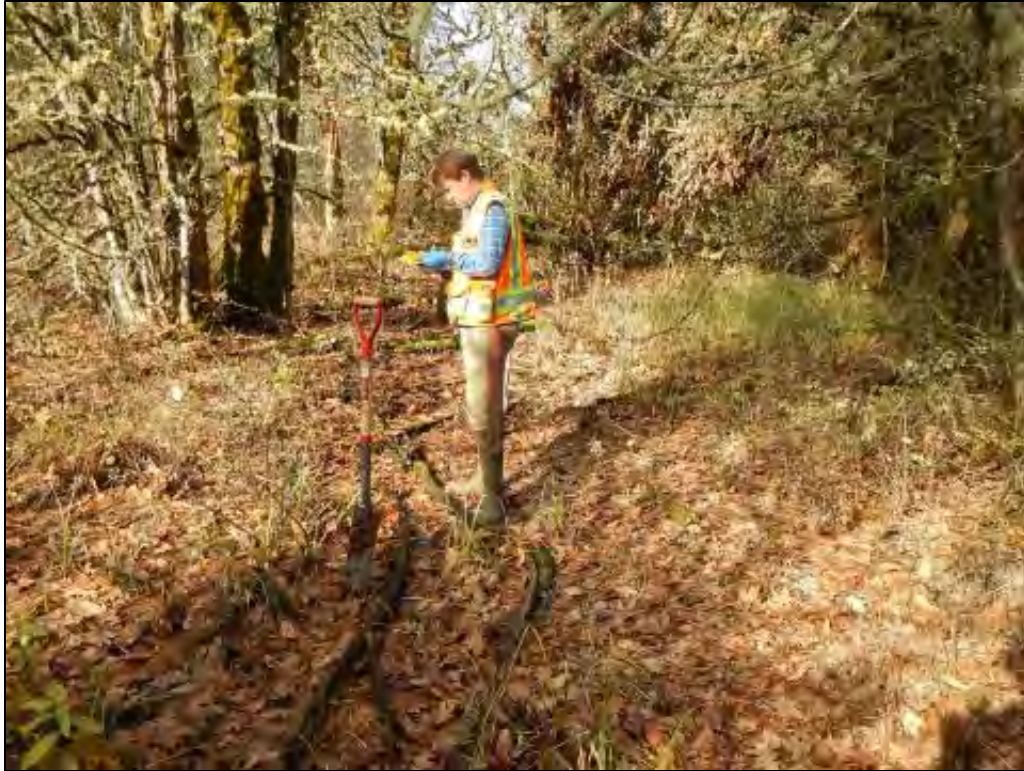
**Photo 11: Facing southwest at the southern end of Wetland F (November 3, 2016).**

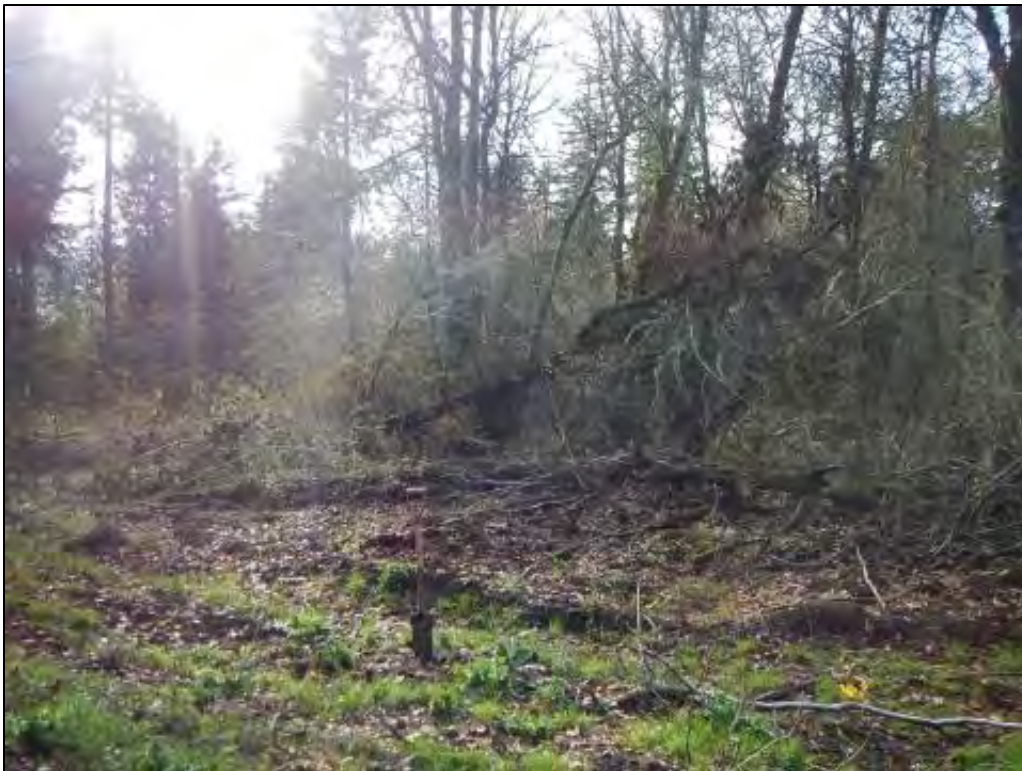
**Photo 12: Facing southwest toward the northern boundary of Wetland F (November 3, 2016).**
