Re: **Tualatin-Sherwood Industrial Park - Land Use**  
*LU 2020-001 Incompleteness Response*  
Project Number 2180459.04

## **PRELIMINARY SUBDIVISION, SITE PLAN REVIEW, CONDITIONAL USE, AND VARIANCE**

**Request:** Preliminary Subdivision, Site Plan Review, Conditional Use, and Variance application for a five-building industrial park, totaling 535,194 square feet within the Tonquin Employment Area (TEA)

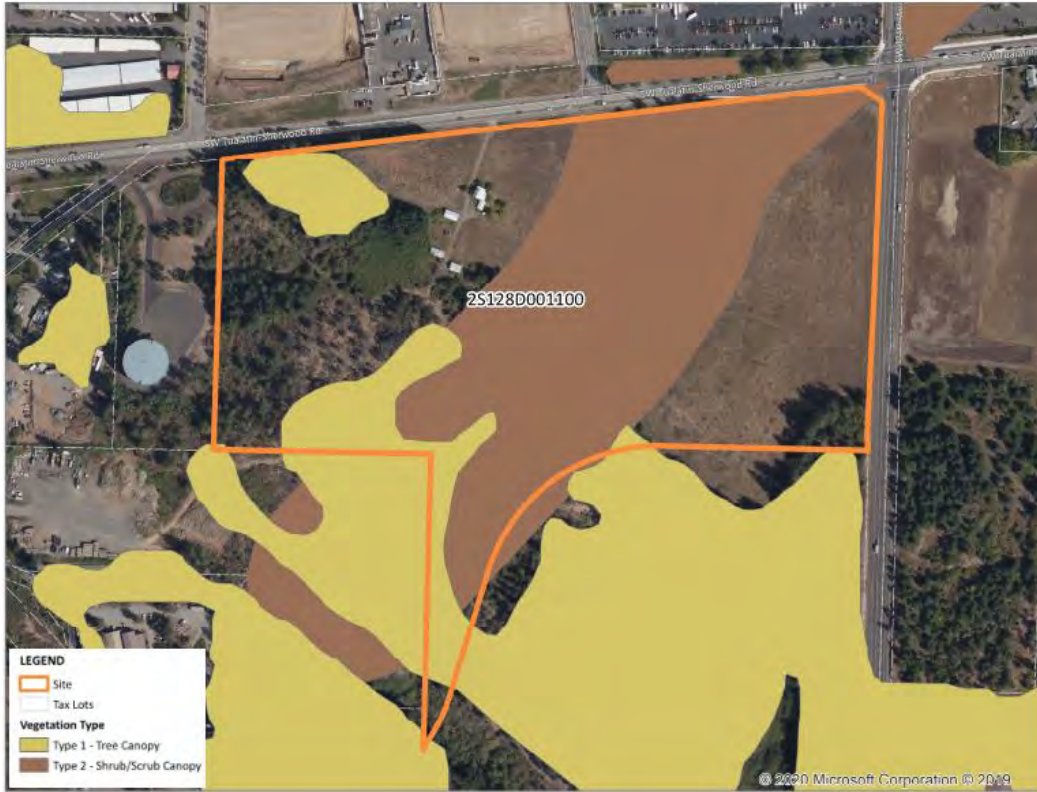
Figure 4: Metro Vegetative Cover

**Response:** Figure 4 below illustrates the documented vegetation types throughout the development area, per Metro’s GIS Vegetation data. Per the Pacific Habitat Services Natural Resource Assessment (Attachment 15), a summary of plant communities adjacent to the associated delineated wetlands has been prepared.
