# SENSITIVE AREA CERTIFICATION FORM

# JBMac Ventures Sherwood Simplified Site Assessment Report

**Site Information:** 14843 SW Oregon Street  
Sherwood, Oregon  
Washington County Assessor's Map 2S 1 29DC  
Tax Lots 500, 600, and 700

This report has been prepared to meet CWS' simplified site assessment requirements listed under Chapter 3 of Clean Water Services' *Design and Construction Standards* (R&O 19-22).

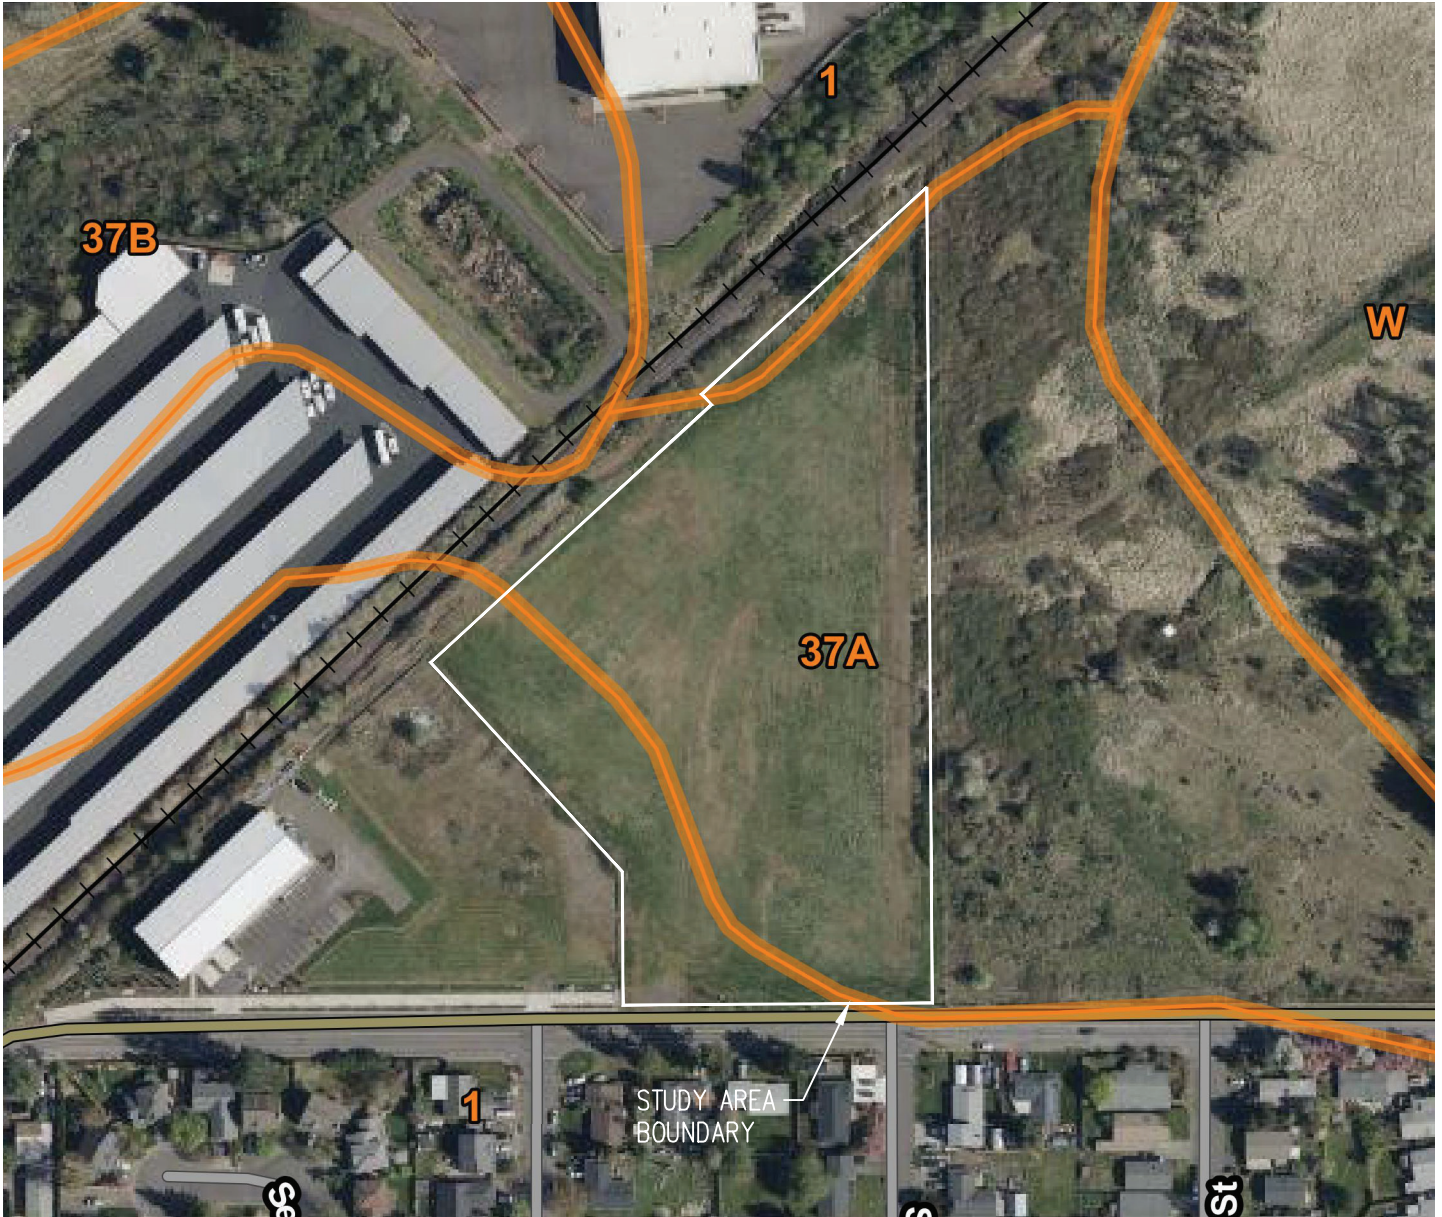
NRCS SOIL SURVEY MAP  
JBMAC VENTURES NATURAL RESOURCES SITE ASSESSMENT REPORT

The following soil units are mapped within the study area, according to the Natural Resources Conservation Service (NRCS) Washington County Area Soil Survey Map and Washington County hydric soil list (Figure 3):

- (Unit 37A) Quatama loam, 0 to 3 percent slopes; Non-hydric

- (Unit 1) Aloha silt loam; Non-hydric

MAP UNIT SYMBOL	MAP UNIT NAME
1	ALOHA SILT LOAM; NON-HYDRIC
37A	QUATAMA LOAM, 0% TO 3% SLOPES; NON-HYDRIC

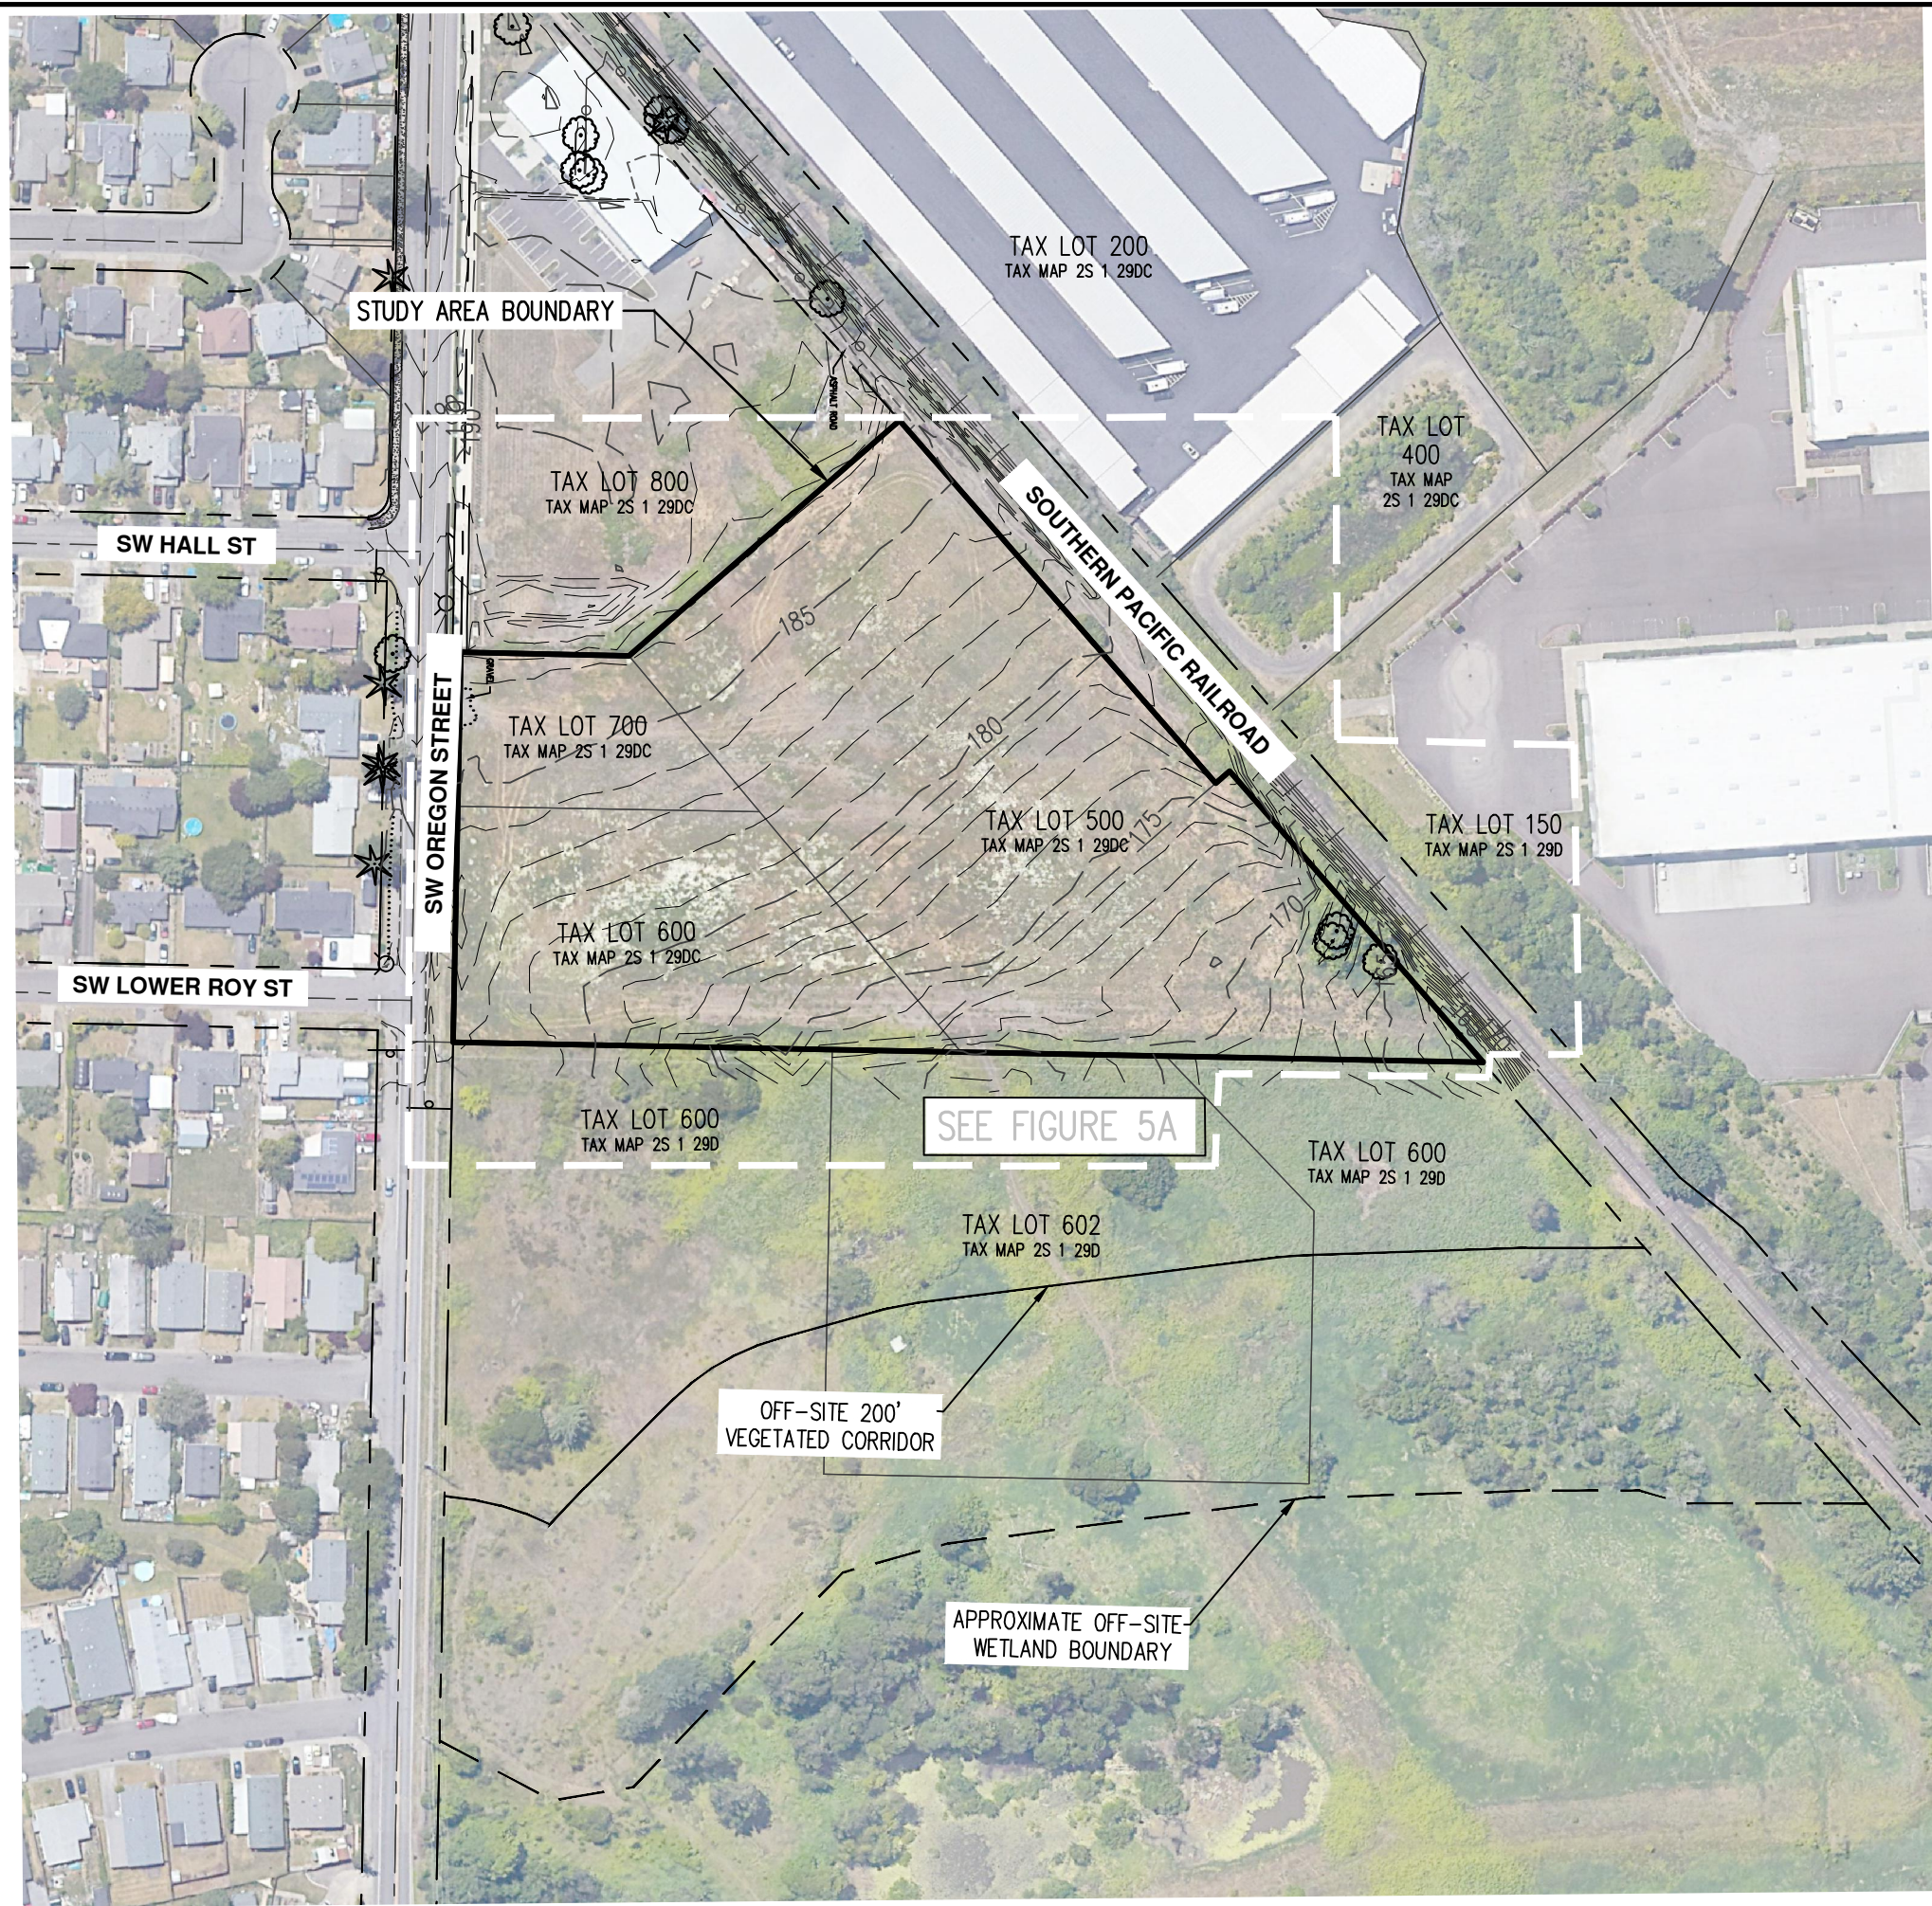
NATURAL RESOURCES EXISTING CONDITIONS OVERVIEW MAP

Soils, vegetation, and indicators of hydrology were recorded at four sample plot locations on standardized wetland determination data sheets to document site conditions. The wetland determination data sheets are included in Appendix C. The plot locations were mapped using a handheld Trimble GPS unit with submeter accuracy. Representative site photos are included in Appendix D and photo and plot locations are shown on the Existing Conditions Map (Figures 5 and 5A).

PLOT LOCATIONS SHOWN WERE LOCATED BY AKS ENGINEERING & FORESTRY, LLC ON APRIL 28, 2022 USING A TRIMBLE GEO 7X HANDHELD GPS RECEIVER WITH SUB-METER ACCURACY. NO WETLAND OR WATER BOUNDARIES WERE DELINEATED ON-SITE.

1 FT INTERVAL GROUND CONTOURS, STUDY AREA BOUNDARY AND TREE SURVEY >6" DBH DERIVED FROM AKS PROFESSIONAL LAND SURVEY.

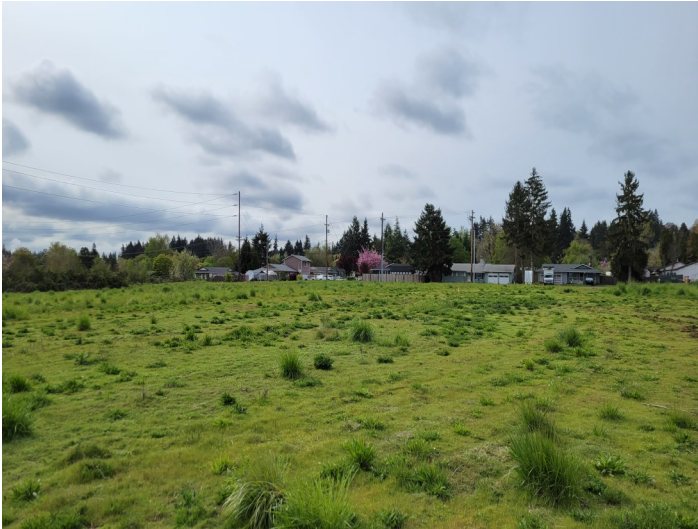
**Photo A.** General site conditions, oriented south-east

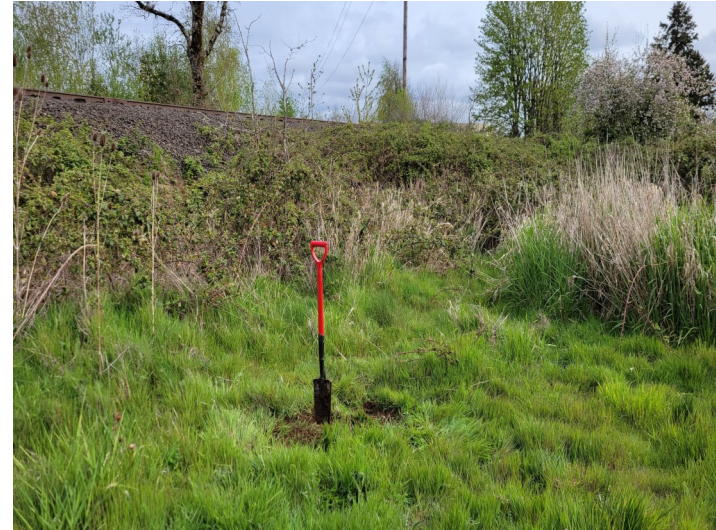
Plot 1 was located in the northeast corner of the study area in the vicinity of wetland delineated under WD2002-0062. Vegetation was dominated by Himalayan blackberry, black hawthorn, bentgrass, tall false rye grass, and reed canary grass. Soils lacked hydric soil indicators. Soils were dry throughout, lacking a

**Photo B.** View of *Plot 1* oriented northeast.

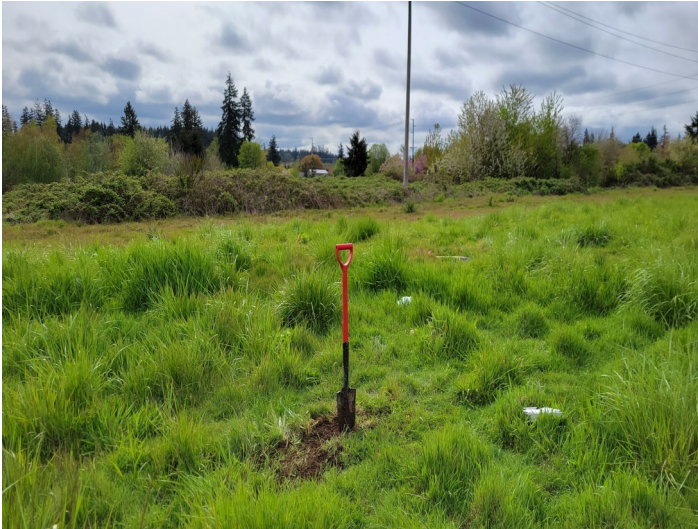
Plot 3 was taken within the lowest topographic location in the vicinity of a former wetland identified during the 2002 Wetland Delineation (WD2002-0062). Vegetation was dominated by bentgrass, bluegrass (*Poa* spp.), field meadow foxtail (*Alopecurus pratensis*), and lesser amounts of common weedy forbs. Plot 3 lacked hydric soil and wetland hydrology indicators.

**Photo C.** View of *Plot 3* oriented east.

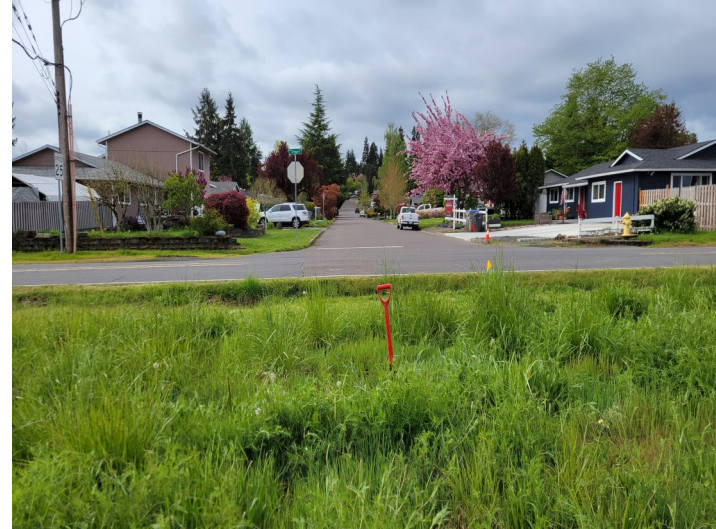
Plot 4 was taken in an area of low topography adjacent to SW Oregon Street at the southern end of the study area. Vegetation was dominated by field meadow foxtail, tall false rye grass, and common weedy forbs. Soils were dry throughout, lacking indicators of wetland hydrology.

**Photo D.** View of *Plot 4* oriented south.
