Re: WD # 2022-0166 **Approved**
Wetland Delineation Report for Sherwood Industrial Park Phase 3
Washington County; T2S R1W S29D TLs 151 and 150 (Portion)
RGL # 1758, Sherwood Local Wetlands Inventory, R-3, R-5, and R-6

Wetland Delineation Overview and Sheet Index
 Sherwood Industrial Park Phase III Development Site - Sherwood, Oregon

Sherwood Industrial Park Phase 3 Development Site, Sherwood, Oregon

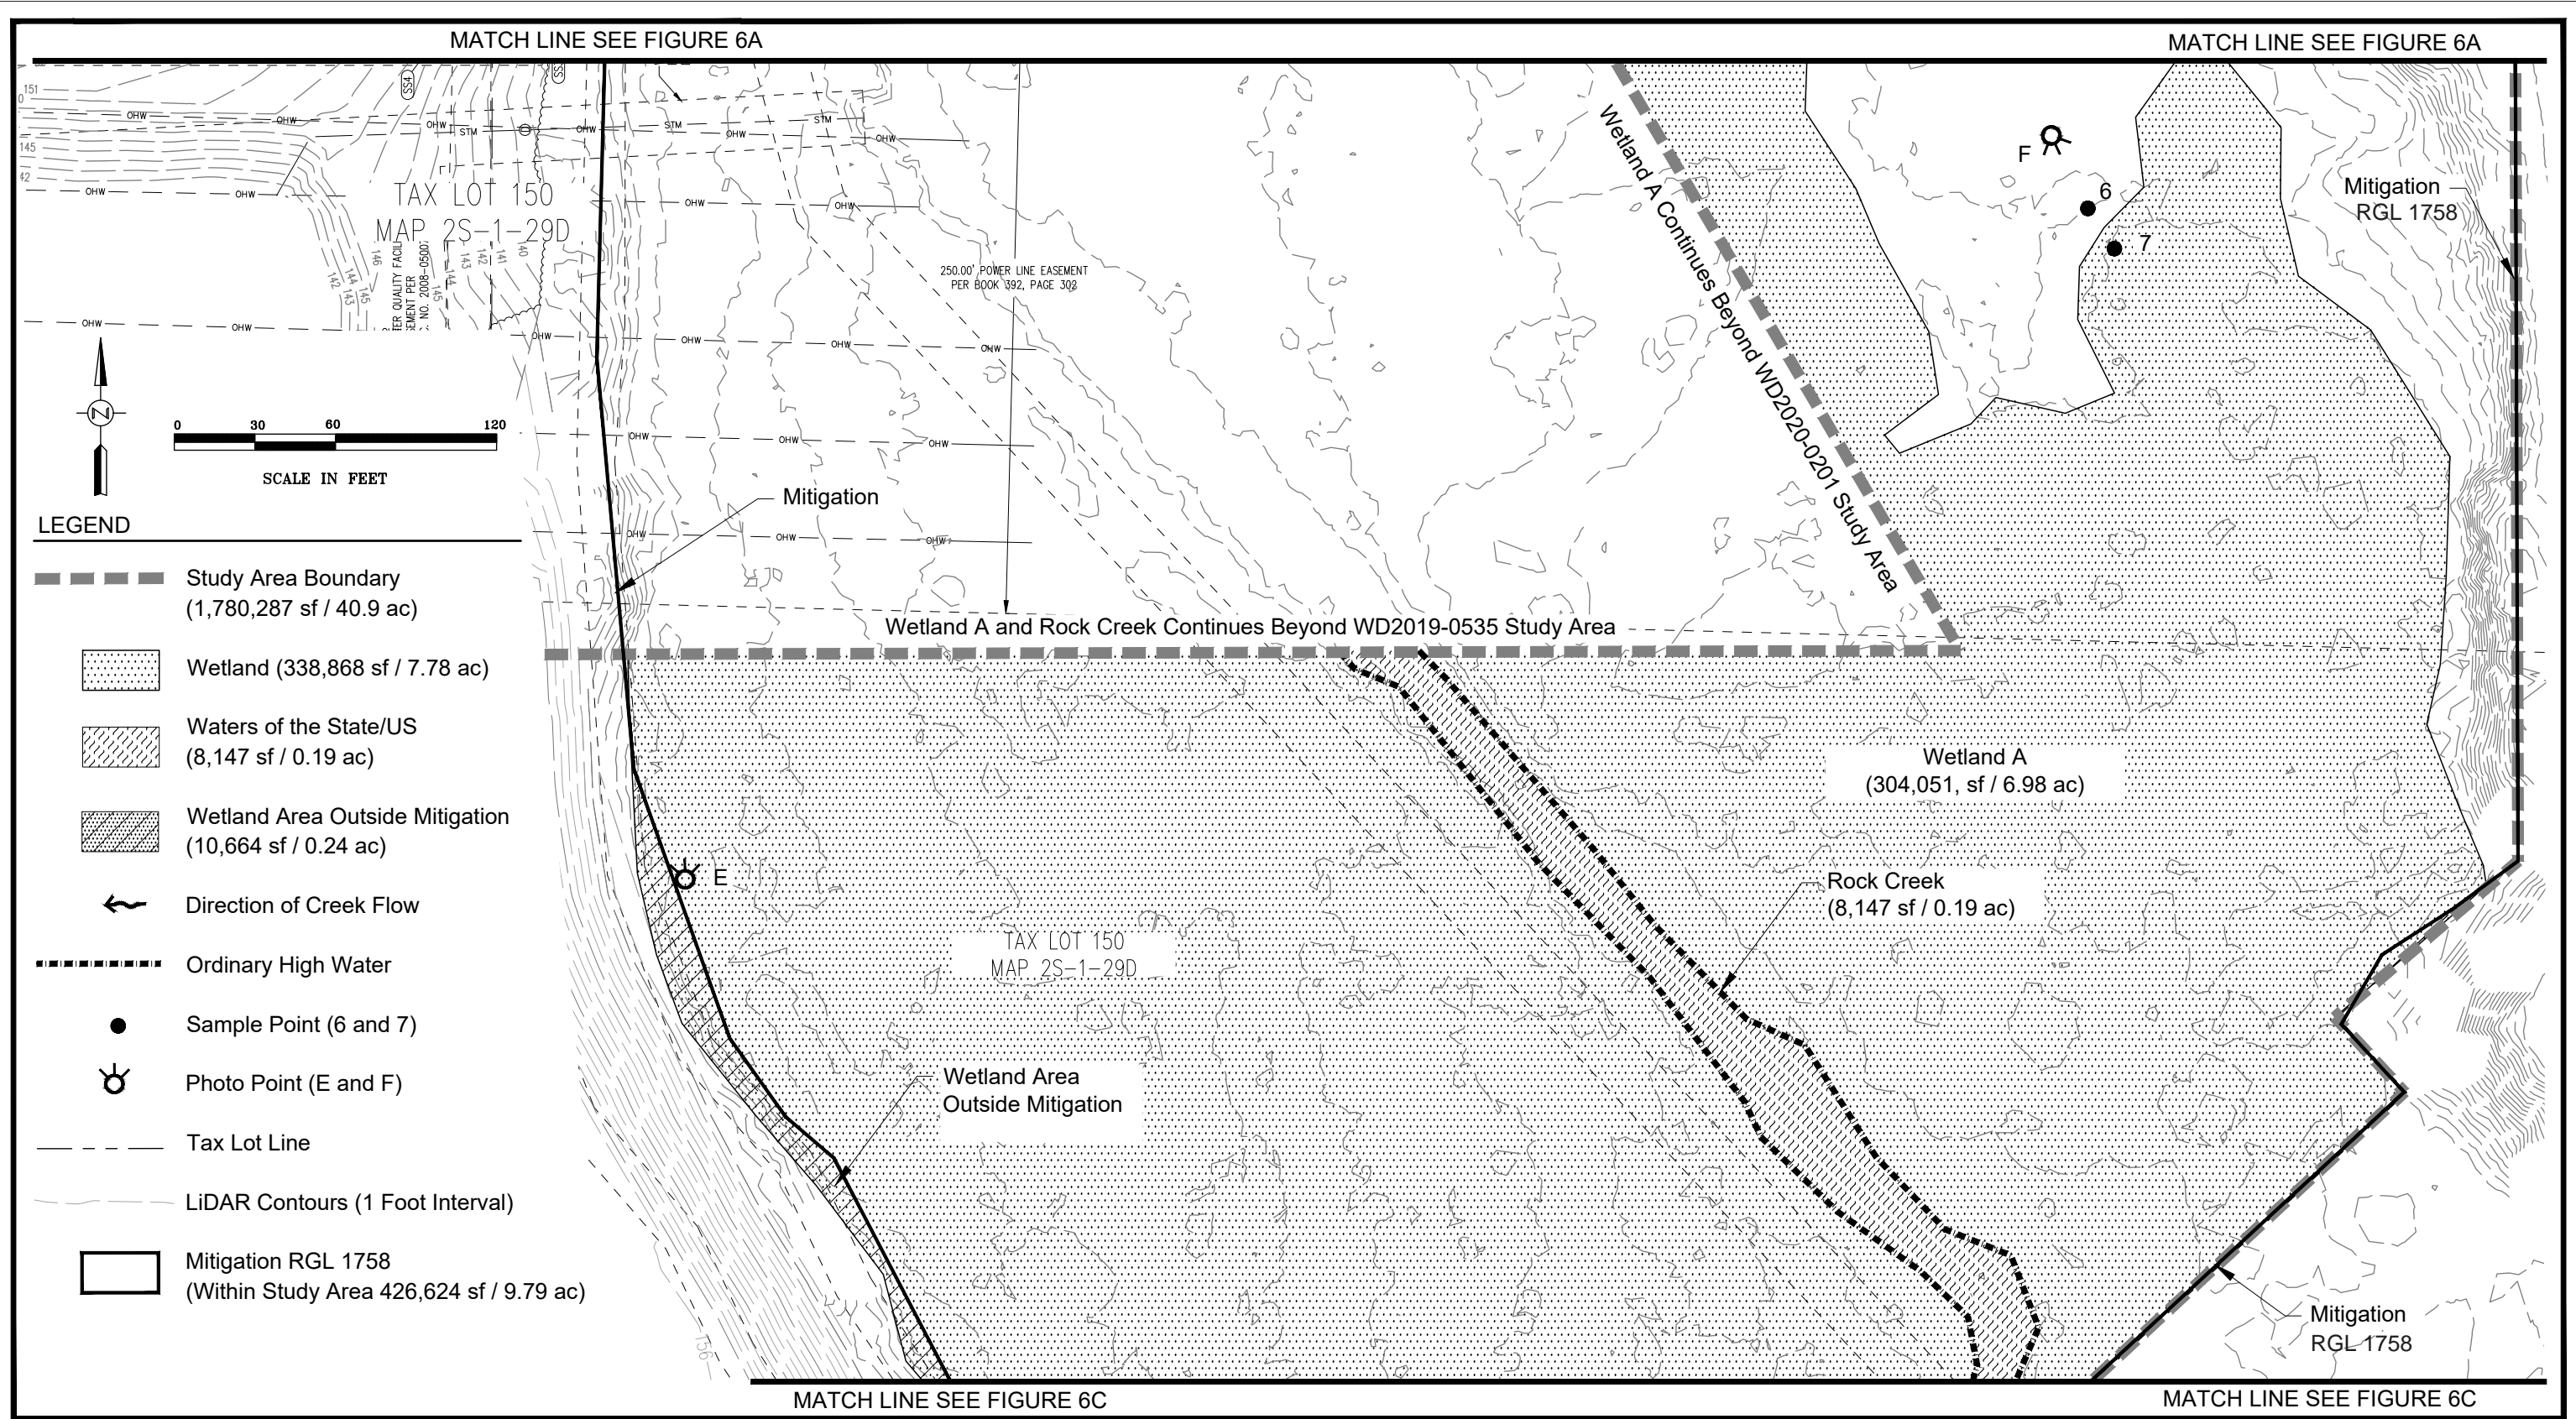
FIGURE
6B

Wetland Delineation
Sherwood Industrial Park Phase III Development Site - Sherwood, Oregon

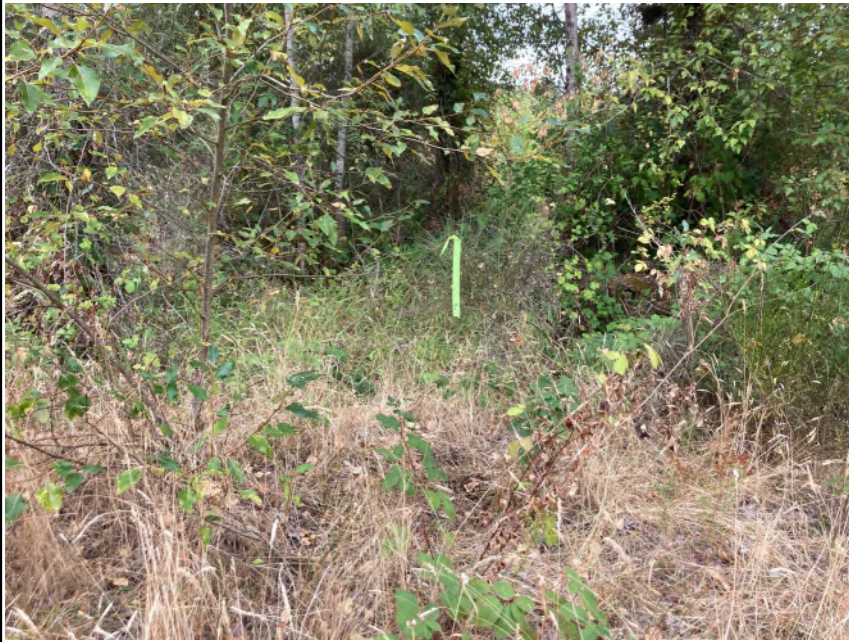
Photo A:

Looking southwest at sample points 8 and 9 and the east side of Wetland A.

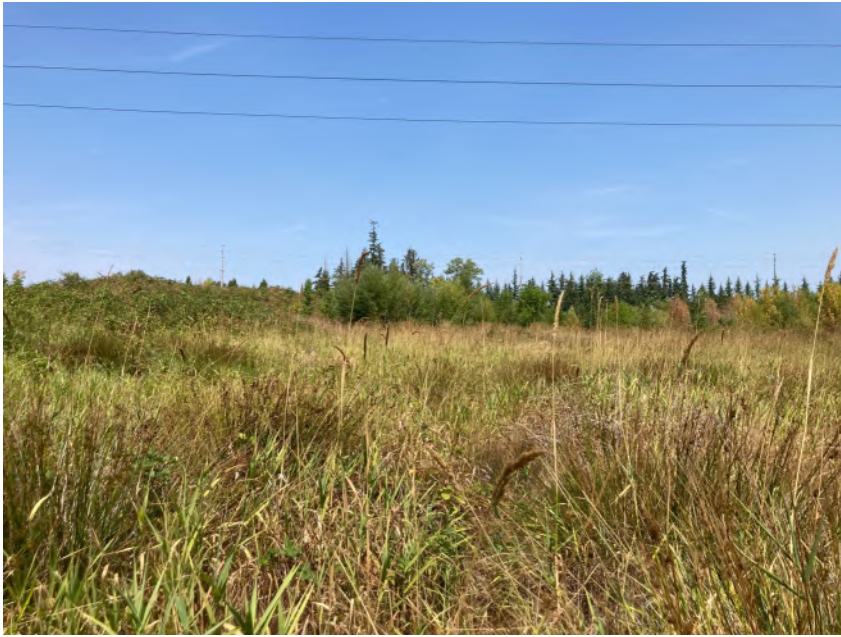
Photo E:

Looking north at Wetland A.

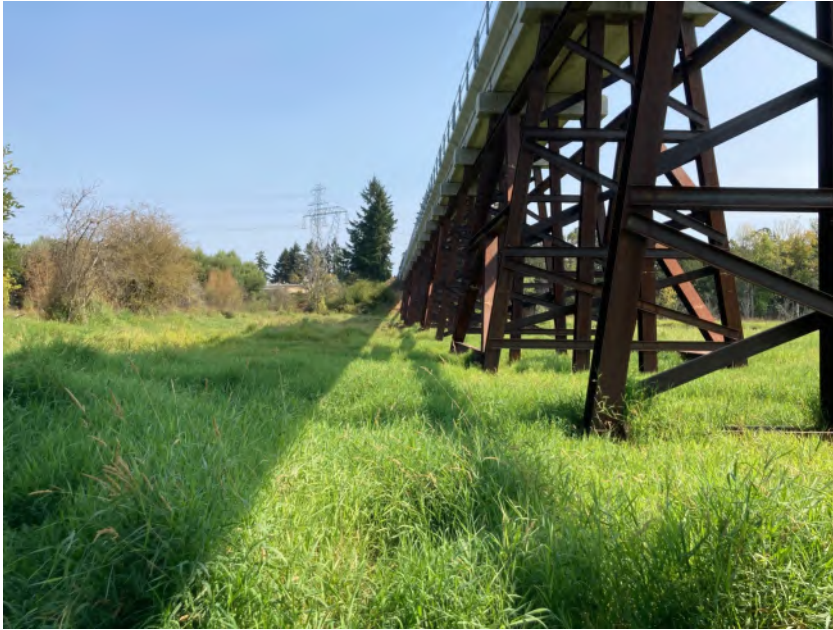
Photo G:

Looking northeast at the wetland terrace adjacent to Rock Creek.

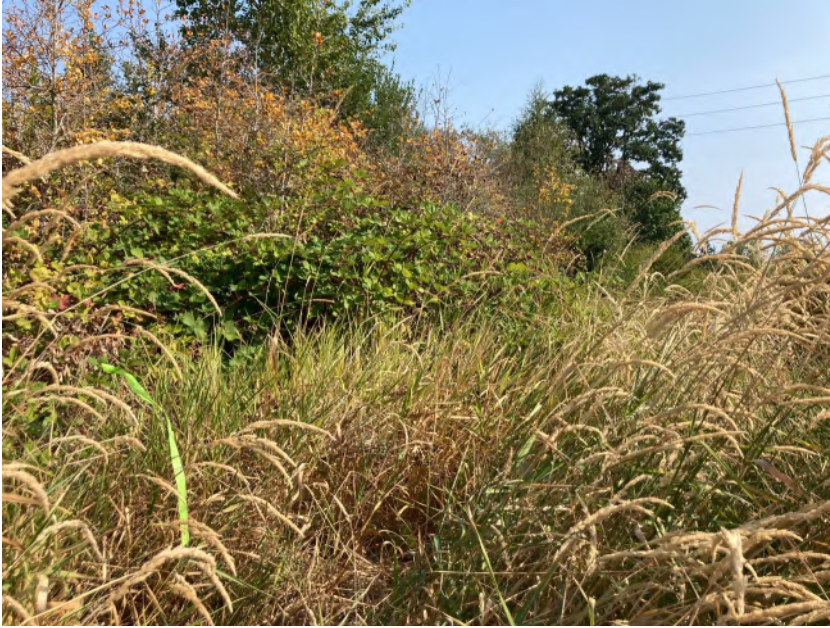
Photo I:

Looking northeast at sample point 10 in an upland ditch.

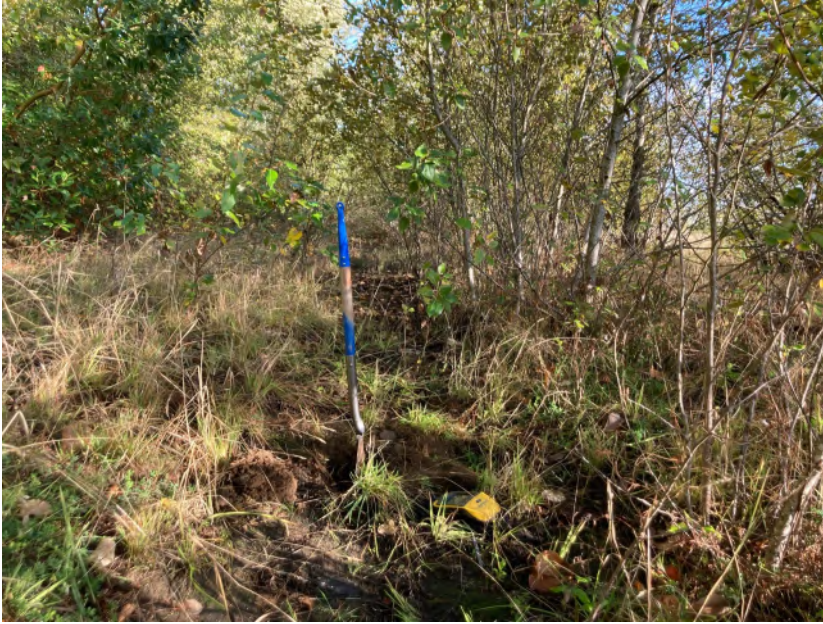
Photo K:

Looking north at sample point 12 in a remnant ditch.

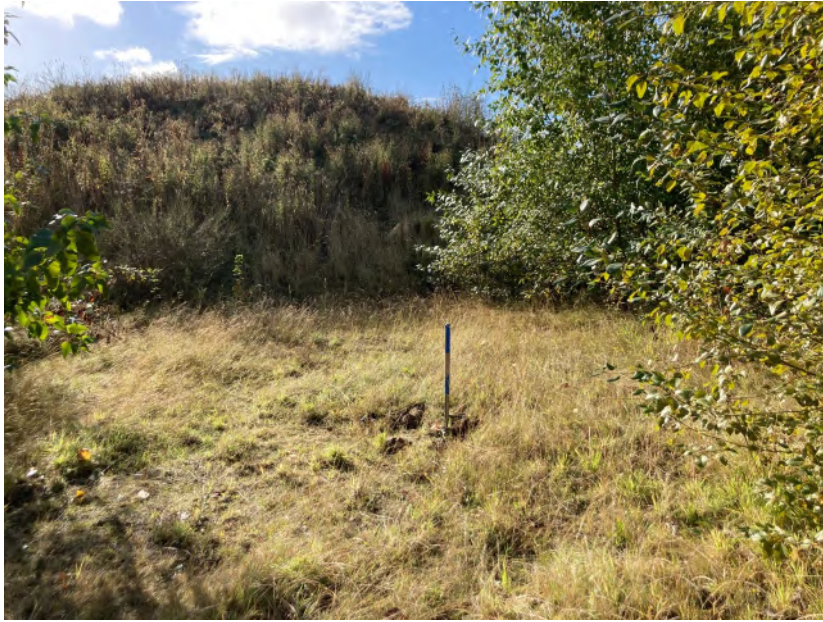
Photo M:

Looking south at sample point 14 in a low-lying upland area adjacent to an old stockpile.

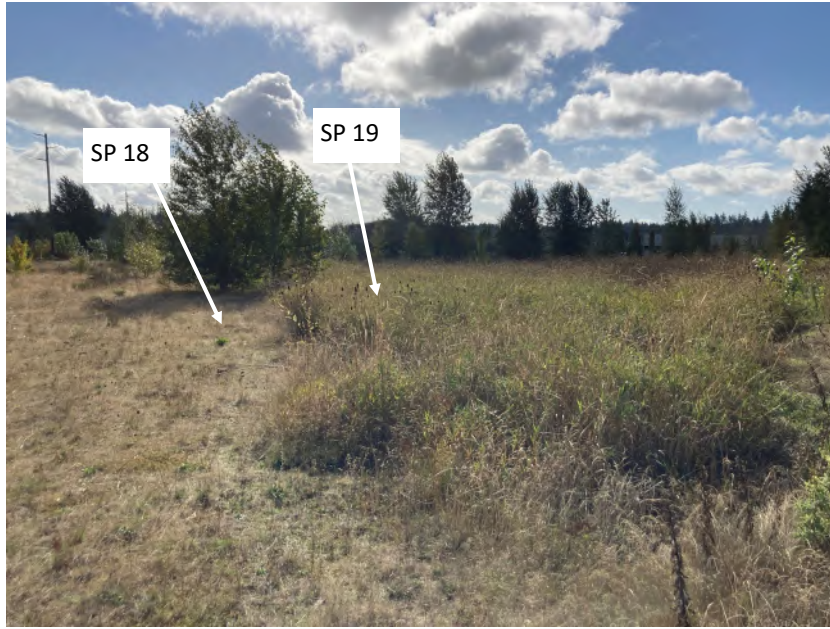
Photo O:

Looking southeast at Wetland B. Sample Points 18 and 19 are in the foreground.

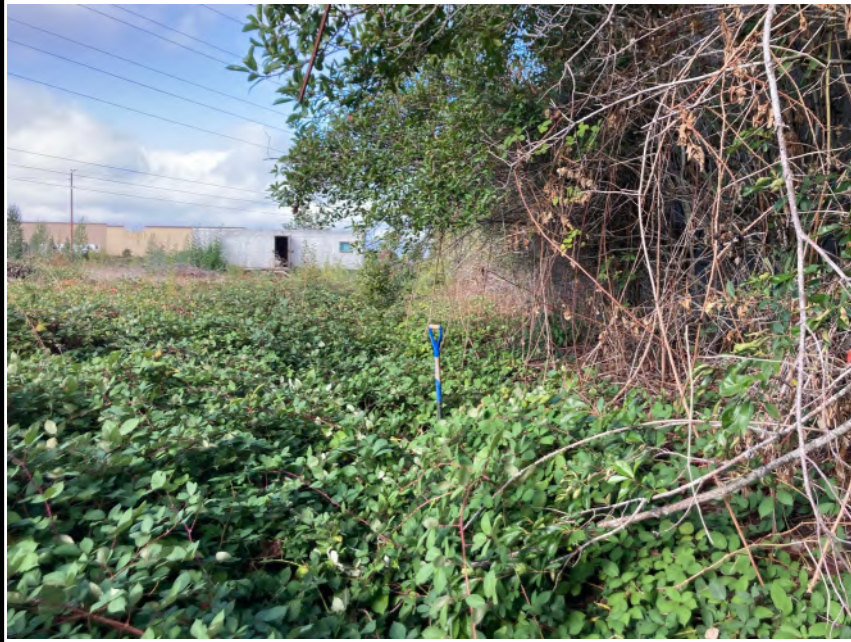
Photo Q:

Looking west at sample point 20 in an upland ditch.
