**GEOTECHNICAL REPORT**

**Sherwood Industrial  
13700 Southwest Tonquin Road  
Sherwood, Oregon**

**Project No. T-8912**

**July 20, 2023**

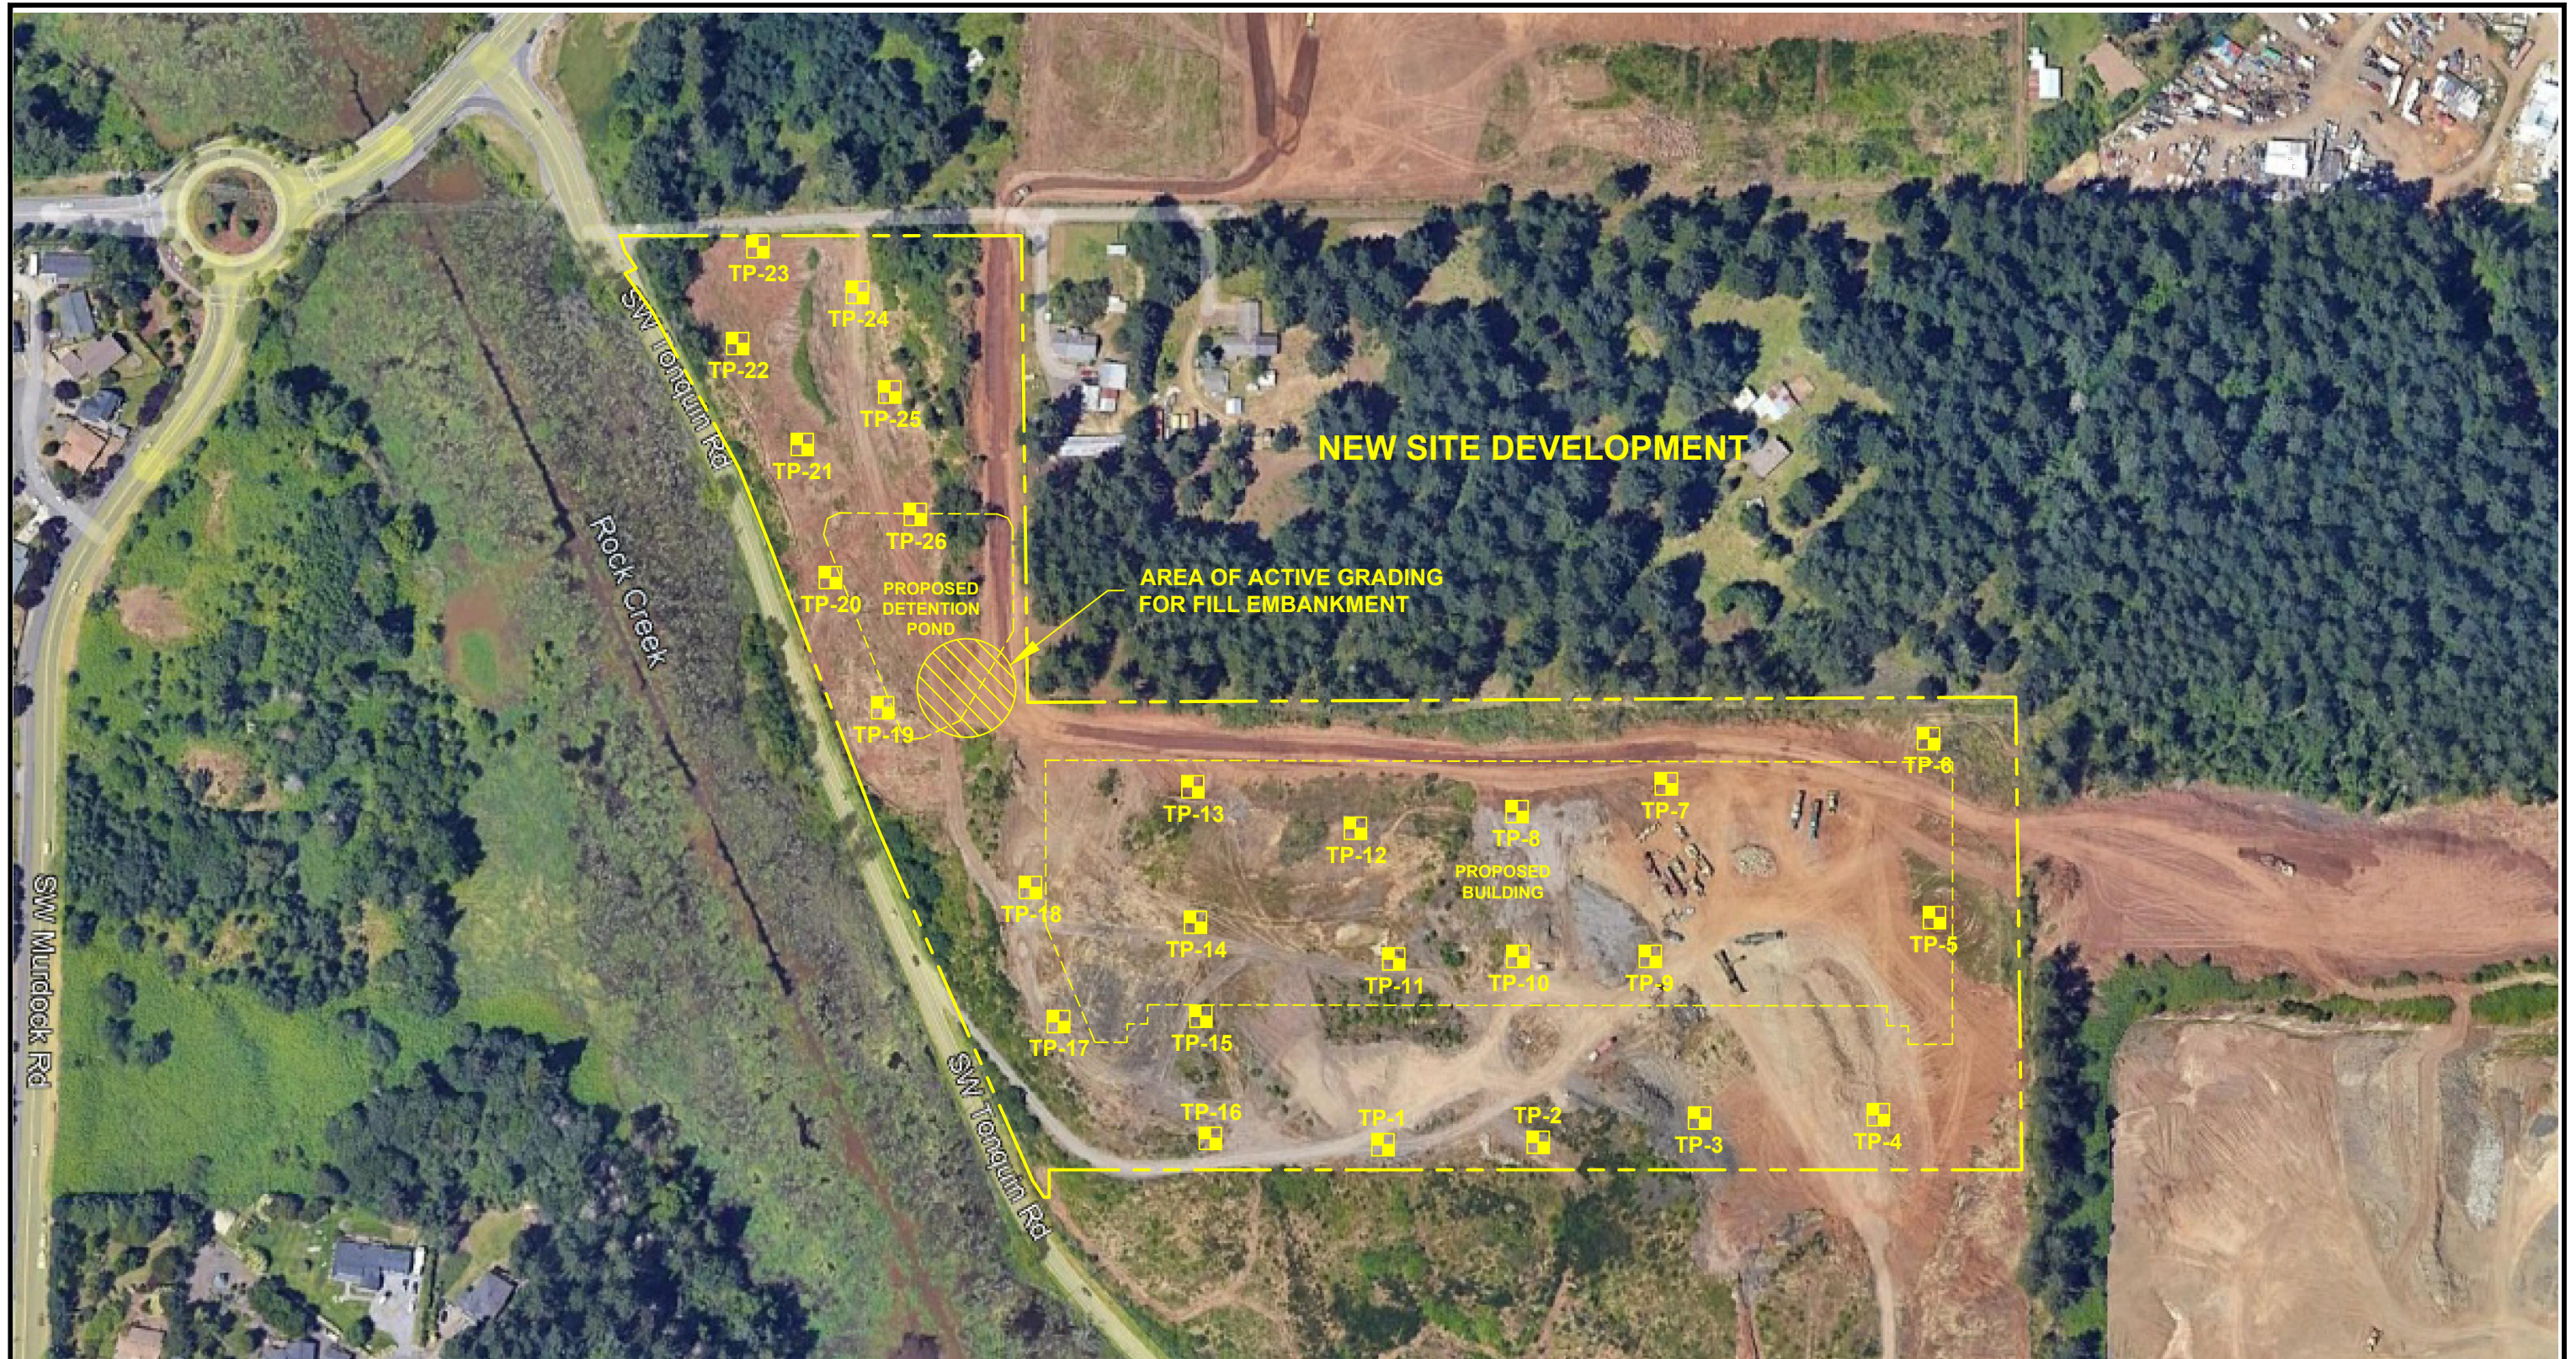
Figure 3

Detailed descriptions of the subsurface conditions observed in the test pits are presented on the Test Pit Logs in Appendix A. The approximate test pit locations are shown on Figure 3.

We explored subsurface conditions at the site in 26 test pits excavated to depths ranging between about 1 foot and 10.5 feet using a track-mounted excavator. Test pit locations were determined in the field using hand-held GPS locating and by sighting relative to existing surface features. The approximate location of the test pits is shown on Figure 3. The Test Pit Logs are attached as Figures A-3 through A-28.
