WETLAND DELINEATION / DETERMINATION REPORT COVER FORM

Project Name:	Latitude: 45.3637 Longitude: -122.8162 <small>decimal degree - centroid of site or start & end points of linear project</small>
Ice Age Drive	Tax Map # 2S 1W 28C Tax Lot(s) 600, 700, 701, and Bonneville Power right-of-way
Proposed Use: Street construction	Tax Map # 2S 1W 28D Tax Lot(s) 400, 500, 600, 601, 602, 700, 800, 900 & portions of BPA and Dahlke Lane rights-of-way
Project Street Address (or other descriptive location): 21428 SW Dahlke Lane and adjoining parcels to the east	Township 2S Range 1W Section 28 QQ C & D Use separate sheet for additional tax and location information
City: Sherwood County: Washington	Waterway: none River Mile: N/A

Wetland Delineation
 Ice Age Drive - Sherwood, Oregon

Ice Age Drive Extension Project - Sherwood, Oregon

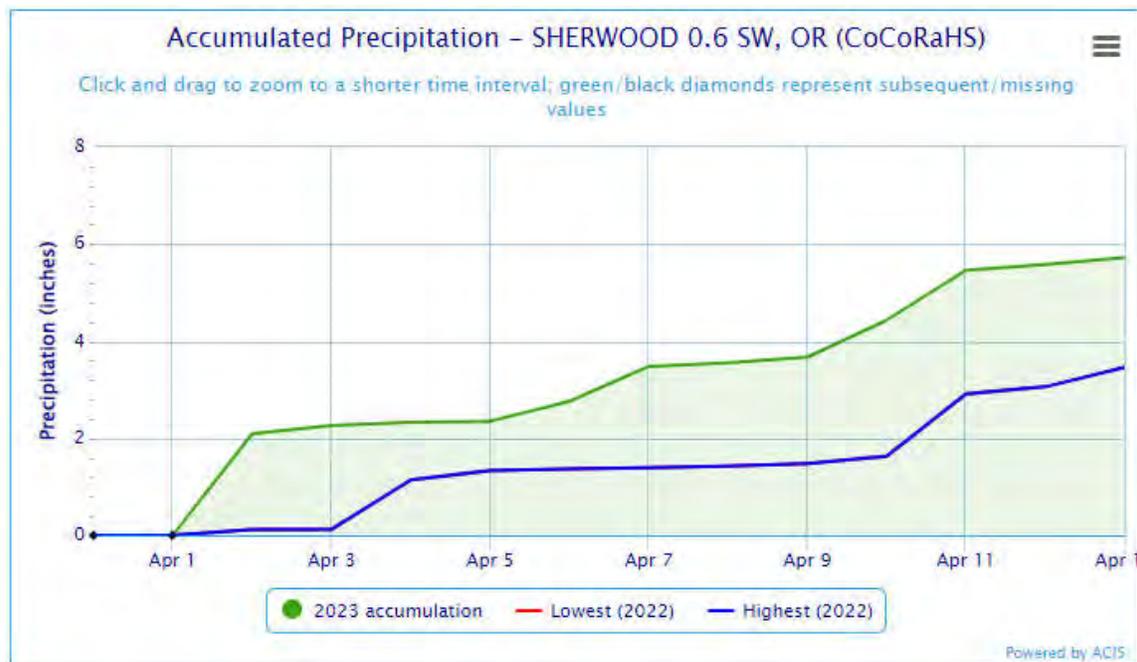
Graph 1. Accumulation graph from SHERWOOD 0.6 SW, OR spanning from March 31st to April 13th, 2023.

Below is an accumulation graph illustrating precipitation levels from two weeks prior to the site visit on April 14th, 2023. Precipitation data from SHERWOOD 0.6 SW shows that rainfall accumulation levels reached 5.72 inches. The total precipitation for the first half of April in 2023 exceeded the average total precipitation for the whole month of April every year since 1953 except for April of 1993 that experienced 7.00 inches total, indicating that rainfall was above average prior to the site visit.

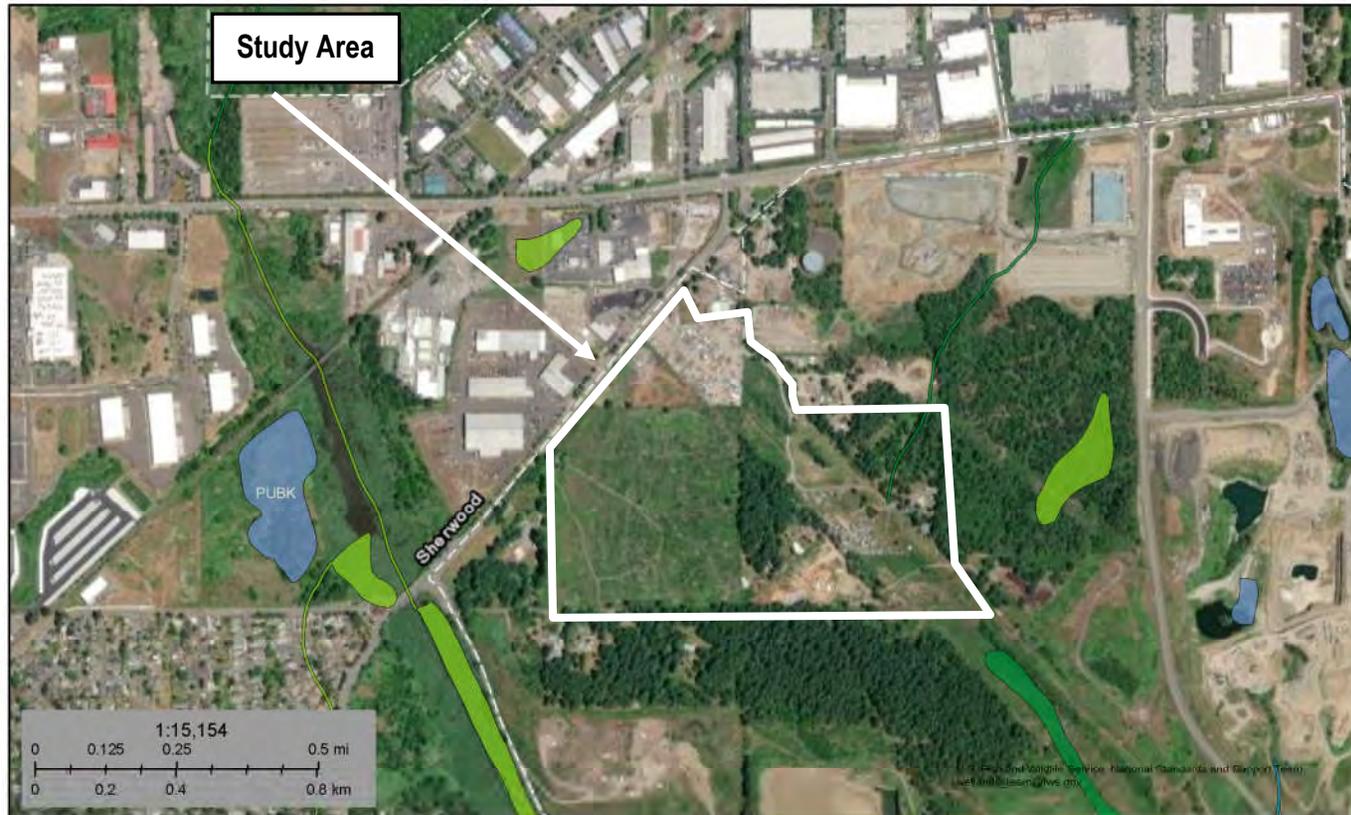
This map is for general reference only. The US Fish and Wildlife Service is not responsible for the accuracy or currentness of the base data shown on this map. All wetlands related data should be used in accordance with the layer metadata found on the Wetlands Mapper web site.

NWI maps are generated primarily through the interpretation of color infrared aerial photographs from 1981 (scale of 1:58,000), with limited "ground truthing" to confirm the interpretations. The small size of the on-site wetland, and the scale of the aerial photographs used to prepare the NWI is the likely reason for the discrepancy between the wetlands mapping and the existing on-site conditions.

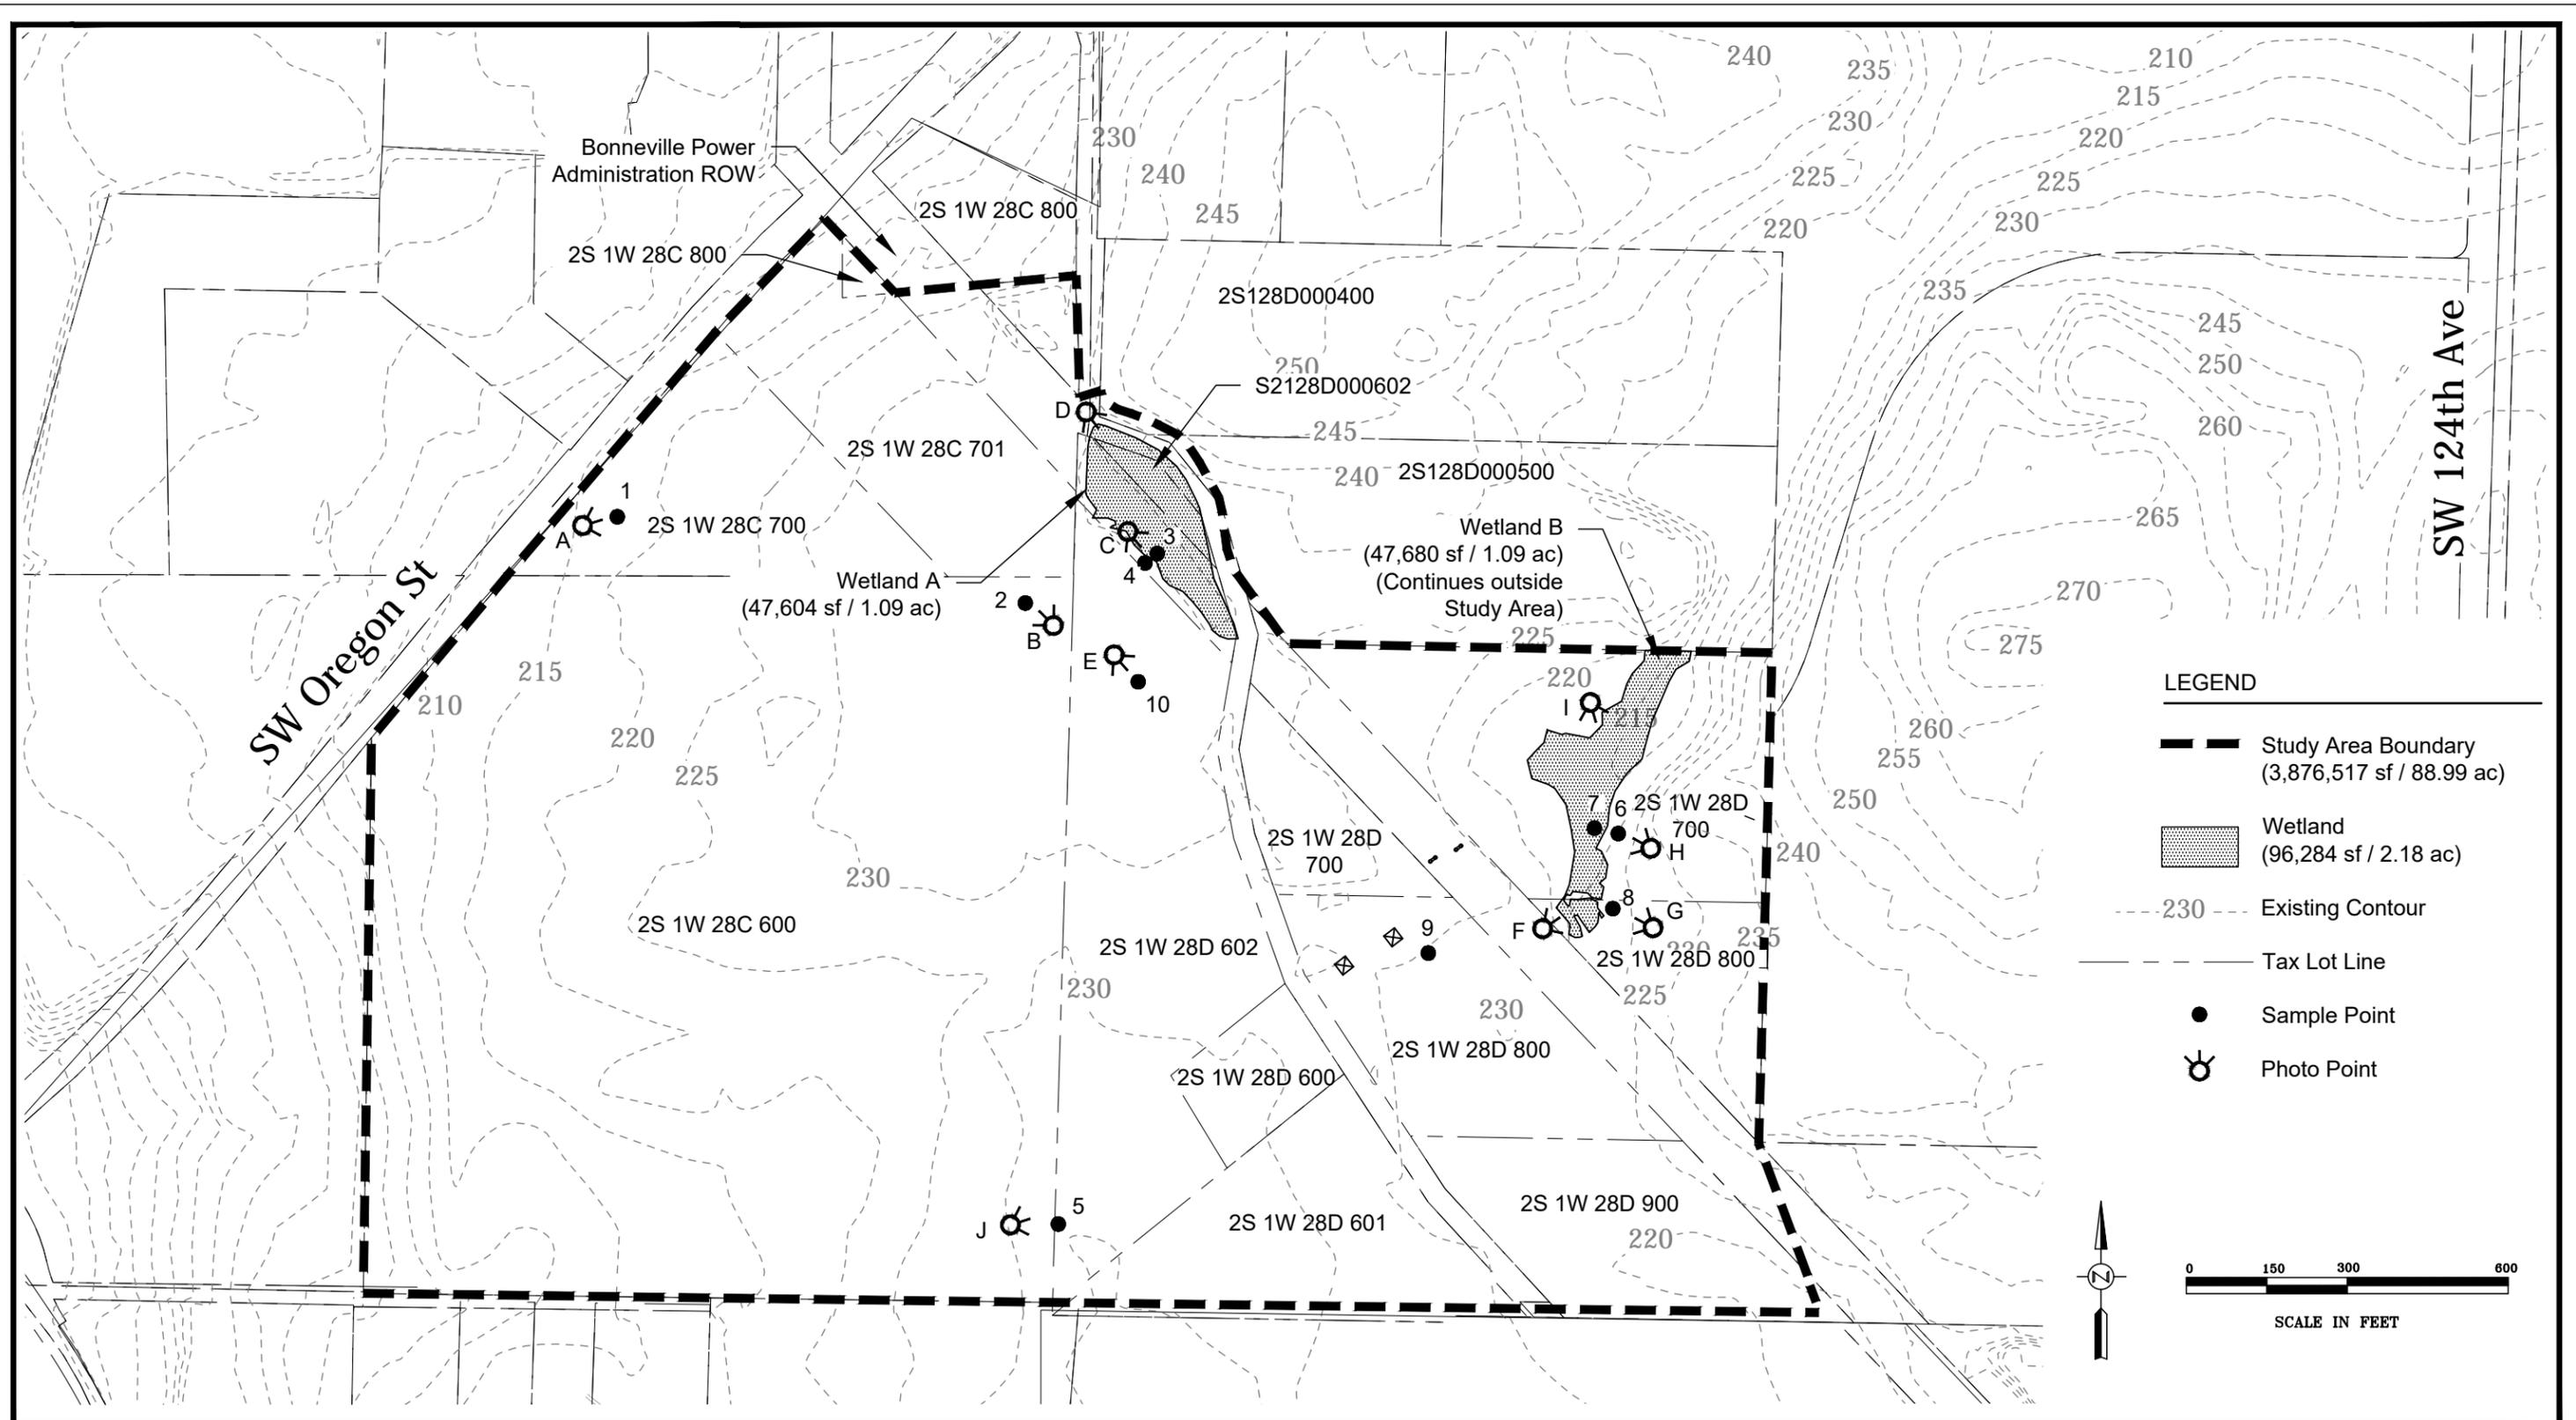
- LEGEND**
- Study Area Boundary (3,876,517 sf / 88.99 ac)
 - Wetland (96,284 sf / 2.18 ac)
 - Existing Contour
 - Tax Lot Line
 - Sample Point
 - Photo Point

Boundaries and sample points were GPS'ed by PHS and have sub meter accuracy.

The entire study area was investigated for the presence of wetlands or other waters. Two wetlands were delineated within the study area. Wetlands A and B were delineated based on topographic changes and changes from observed hydric soils to soils where no hydric indicators

were observed. Vegetation changes from facultative shrubs to upland trees were also used to determine the wetland/upland boundary.

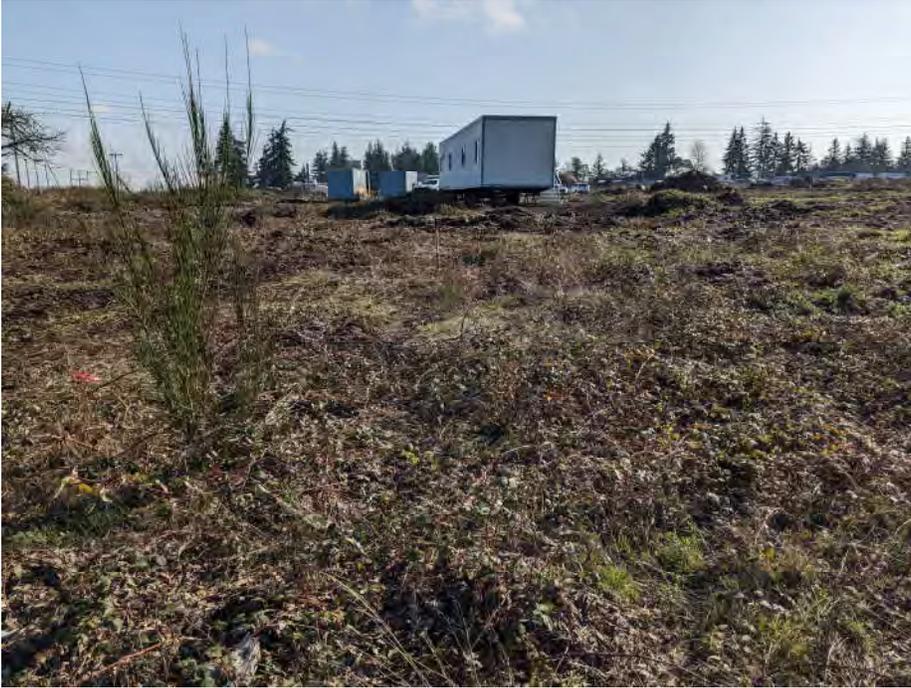
Photo A:

Sample Point 1 near the northwest study area boundary. Photo shows characteristic upland vegetation west of the industrial/equipment storage area at the northern part of the study area.

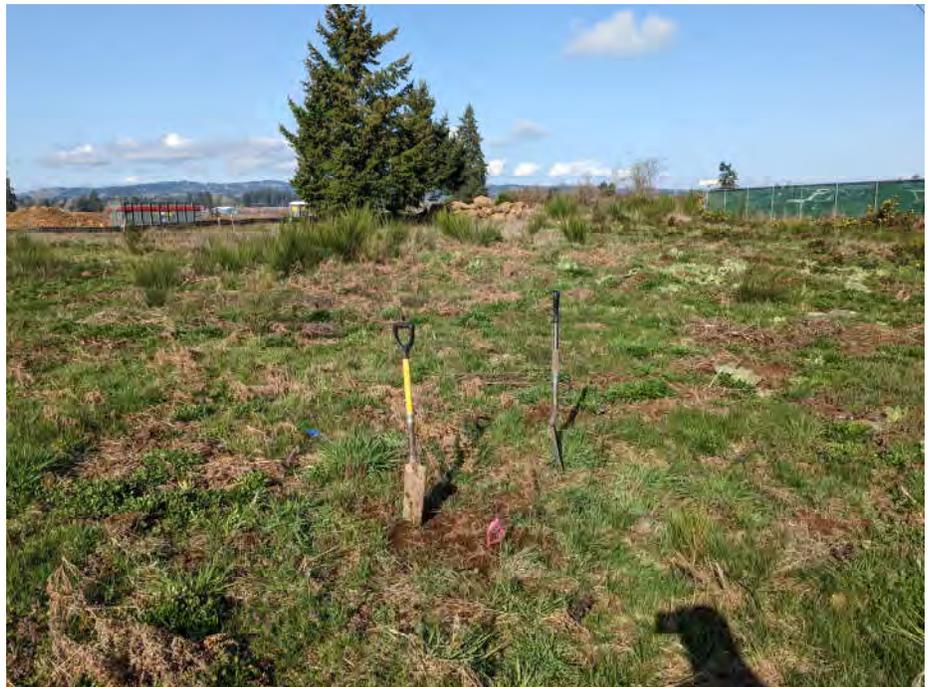
Photo B:

Sample Point 2 located within the BPA corridor south of the north end industrial area.

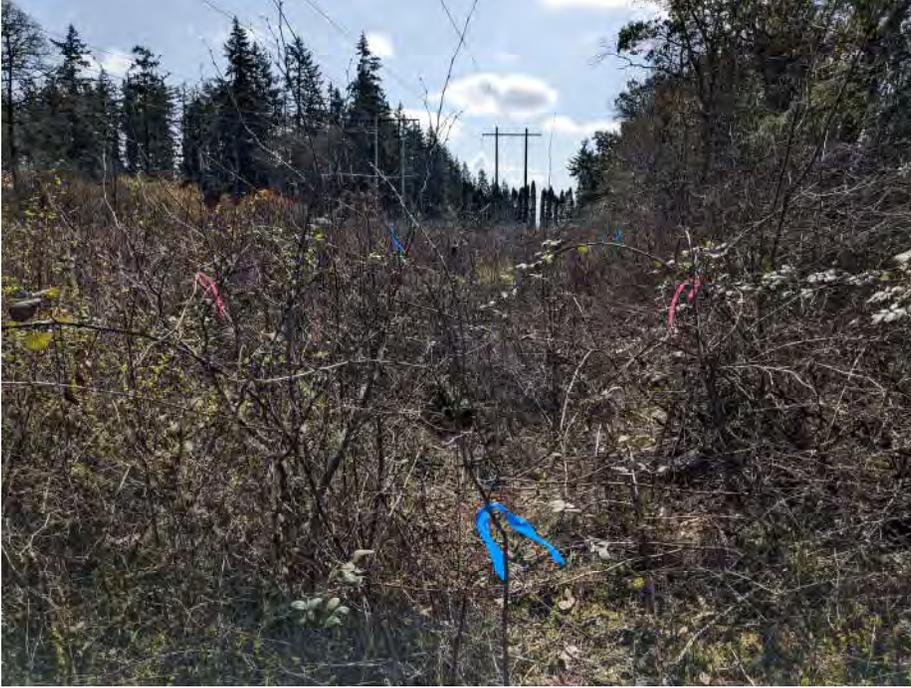
Photo C:

Sample Points 3 & 4 along the western boundary of Wetland A.

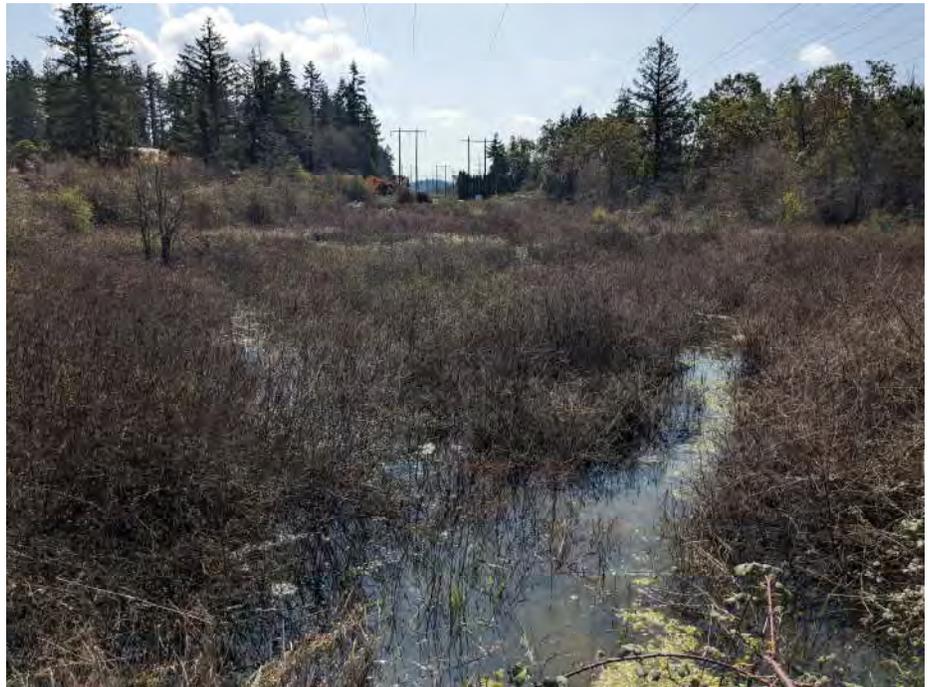
Photo D:

Depiction of hydrologic conditions found throughout Wetland A at the time of the site visit. Photo was taken from the northern-most boundary.

Wetland A is isolated, bordered by industrial and commercial activity to the north and upland on the south side, and likely experiences prolonged periods of ponding throughout given its geomorphic position; onsite observations revealed that ponding was greater than 1 foot in certain areas. The dominant vegetation throughout the wetland is swamp rose (*Rosa pisocarpa*) with intermixed invasive blackberry found in the periphery of the wetland. The inner portion of the wetland is shallow, open water. Hydrology is sourced mainly from precipitation and runoff from the surrounding topography that slopes towards the wetland.

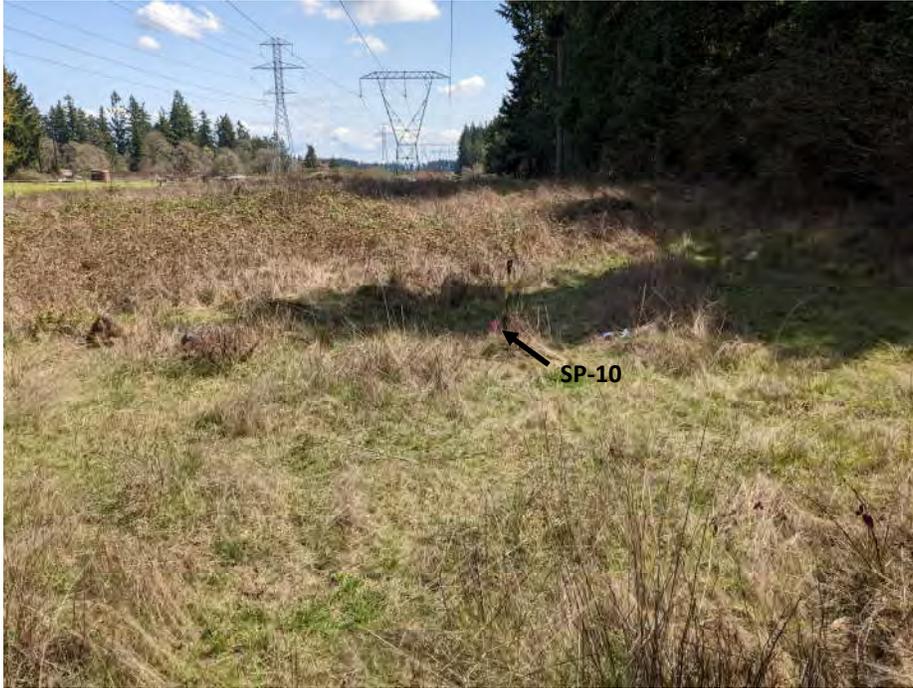
Photo E:

Sample Point 10 located southeast of Sample Point 2, both of which are in the BPA corridor.

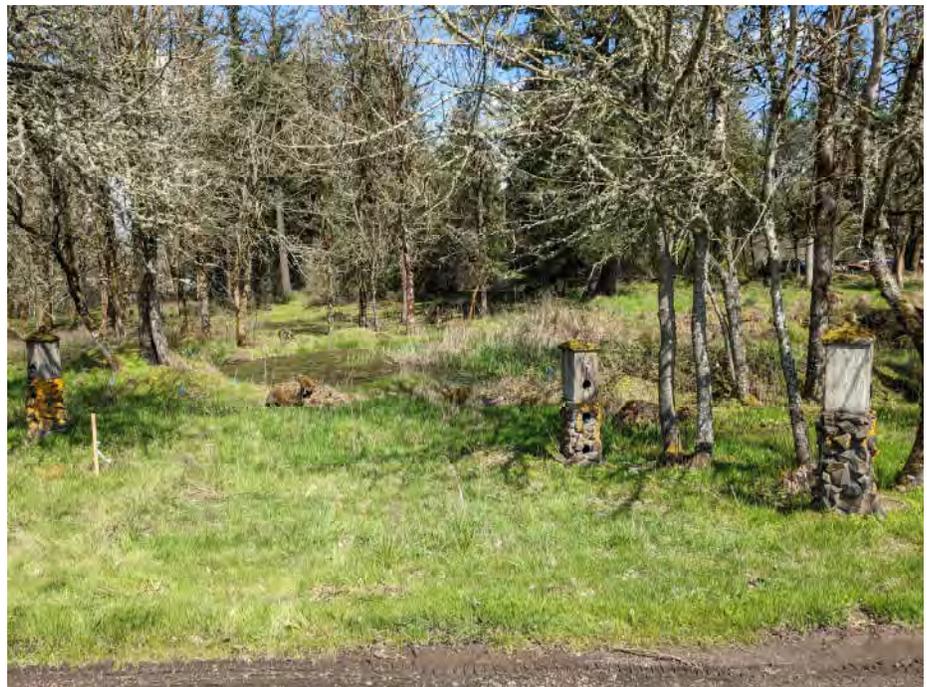
Photo F:

View of the south end of Wetland B as seen from a road within the BPA right-of-way.

Wetland B continues north beyond the study area. Hydrology sources for the wetland include precipitation, surface runoff, and subsurface lateral flows. Surface hydrology flows northward from the onsite pond at the southern end of the wetland. At the time of the site visit, sheet flow spanned most of the wetland's width as it flowed towards the fences on the north property border. Areas that were inundated with flowing water were generally grassy with some creeping buttercup intermixed and a few shrub-sized ash trees found near the northern end.

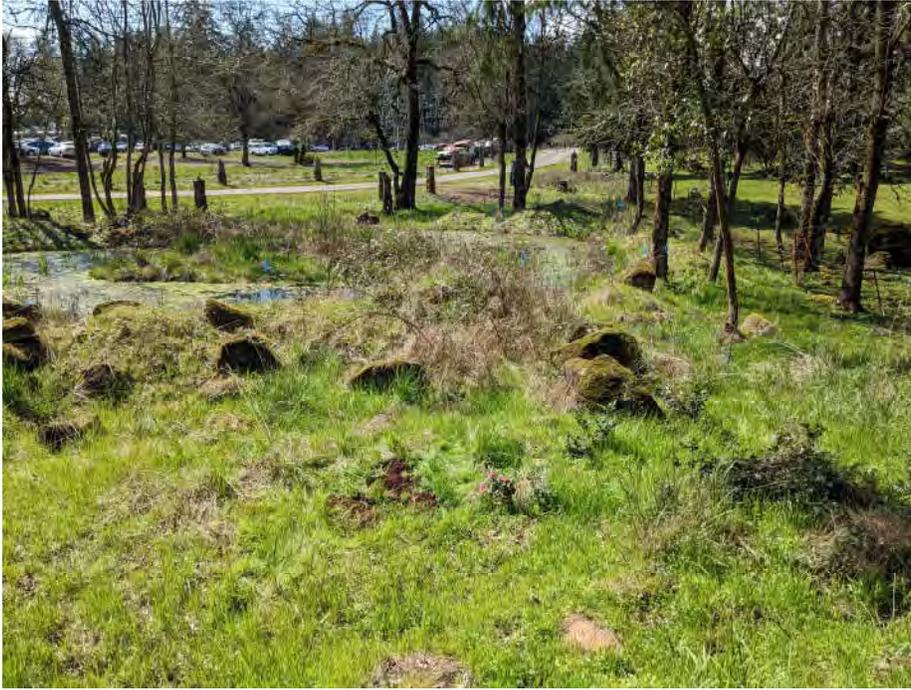
Photo G:

Sample Point 8; facing southwest towards the pond at the southern tip of Wetland B.

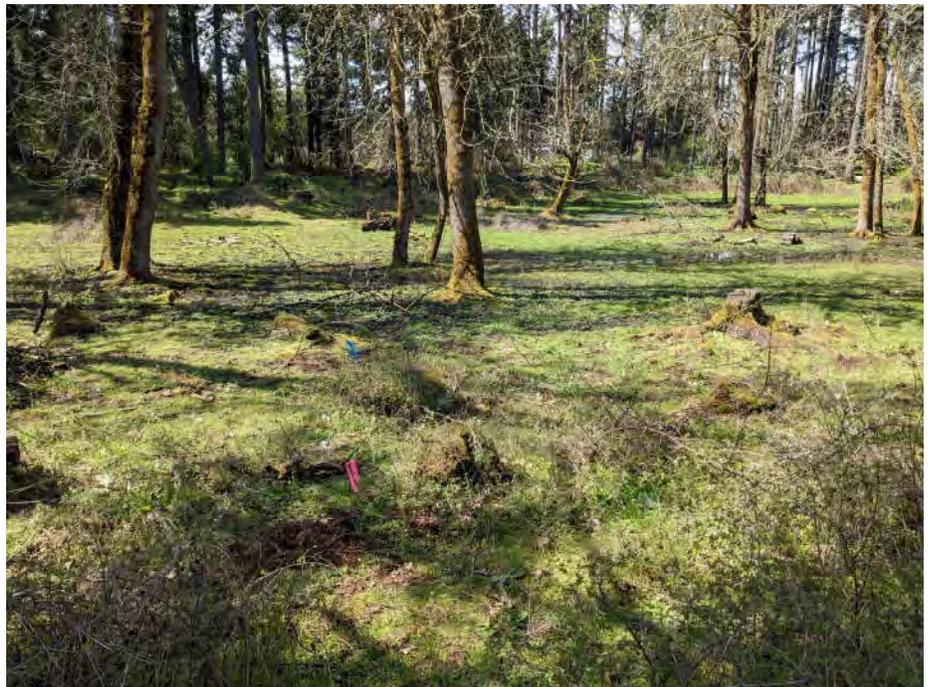
Photo H:

Sample Point 6 (the pink flag), with Wetland B beyond.

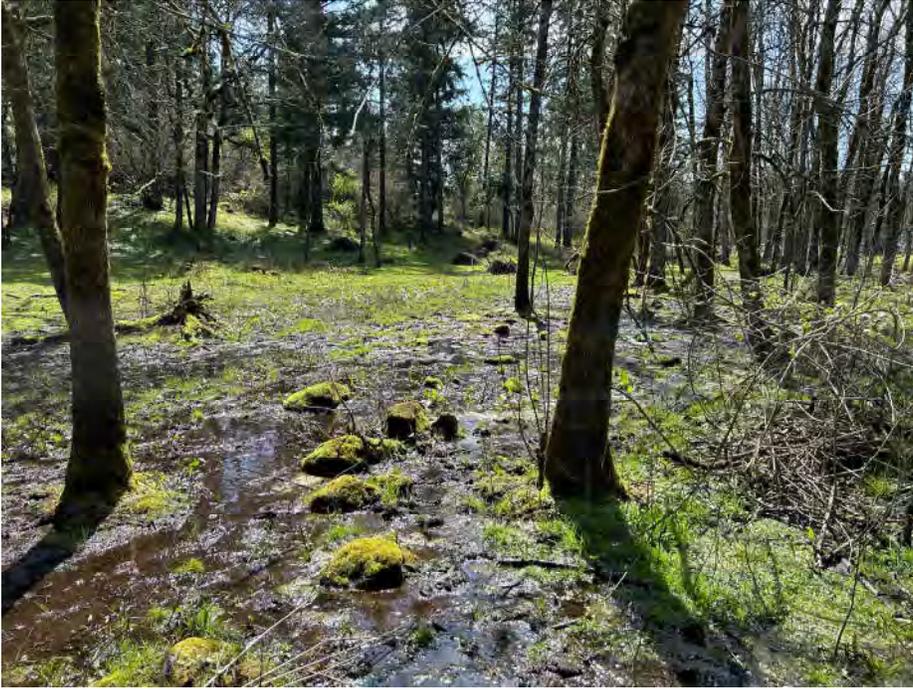
Photo I:

Facing southeast towards the interior of Wetland B from the middle of the western boundary.

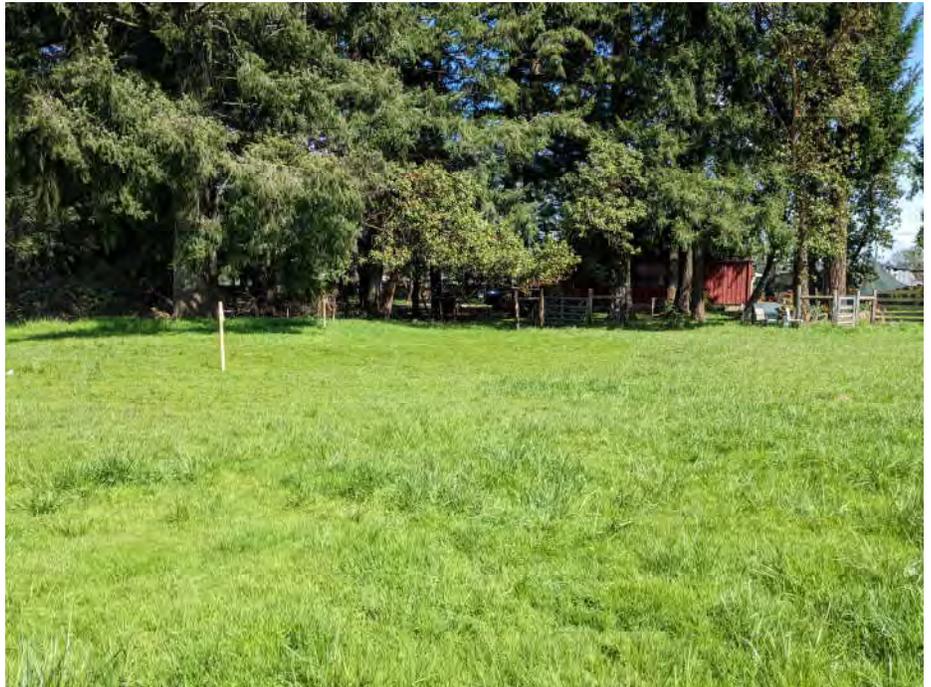
Photo J:

Vicinity of Sample Point 5; taken near the middle of southern border of study area adjacent to an onsite residence. (Photo taken prior to data collection and placement of flag.)
