Open Space Tree Removal and Storm Water Quality Facility (SWQF) CIP Project-Tree Removal

September 12, 2016

Open Space and City Property Tree Removal Request

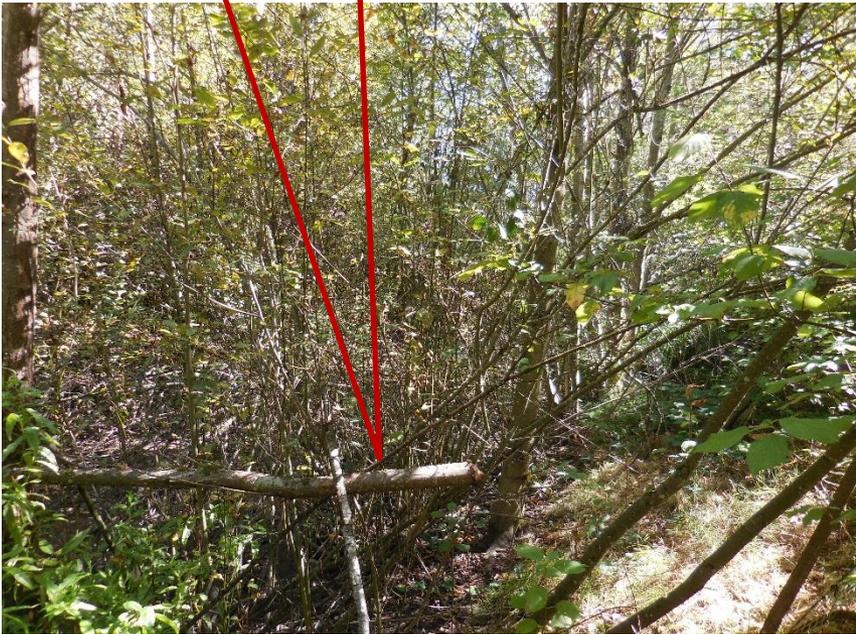
downed and overgrown
willow/volunteer
cottonwood trees

- Removal of approximately 25 volunteer Cottonwood and planted Alders and Willows
- Removal of various Willow and downed/dead trees in bottom of pond swale
- Core-out and regrade facility for storm system to operate properly
- Planting of sedges and grasses in bottom of wet pond and work with volunteers to plant trees and shrubs fall and spring

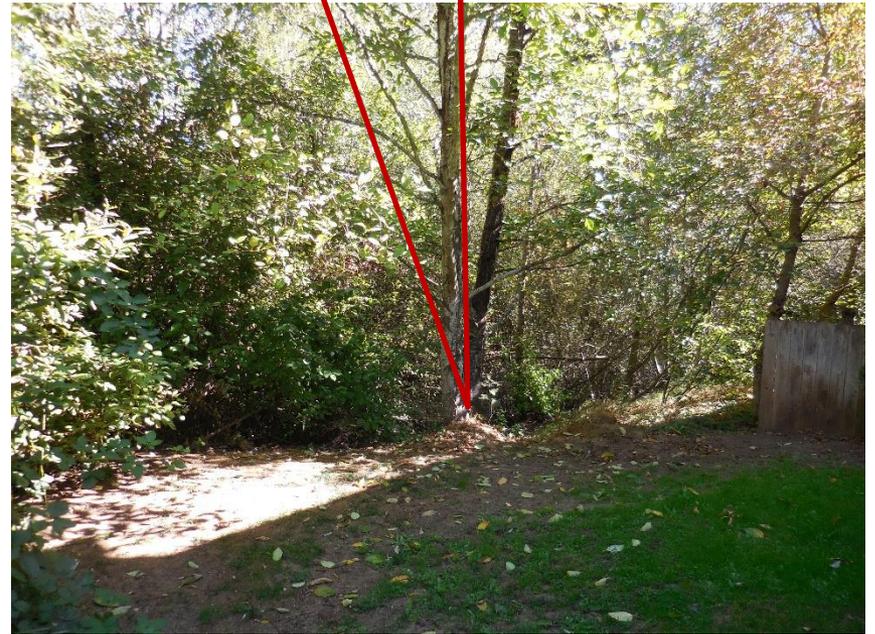
Large volunteer
cottonwood causing
channeling of water
within swale

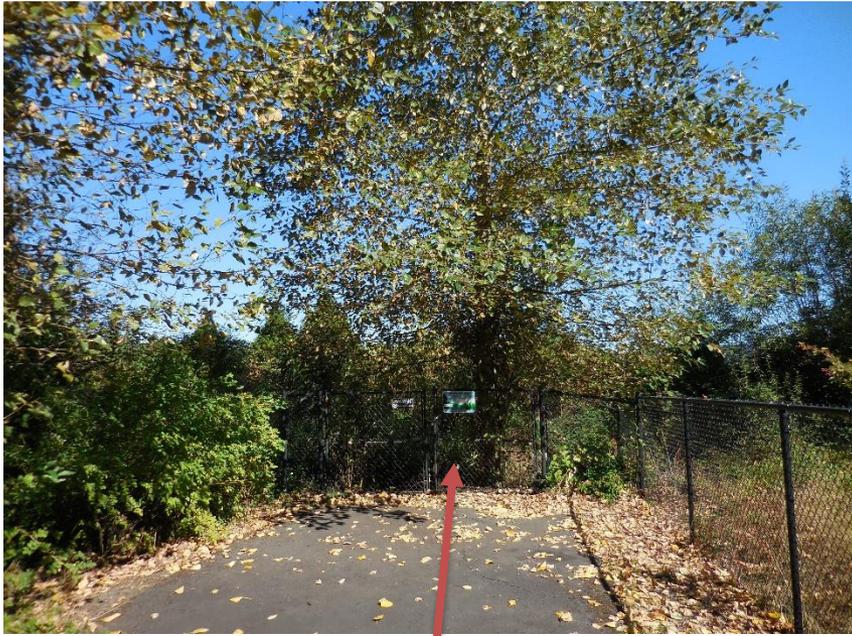
Volunteer Cottonwood blocking access to facility

- Removal of approximately 10 volunteer Cottonwood and planted Willow
- Removal of various Willow and downed/dead trees in bottom of pond channelization of swale and blocking access to facility
- Core-out and regrade facility for storm system to operate properly
- Planting of sedges and grasses in bottom of wet pond and work with volunteers to plant trees and shrubs fall and spring

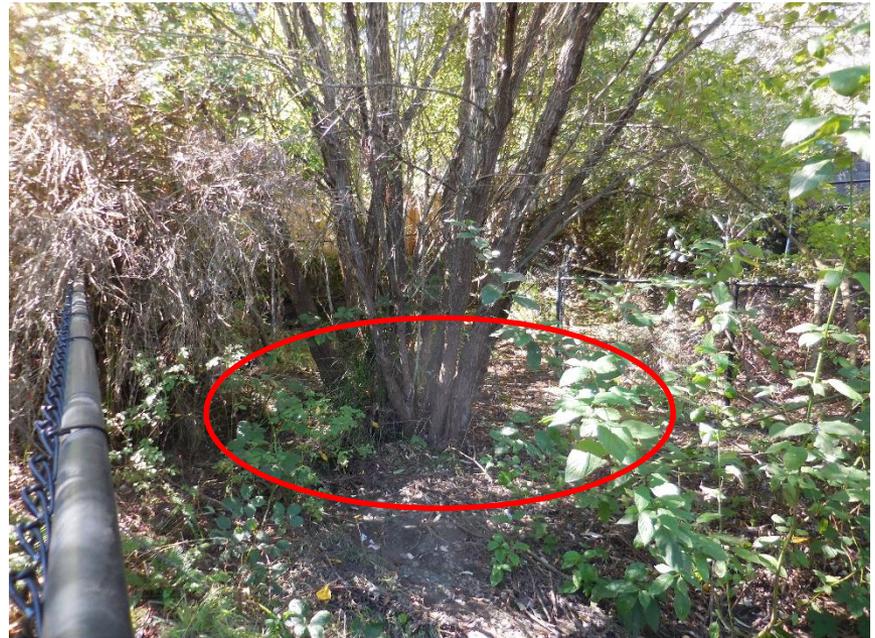
Willow in bottom of swale, causing channelization and erosion at outlet
