Land Use Application for Middlebrook Subdivision

September 2018
Updated January 2019

Exhibit A: Preliminary Plans (Updated 12/18/2018)

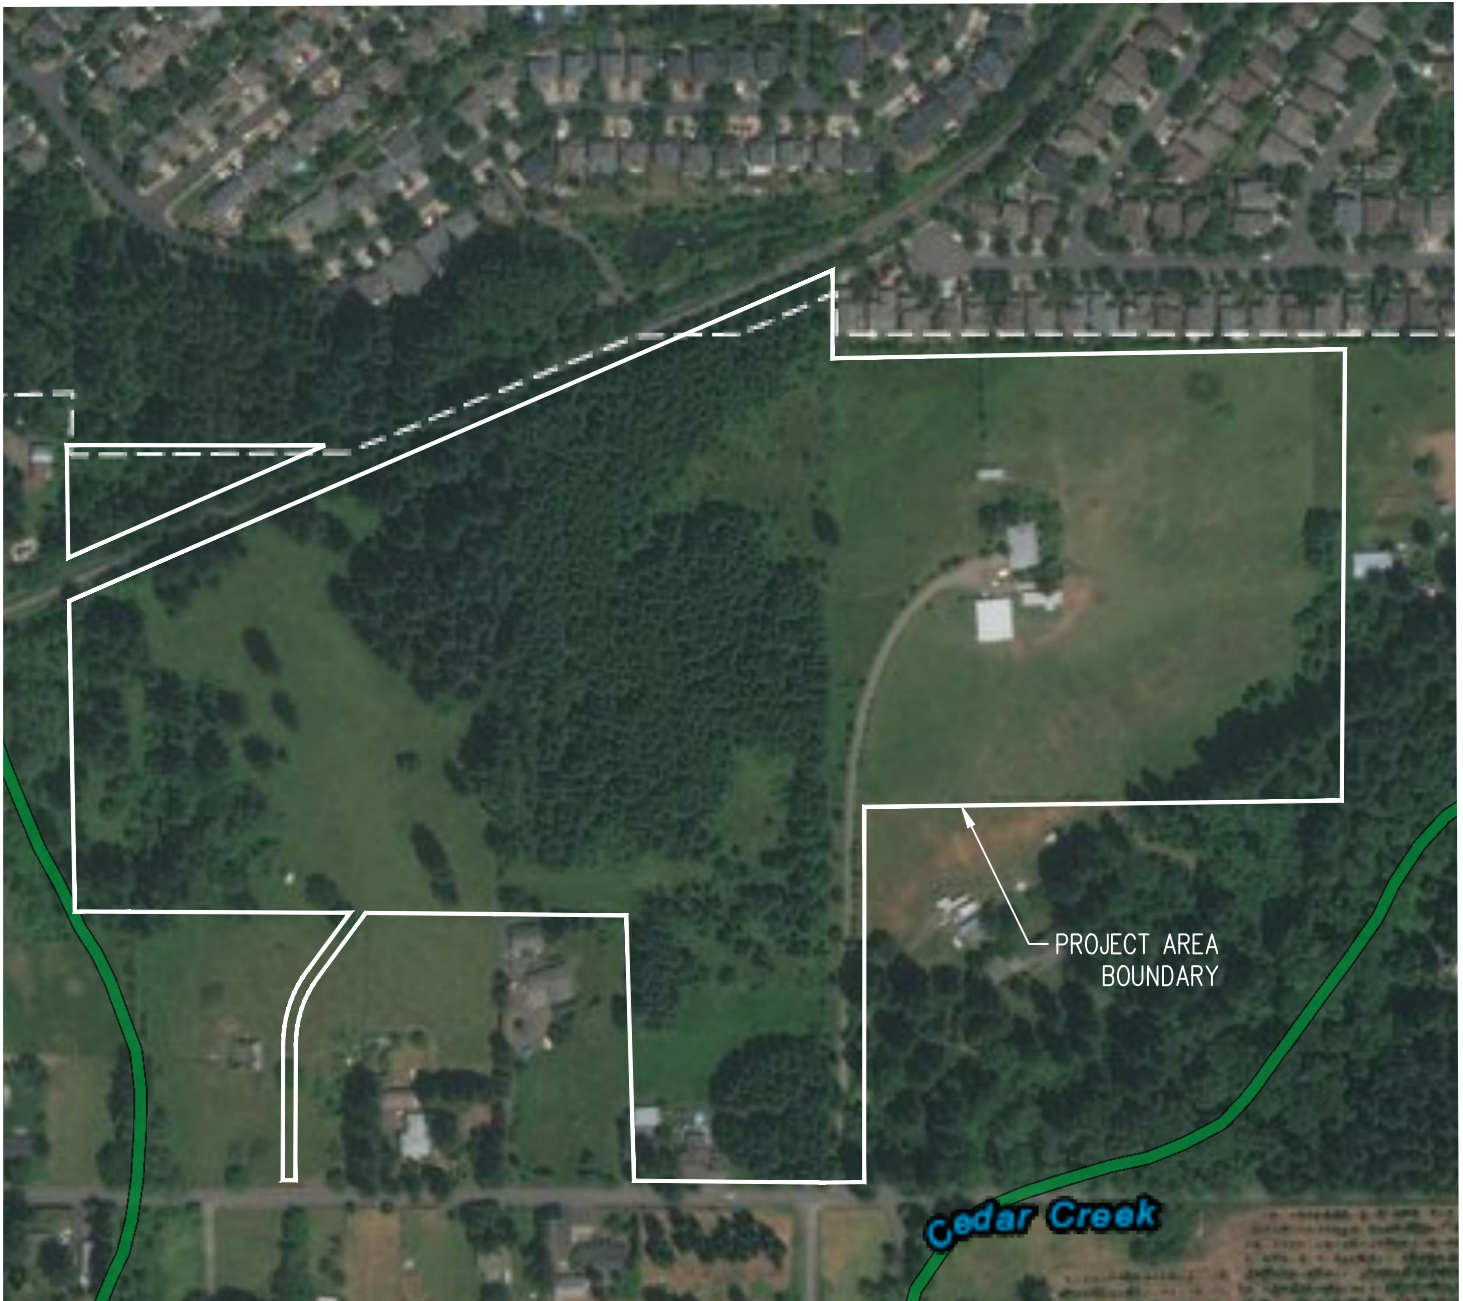
FIGURE
3

Figure 3. NRCS Soil Survey Map

The following soil units are mapped within the study area, according to the Natural Resources Conservation Service (NRCS) Washington County Area Soil Survey Map (Figure 3 in Appendix A):

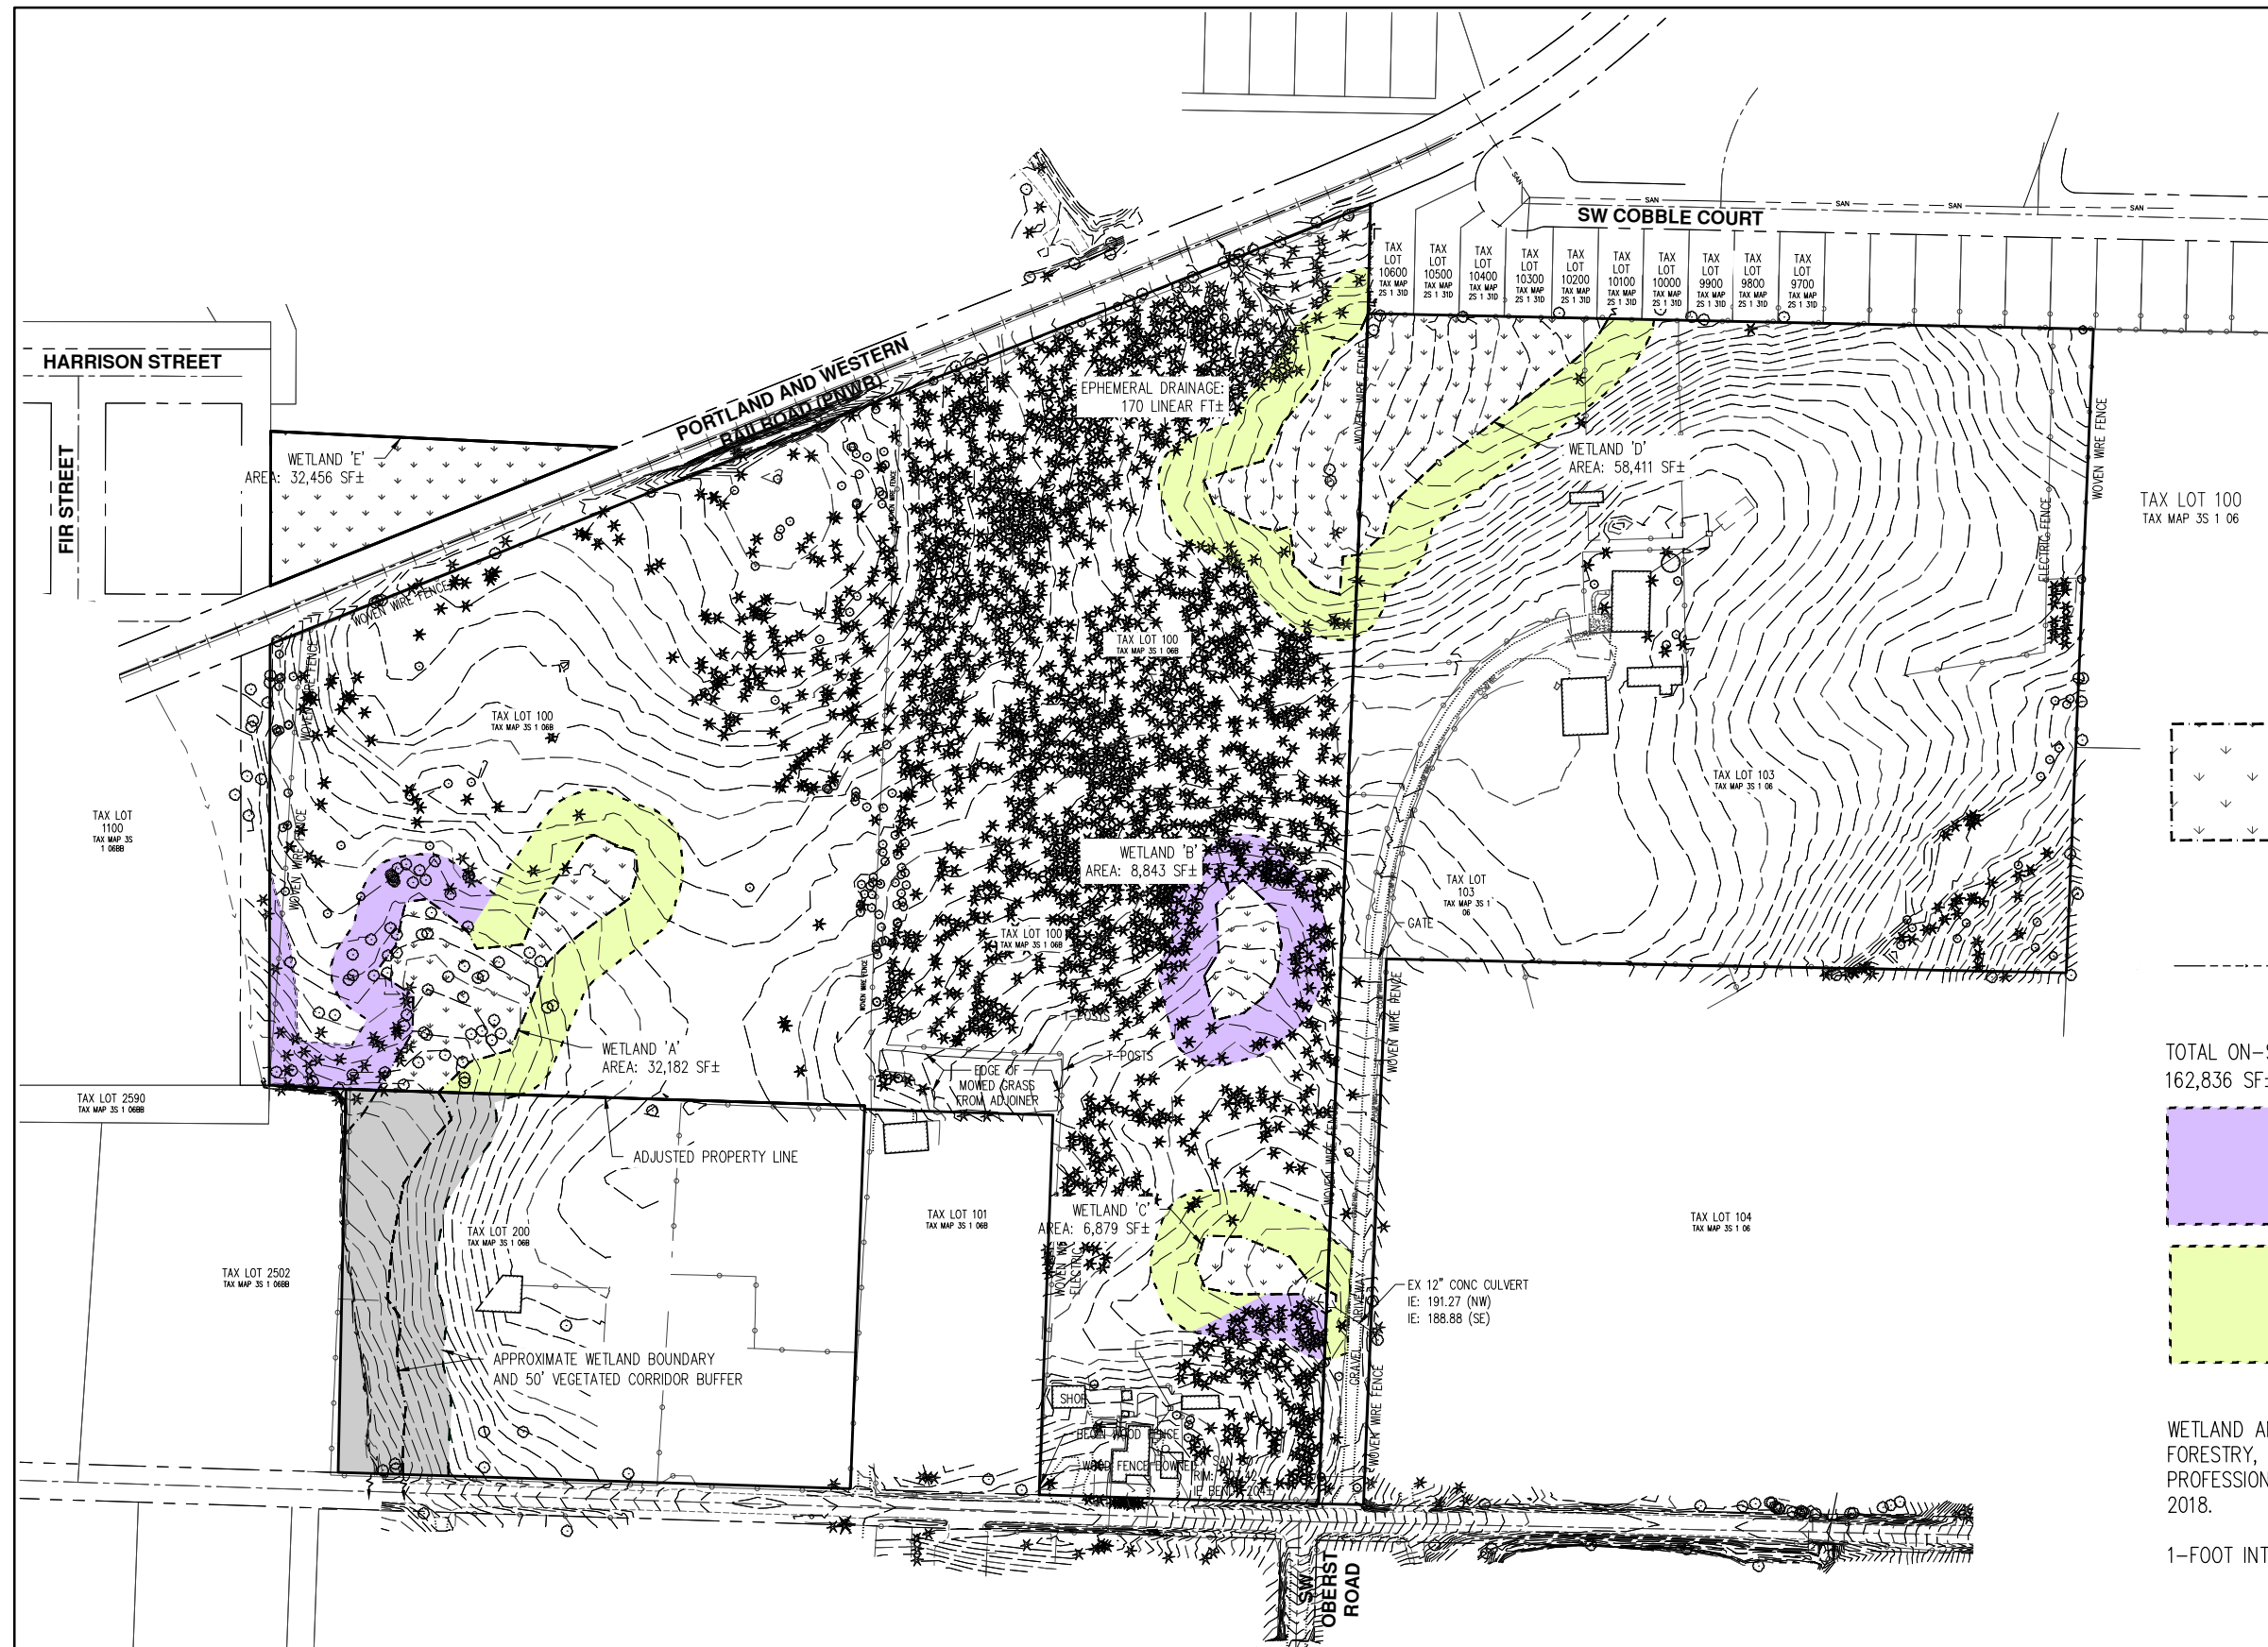
NATIONAL WETLAND INVENTORY MAP BROOKMAN RESIDENTIAL SUBDIVISION NATURAL RESOURCE ASSESSMENT		FIGURE 4
AKS ENGINEERING & FORESTRY, LLC 12965 SW HERMAN RD SUITE 100 TUALATIN, OR 97062 www.aks-eng.com PHONE: 503.563.6151 FAX: 503.563.6152		DRWN: KMK CHKD: SAR AKS JOB: 3591

Figure 4. National Wetland Inventory Map (NWI)

The U.S. Fish and Wildlife Service (USFWS) National Wetland Inventory (NWI) maps one small freshwater emergent wetland off-site to the west as seen on Figure 4. Wetlands A through E and the ephemeral drainage delineated under this study were not present on the NWI map. The study area was not included in the City of Sherwood Local Wetland Inventory.

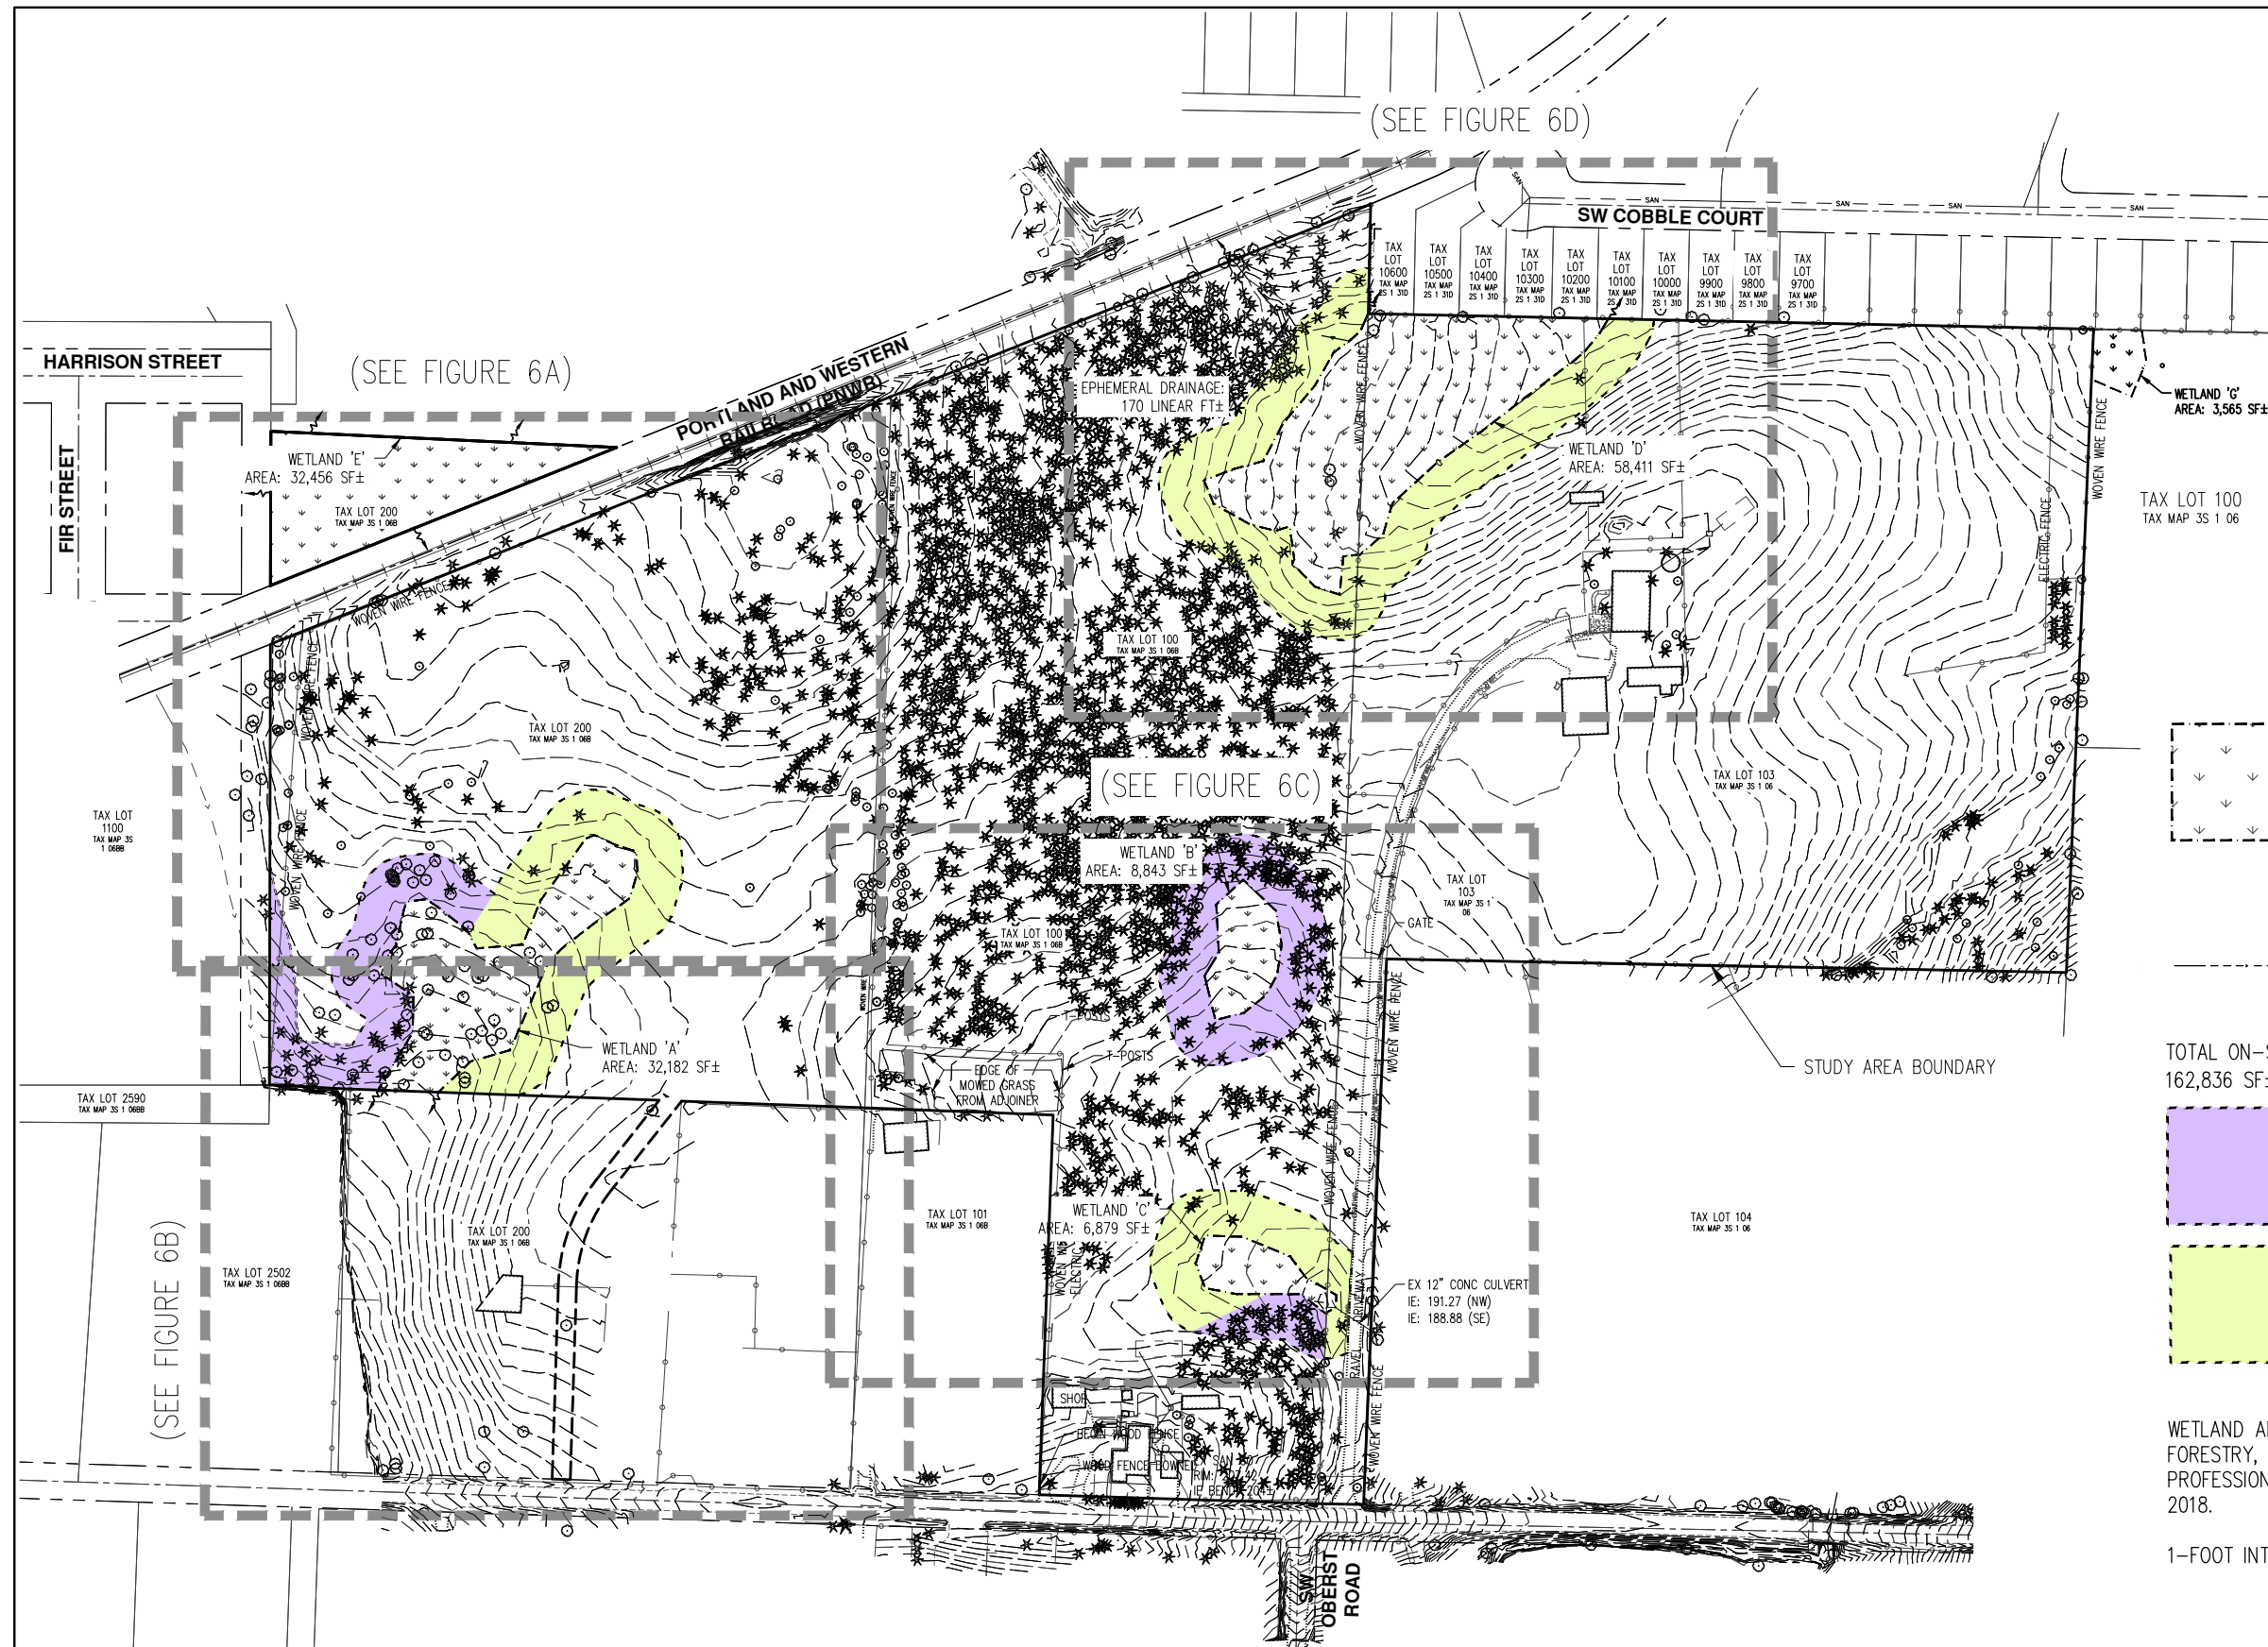
PROPERTY LINE ADJUSTMENT	FIGURE
BROOKMAN RESIDENTIAL SUBDIVISION NATURAL RESOURCE ASSESSMENT	5
AKS ENGINEERING & FORESTRY, LLC 12965 SW HERMAN RD, STE 100 TUALATIN, OR 97062 P: 503.563.6151 F: 503.563.6152 aks-eng.com	DRWN: KMK CHKD: SAR AKS JOB: 3591

- ON-SITE WETLANDS TOTAL: 138,771 SF± (3.19 ACRES±)
- WETLAND A: 32,182 SF± (0.74 ACRES±)
- WETLAND B: 8,843 SF± (0.20 ACRES±)
- WETLAND C: 6,879 SF± (0.16 ACRES±)
- WETLAND D: 58,411 SF± (1.34 ACRES±)
- WETLAND E: 32,456 SF± (0.75 ACRES±)
- ON-SITE PORTION OF EPHEMERAL DRAINAGE:
170 SF± (170 LINEAR FT±)
- TOTAL ON-SITE VEGETATED CORRIDOR:
162,836 SF± (3.74 ACRES±)
- MARGINAL CONDITION VEGETATED CORRIDOR TOTAL:
59,720 SF± (1.37 ACRES±)
- DEGRADED CONDITION VEGETATED CORRIDOR TOTAL:
103,116 SF± (2.37 ACRES±)

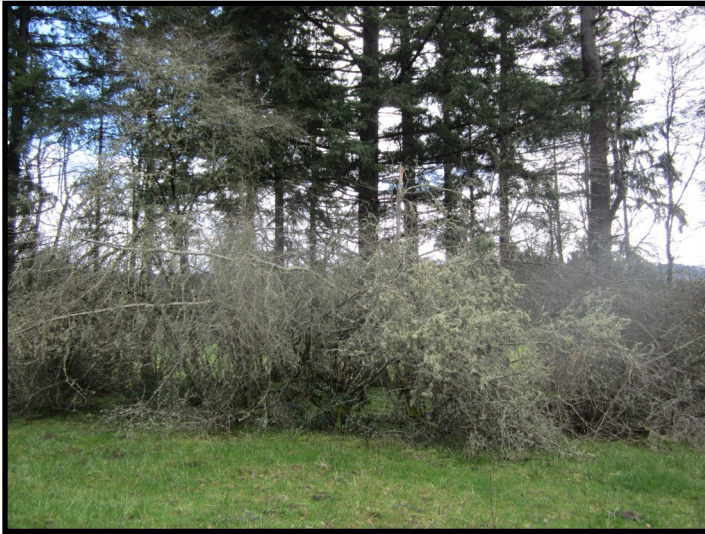
Photo A. View facing east toward VECO Plot A. Tree canopy is marginal throughout this portion of the vegetated corridor.

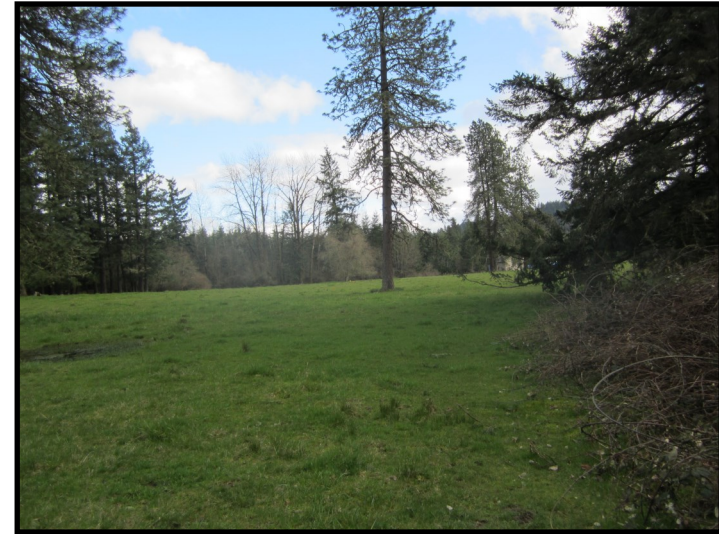
Photo B. View facing south toward VECO Plot B. The area lacks a tree and shrub layer and is dominated by non-native grasses.

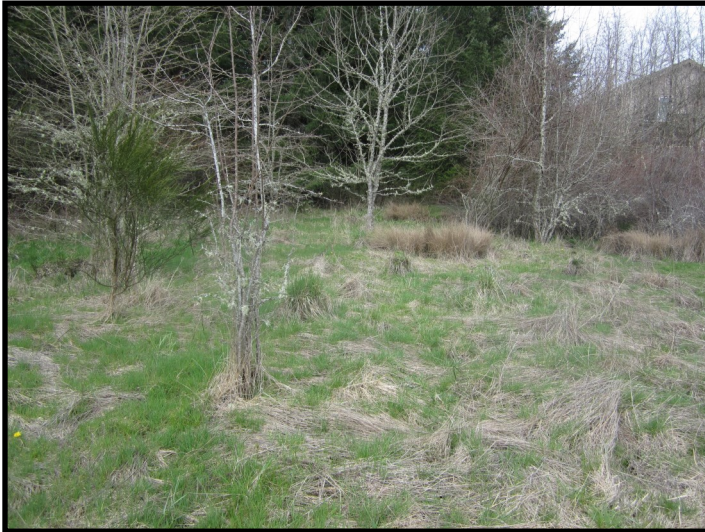
Photo C. View facing north of VECO Plot C. The area is dominated by invasive shrubs and grasses and lacks a dense tree canopy.

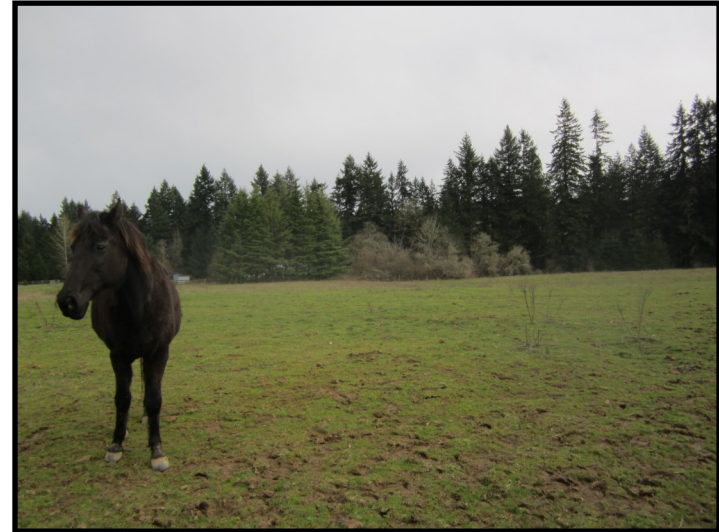
Photo D. View facing east from VECO Plot D. The area is heavily grazed by horses and lacks any shrub or canopy cover.

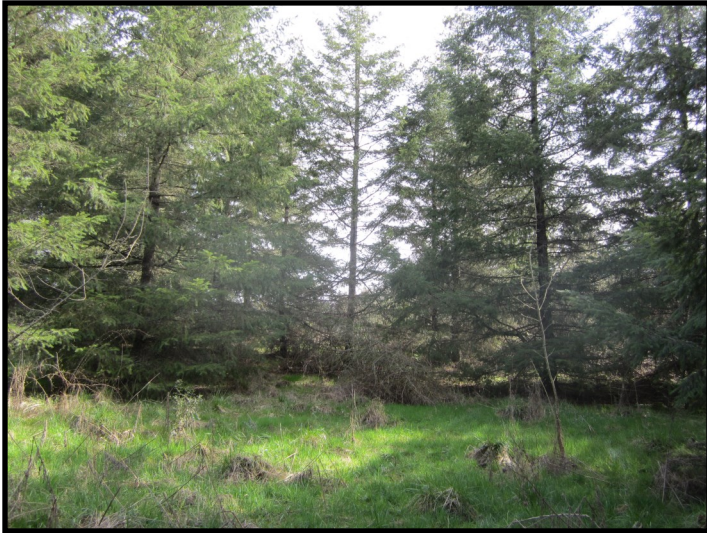
Photo E. View facing east from Wetland B. This picture represents VECO Plot E. Marginal canopy cover with dominant non-native and invasive species throughout.

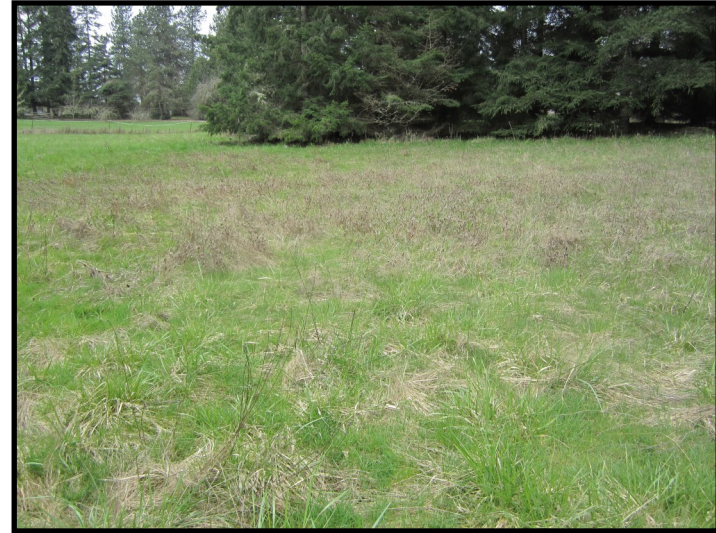
Photo F. View facing west from VECO Plot F. The area lacks a tree and shrub canopy and is dominated by non-native grasses.

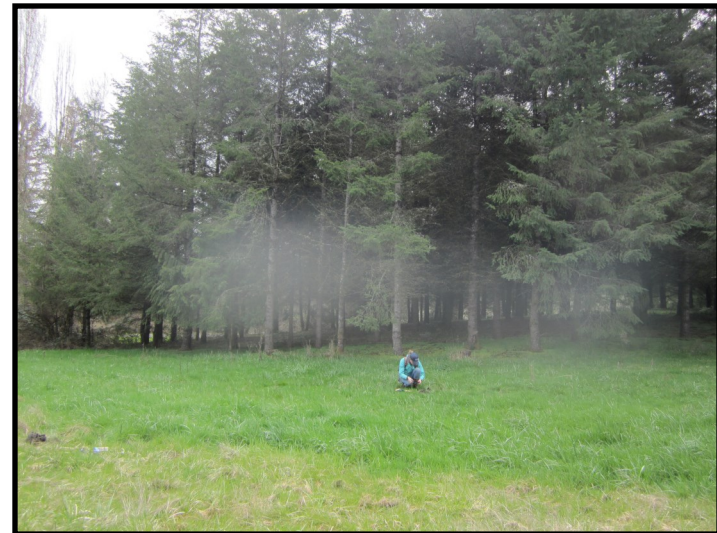
Photo G. View facing west towards VECO Plot G. The forested area is a majority of the *marginal* condition vegetated corridor.

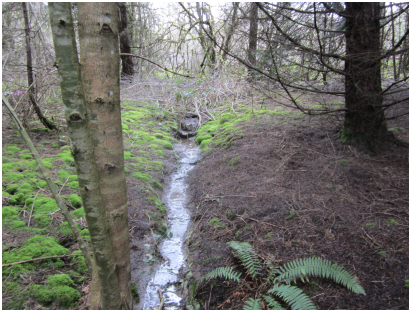
Photo A. Drainage contains flow after a period of heavy rainfall. FAC and FACU vegetation is located adjacent to channel.
